Failure analysis of gas turbine blades in a gas turbine engine used for marine applications

Abstract

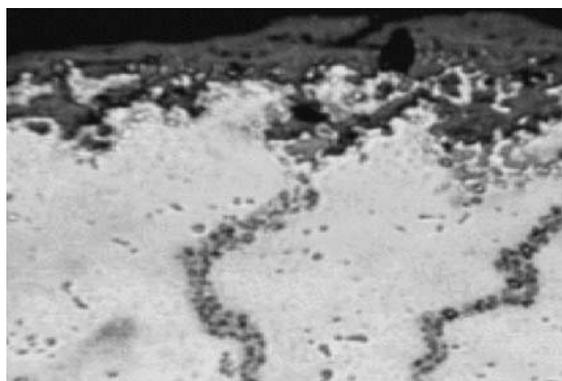
Hot corrosion on turbine blades can be intensified by the presence of vanadium, which produces V_2O_5 , in combination with the alkalis, while in molten state, can aggressively dissolve metal oxides. High temperature hot corrosion is also known as Type I corrosion, which occurs in the approximate temperature range of 825°C to 950°C (Meher-Homji). Figure.1 shows the micro-structure of the surface of the turbine blade material near the tip which has suffered from the hot corrosion.

Figure 1. Type I hot corrosion, grain boundary diffusion

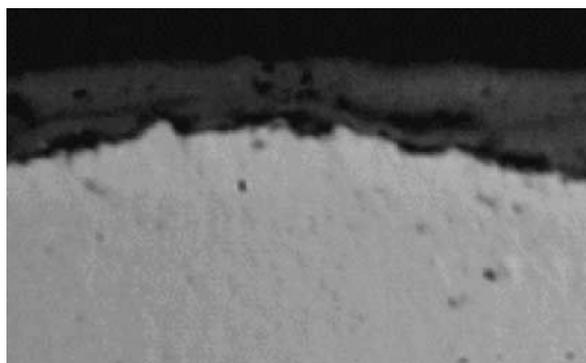
Low temperature hot corrosion (LTHC) is also known as Type II hot corrosion which occurs during the approximate temperature range of 700°C to 800°C . From the Figure.2, it was noticed that the pitting attack was typically non-uniform, with layered type corrosion scales. No intergranular attack was found in the base metal. Very little sulphide formation within the metal was observed. Figure.2 shows the micro-structure of the surface of the blade material close to the root of the blade with no grain diffusion but suffered from low temperature hot corrosion (LTHC). In both types of hot corrosion, there is a breakdown in the protective oxide layer scale aided by thermal cycling (Meher-Homji).

Figure 2. Type II hot corrosion, no grain boundary diffusion

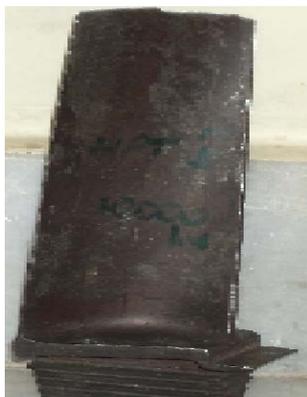
The failed HPT gas turbine blade was presented in figure 3. The blade that had operated for about 10000 hrs before its failure was made of Ni-based superalloy. The failed blade considered here was used in gas turbine engines meant for marine applications. As a part of investigation on the gas turbine blade, the following activities have been carried out to know the causes of blade failures.

Figure 3: HPT Gas turbine blade

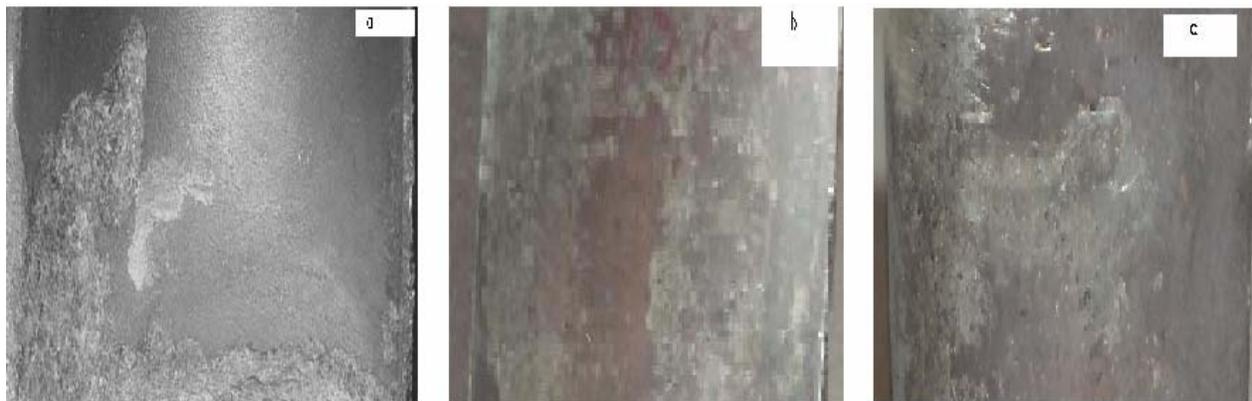
The macroscopic features of the turbine blade were observed by visual examination as a part of failure analysis. Very rough surface was noticed in the region, close to the root of the blade, and exhibited some colour change shown in Figure 4. (a). This indicates the formation of low temperature hot corrosion at this region of the blade. At the region close to the root of the blade, the temperature is normally lower than the temperature of the other parts of turbine blade during operation and therefore, these regions could be prone to be affected by low temperature hot corrosion (LTHC). Previous researchers have confirmed from their studies that the low temperature hot corrosion (LTHC) was more affective in the region close to the root of the blade and with increasing height from the root (platform), the extent of this type of corrosion gradually decreased (Viswanathan, 2001).

From the Figure 4 (b) it was observed that there was loss of some material and thickness as well, at the tip of the turbine blade which is attributed to the combined mechanisms such as hot corrosion and fatigue etc. It was further observed that there was a presence of green coloration at the tip of the blade. Some studies have reported that the greenish colour is a macroscopic feature of high temperature hot corrosion (HTHC) (Eliaz, 2002). In another study, it was confirmed that HTHC occurs away from the edges and with increasing height from the base (root) of the blade, the extent of this type of corrosion increased (Viswanathan, 2001).

Based on the visual observation and material verification, it was concluded that there was a formation of sulphidation on the turbine blade surface. Sulphidation is an important contributing factor to the failure of turbine blades especially in the turbines operating in marine environment. Figure .4 (c) depicts the pressure side of the blade which shows the damage due to hot corrosion. It was more severe near the trailing edge. The sulfur from the fuel might have reacted with the protective oxide layer attacking the base impurities, resulted in the formation of slag called liquid sodium sulfate (Na_2SO_4). Under this slag, protective oxide layer might be broken down, permitting the attack of parent blade material and causing very severe damage. This mechanism of sulphidation will rapidly damage the base material and results in loss of material. The loss of material could shift natural frequencies into dangerous regions causing the blade to vibrate with much higher amplitudes (resonance) and thereby leading to high cycle fatigue and reduced blade life time (Cyrus).

Figure 4 (a). Rough surface of the blade at the root, (b). Surface of the blade near its tip which shows some green coloration, (c). Pressure side of the blade showing the damage due to hot corrosion
