## **Investigation of Road Failure at Ogun-Osun-Alabata Road, Nigeria, Using Vertical Electrical Sounding Technique**

### **Abstract**

The road investigated in this study is a portion of Alabata road, Abeokuta. The study area of about 1000 m lies between longitude  $3^{\circ} 26' 22.61''$  and  $3^{\circ} 26' 13.81''$ E and latitude from  $7^{\circ} 11' 54.75''$  to  $7^{\circ} 11' 26.01''$ N. Alabata road is a road that links the Federal University of Agriculture, Abeokuta (FUNAAB) with the outside world (Figures 1). The economic, educational and political sections of the university depend solely on this road. Some years ago, the road was constructed to allow easy movement to and fro the campus.

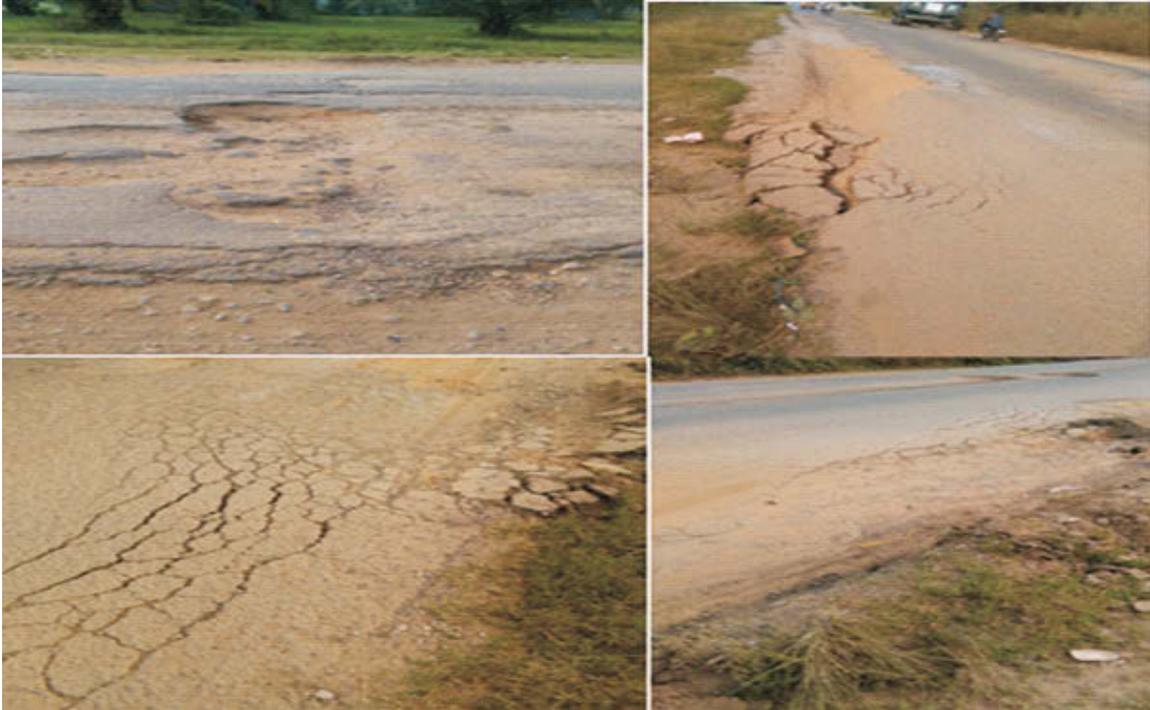
Also, the lack of drainage system along the study area has resulted in the flooding and washing away of the pavement. Over the years, the road experienced lots of failure (pot holes, faults, cracks, etc.) which affected the academic and economic growth of the institution to date.

Figure 1: Failed portion along Alabata road

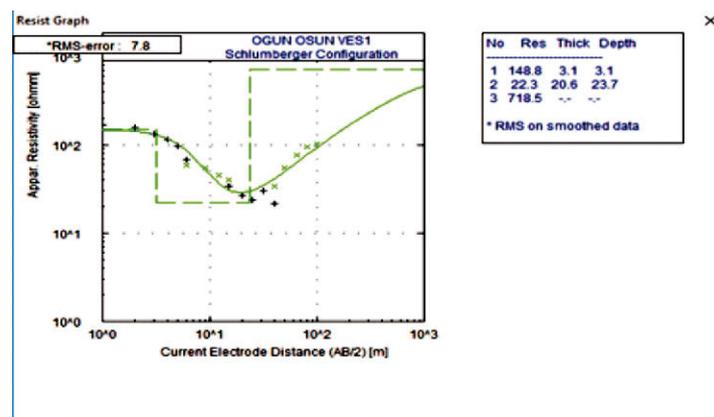
Figure 3: Interpreted Schlumberger depth sounding curve for VES 1.

VES 1 is located at latitude  $7^{\circ} 11' 54.75''$  and longitude  $3^{\circ} 26' 22.61''$ . The curve type of VES 1 is H with three geo-electric layer. The first geo-electric layer of this figure is comprised of topsoil with resistivity values of  $148.8 \Omega\text{m}$  and the thickness is 3.1 m and the depth of 3.1 m as shown in Table 1. The second geo-electric layer composed of sandy clay with resistivity values of  $22.3 \Omega\text{m}$  and thickness is 20.6 m. The third geo-electric

layer is composed of fractured basement with resistivity value of 718.5  $\Omega$ m (Figures 3 and 8a).

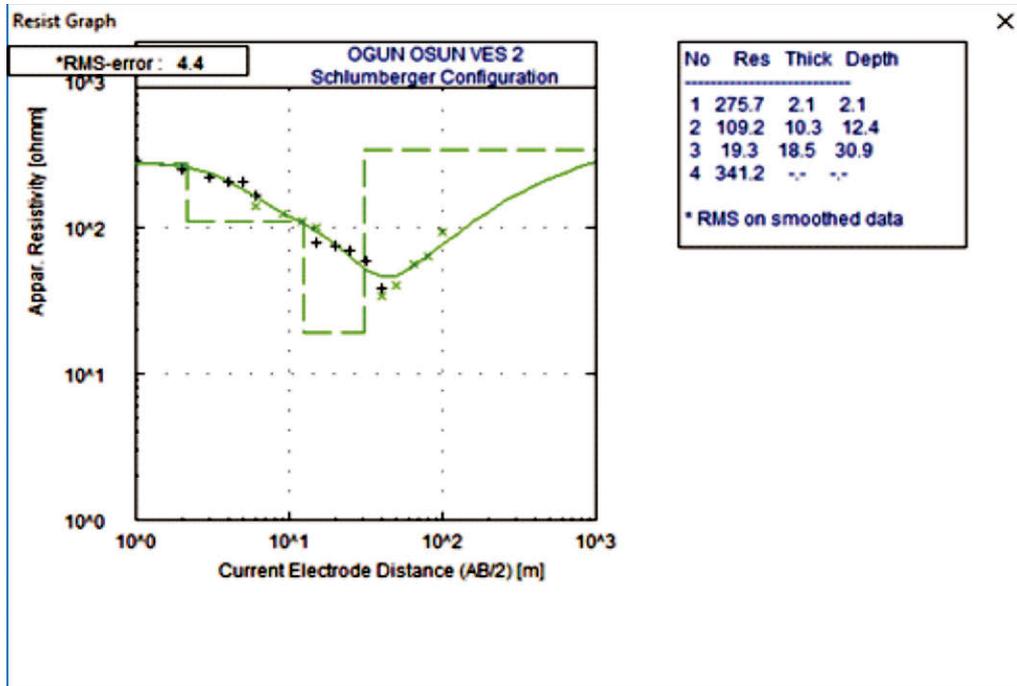
Figure 4: Interpreted Schlumberger depth sounding curve for VES 2.

The curve type of VES 2 located at latitude 7° 11' 47.42" and longitude 3° 26' 20.55" is KH with four geo-electric layers. The first geo-electric layer is composed of topsoil with resistivity values of 275.7  $\Omega$ m and thickness of 2.1 m and of depth 2.1 m respectively (Table 1). The second geo-electric layer is composed sandy clay with resistivity values of 109.2  $\Omega$ m and thickness 10.3 m and depth of 12.4 m. The third geo-electric layer is composed of saturated sandy clay with resistivity of 19.3  $\Omega$ m and thickness of 30.9 m. The fourth geo-electric layer is composed of the weathered fractured basement layer with resistivity value 341.2  $\Omega$ m. (figures 4 and 8b)

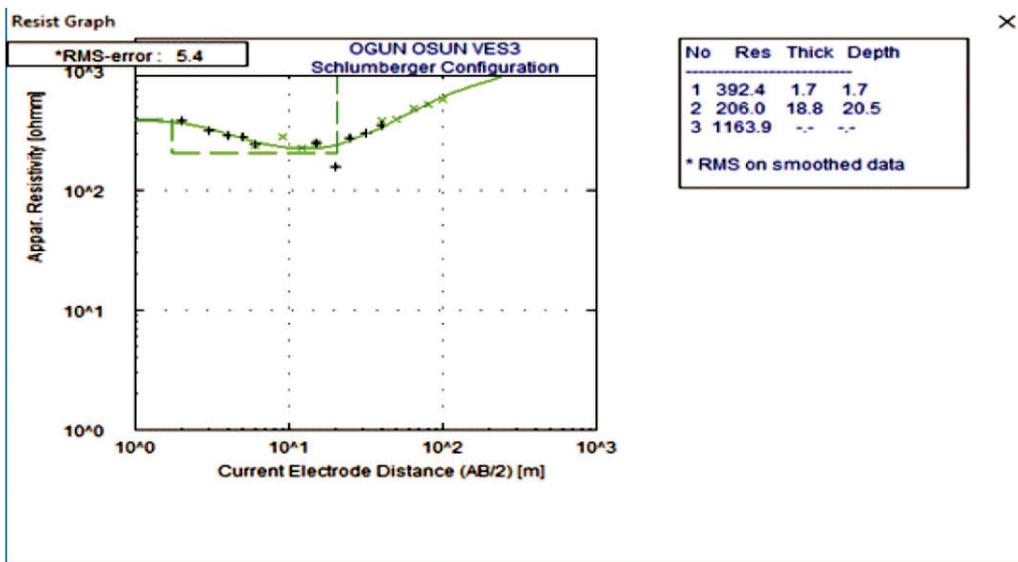
Figure 5: Interpreted Schlumberger depth sounding curve for VES 3

In the VES 3 located at latitude 7° 11' 40.22" and longitude 3° 26' 17.91", the curve type of VES 3 is H with three geo-electric layer VES 4 has 3 geo-electric layer. The first geo-electric layer of this V.E.S is composed of topsoil with resistivity values of 392.4  $\Omega$ m and the thickness is 1.7 m and the depth of 1.7 m. The second geo-electric layer composed of sandy clay with resistivity values of 206.0  $\Omega$ m and thickness is 18.8 m (Table 1). The third geo-electric layer is

composed of fractured basement with resistivity value of 71163  $\Omega$ m as shown in Figures 5 and 8c respectively.

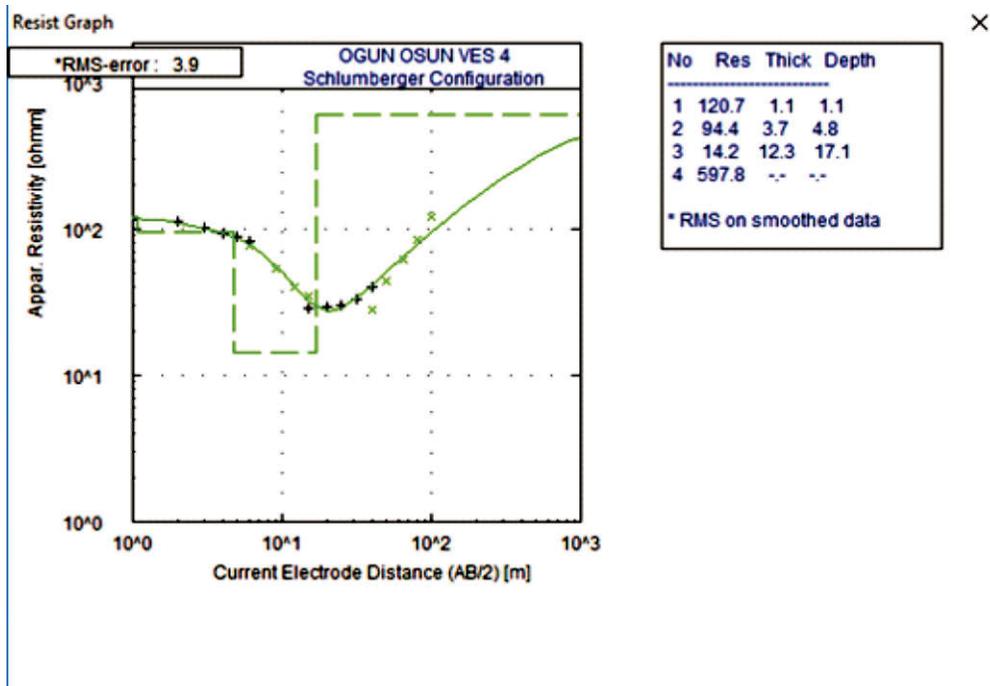
Figure 6: Interpreted Schlumberger depth sounding curve for VES 4

VES 4 is located at latitude 7° 11' 32.44" and longitude 3° 26' 16.61". The curve type of VES 4 is KH with four geo-electric layers. The first geo-electric layer of this VES is composed of topsoil with, resistivity values of 120.7  $\Omega$ m and thickness of 1.1 m and of depth 1.1 m. (Table 1). The second geo-electric layer is composed of sandy clay with resistivity values of 94.4  $\Omega$ m and thickness 3.7 m and depth of 4.8 m. The third geo-electric layer is composed of saturated sandy clay with resistivity of 14.2  $\Omega$ m and thickness of 17.1 m. Figures 6 and 8d show the fourth geo-electric layer composed of the fractured basement layer with resistivity value 597.8  $\Omega$ m.

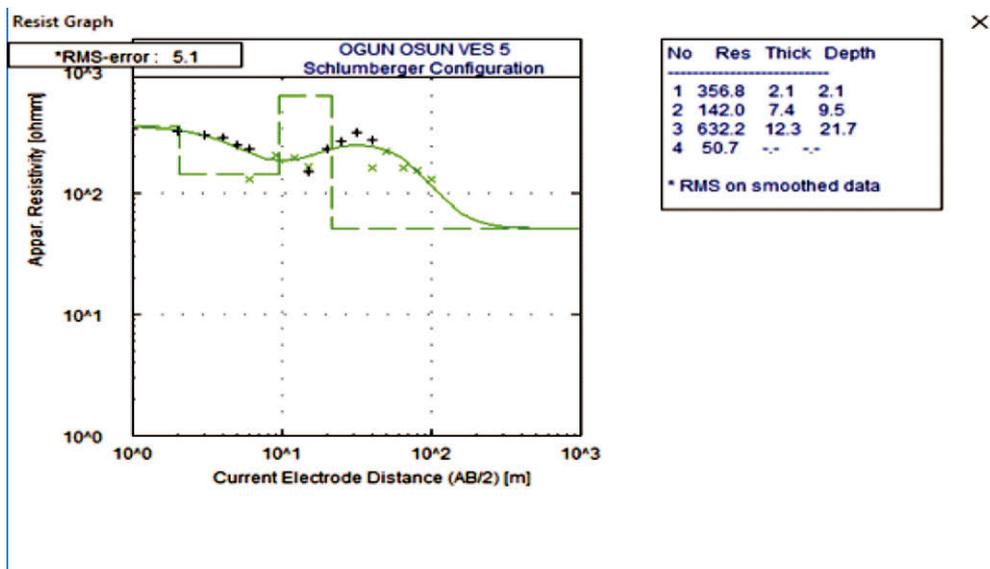
Figure 7: Interpreted Schlumberger depth sounding curve for VES 5

The location of VES 5 is found at latitude 7° 11' 26.01" and longitude 3° 26' 13.81". The curve type of VES point is QH geo-electric layers. The first geo-electric layer of this VES is composed of topsoil with, resistivity values of 356.8  $\Omega$ m and thickness of 2.1 m and of depth 2.1 m. The second geo-electric layer is composed clayey soil with resistivity values of 142.0  $\Omega$ m and thickness 7.4 m and depth of 9.5 m. The third geo-electric layer is composed of lateritic soil

with resistivity of 632.2  $\Omega\text{m}$  and thickness of 17.1 m. The fourth geo-electric layer is composed of the fractured basement layer with resistivity value 50.7  $\Omega\text{m}$  in figures 7 and 8e.

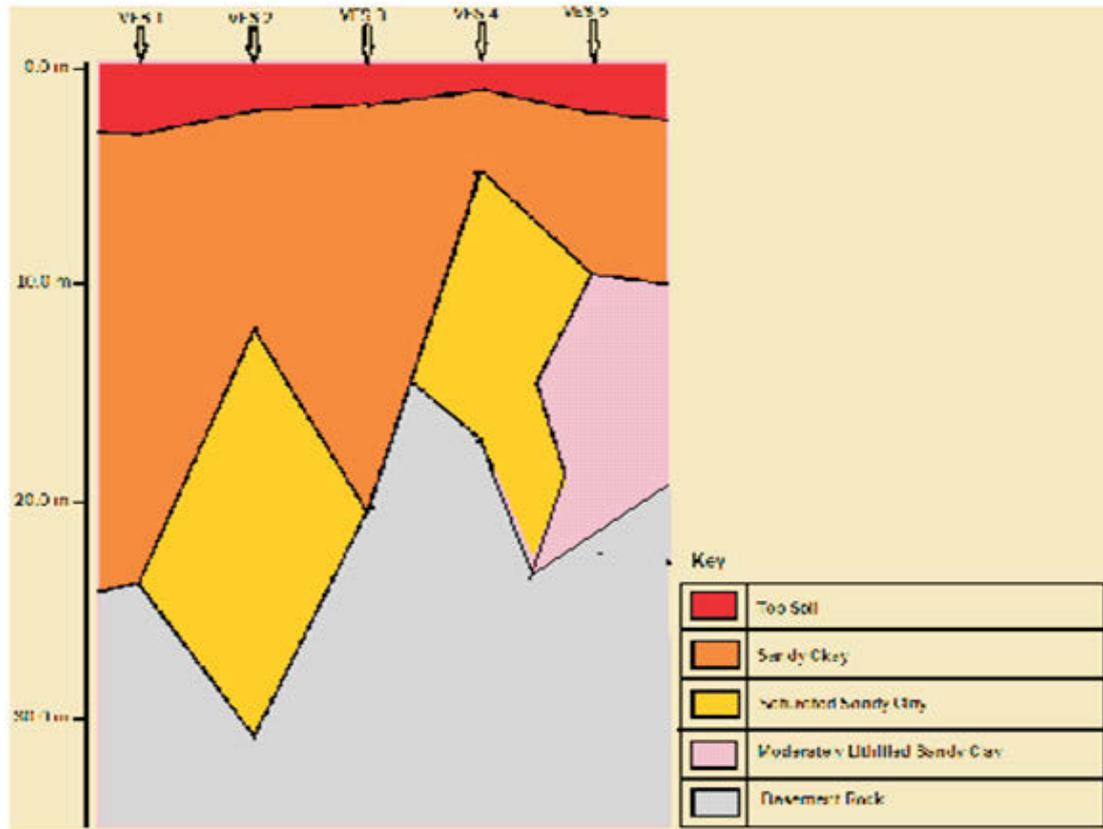
Figure 9: The Goelectric section of the VES.

Geoelectric section for the study area was drawn along VES 1-VES 5 for the road (Figure 9). The geoelectric section for the road is characterized by layers of topsoil, sandy clay (clayey), saturated sandy clay and fractured basement layer except for VES 5, where there is sandy clay (laterite) and weathered basement. The first layer is topsoil which has resistivity ranges from

392.4  $\Omega\text{m}$  with thickness ranging from 1.1-3.1 m. The second layer resistivity (sandy clay) ranges from 22.3 -206  $\Omega\text{m}$  and the thickness ranging from 3.7-20.6 m. The fractured basement layer have resistivity ranging from 50.3 -1163.9  $\Omega\text{m}$ . The saturated sandy clay which is found in VES 2 and VES 4 have resistivity ranging from 14.2 -19.3  $\Omega\text{m}$  and thickness from 12.3-18.5m.

basement/weathered material and fractured basement. Base on this result, the layer with low resistivity (sandy clay) basement cannot be used for road construction purposes. Therefore it has to be excavated and fill with lateritic materials which are more stable.
