# Geophysical Investigation of Road Failure in The Chad Basin, A Case Study of Damaturu Metropolitan Roads, Nigeria

Agada Livinus Emeka, Yusuf Mohammed Auwal

Department of Physics,  
Yobe State University,  
Damaturu.

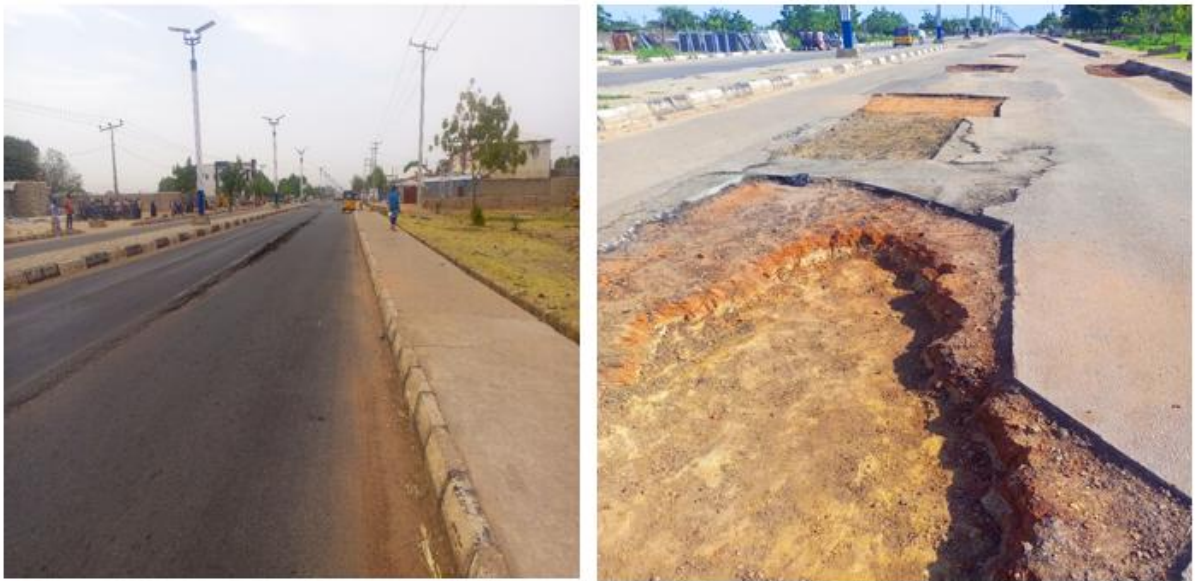
Figure 1: Image of the affected parts of the highway roads in the study area.

The shrinking and swelling of clay materials are significant contributors to road failures in the Chad Basin due to their closeness to the earth's surface. The swelling pressure causes deformation or elevation of near-surface structures, while the shrinking results in differential subsidence of the road surface (Figure 1).

Roads in the study area experience prolonged failures characterized by the emergence of potholes, fracturing, swelling, and depressions along the highway. Inadequate rock materials like clay are unsuitable for supporting road pavement due to their inconsistent reactions to subsurface moisture dynamics. Subgrades that include clay materials are often linked with frequent expansion and contraction that lead to the formation of folds, fractures, and potholes. Road failures are a major contributor to road accidents in the study area and throughout Nigeria. Seasonal fluctuations in subsurface moisture levels increase the frequent swelling and shrinking of roads in the study area, which results in their failures. The results of this study is in consonance with the report of Emmanuel *et al.* (2021) as stated in the literature.

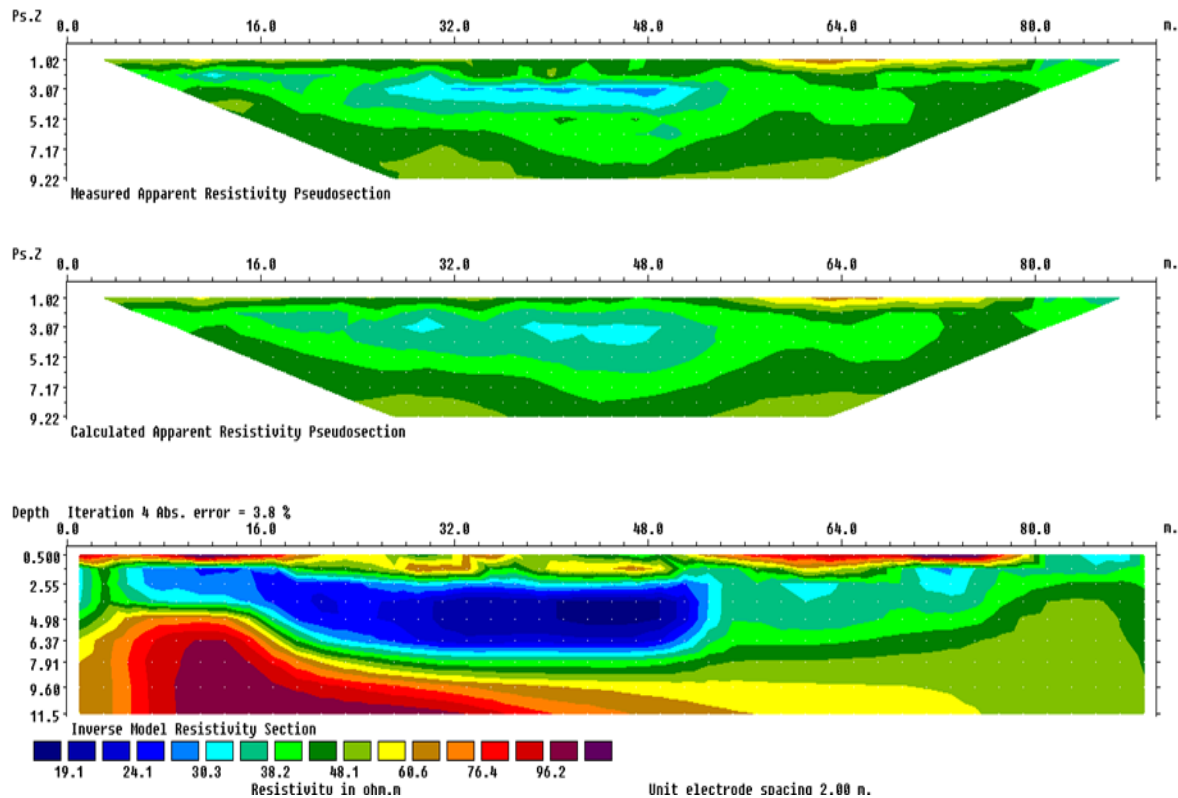
Figure 4: ERT survey results of profile 2.

In certain areas of the study region, the clay materials are located beneath the topsoil (Figure 4), whereas in other areas, they are visible at the surface (Figure 7).

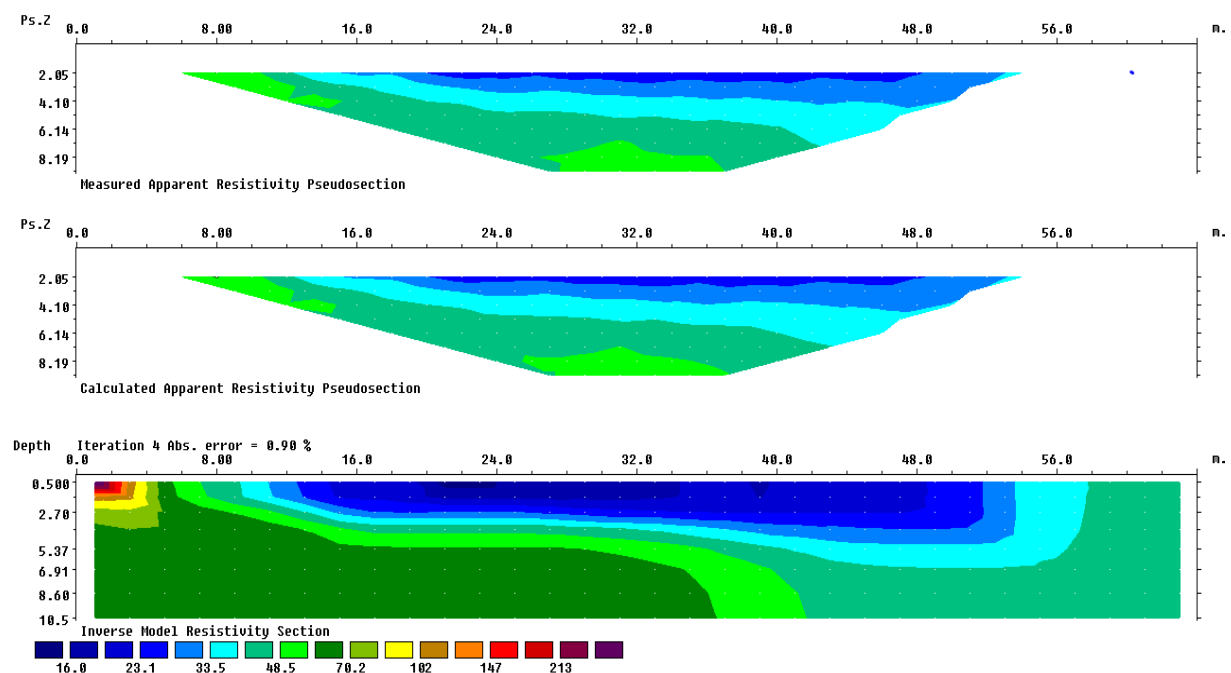
Figure 5: ERT survey results of profile 3.

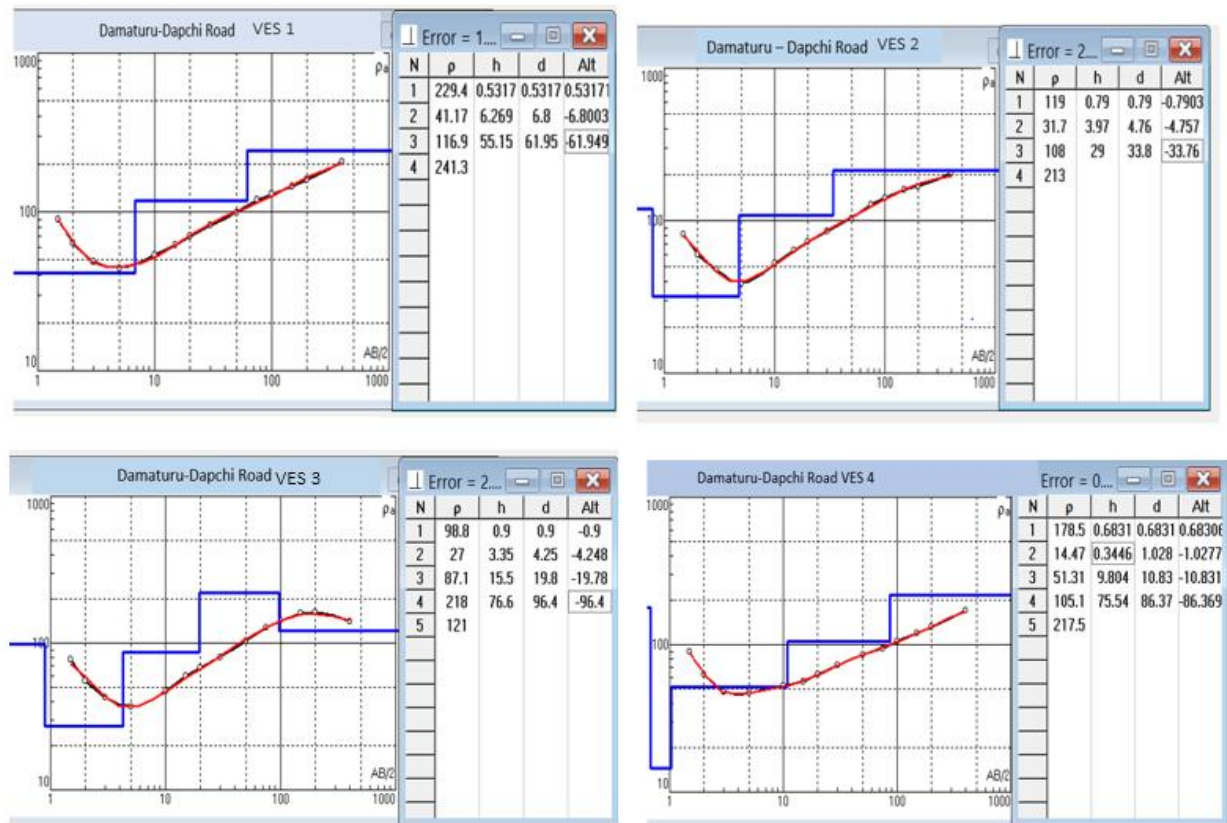
The Vertical Electrical Sounding survey defined geoelectric layers including topsoil, clay, sand, and sandy-clay in the study area. The majority of the geoelectric curves derived from the study area are HA curves (Figure 6).

Figure 6: Typical curves obtained from the study area.

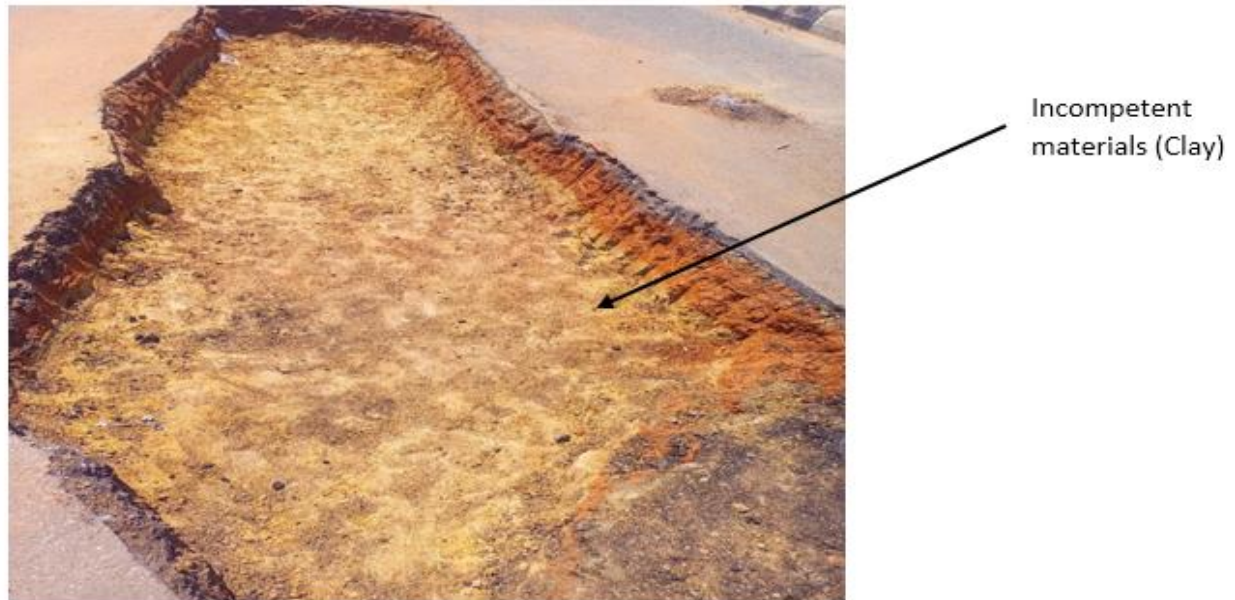
Figure 7: Clay materials underlying the Pavement of the road.
