GEOPHYSICAL INVESTIGATION OF ABANDONED BACK-FILLED RAILWAY LINE: IMPLICATION ON ADJACENT BUILDINGS

ABSTRACT

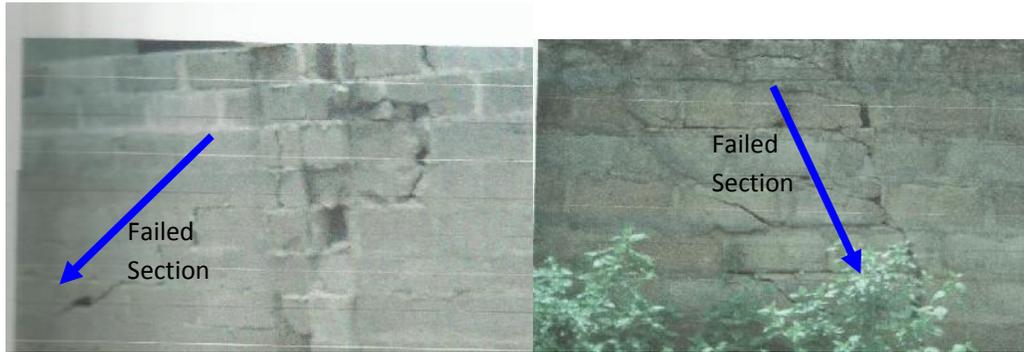
The residents of Okebadan Estate in Ibadan observed conspicuous failure on some buildings in the area, thus drawing the attention of the public to deduce the cause(s) of the failed foundation via jagged spaces noticed on the walls of some buildings (Plates 1 to 4). This study stemmed from the failure associated with buildings constructed on the back-filled railway route at Okebadan Estate. A fish pond cited along the failed section leaked into the nearby hand dug well, thus, contaminating the groundwater in the vadose zone. Geophysical mapping of the subsurface foundation material in the failed segment was carried out using electrical resistivity method. Electrical resistivity method has shown wide usage in foundation investigation because of its simplicity and cost effectiveness, hence it is a rapid tool for geotechnical investigations (Loke (2000), Momoh et al. (2008), Sudha et al. (2009), Oyedele and Olorode (2010)). Two-dimensional (2-D) resistivity tomography has been a vital tool in depicting subsurface layers due to its continuous lateral and vertical imaging along a traverse (Ayolabi et al., 2009). Akintorinwa and Adeusi (2009) studied the foundation material for a proposed engineering structure using combined geophysical and geotechnical approaches; the geo-electric units were established from the resistivity study and also to locate possible fracture which could lead to foundation failure. The result corroborated the geotechnical findings. Sudha et al. (2009) made an attempt to integrate electrical resistivity and geotechnical data in characterising subsurface soil conditions, and also established the suitability and rapid approach of resistivity technique in geotechnical studies. Oyedele and Ekpoette (2011) reported the use of

Plate 1: Structural failure as observed on the wall **Plate 2:** Structural failure as observed on the wall

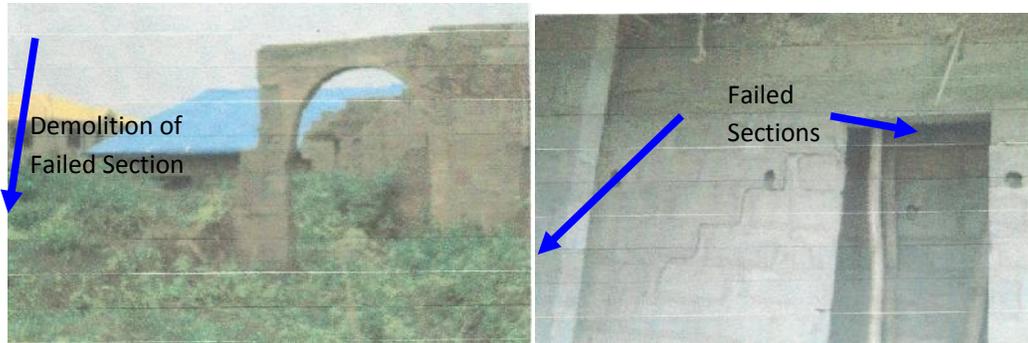
Plate 3: Failed segment led to demolition of some part of the building **Plate 4:** Structural failure as observed on the wall

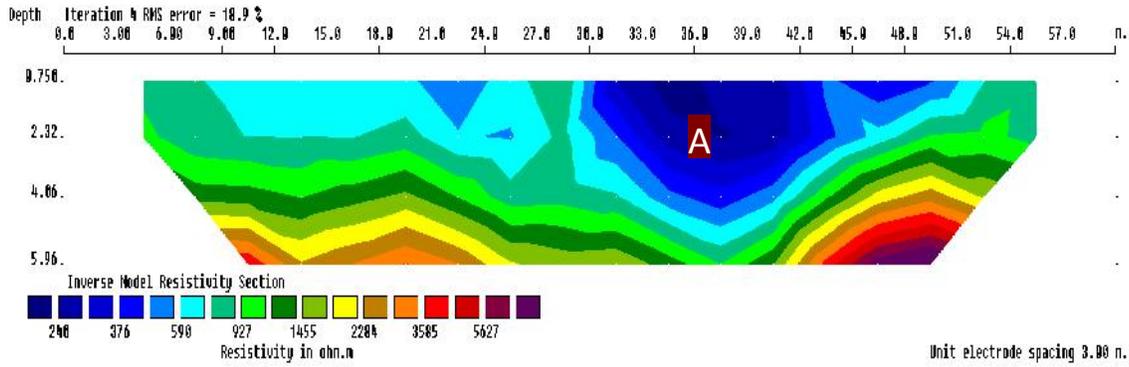
Profile 1 (Figure 2) shows that the inverted section is characterised with non-uniqueness in the subsurface material as compared with the control segment. It could be observed that the less resistive material (248-376 Ω -m) is sandwiched between the more resistive units (>900 Ω -m) from electrode position 30 m to 42 m and to a depth of about 4 m, and this region is denoted with 'A' on the inverted section. The low resistivity region was assumed to be made up of clayey sand material and this region is suspected to be back-filled railway route. This earth material could be responsible for structural displacement of building sited along this particular route. Profile 2 (Figure 3) shows a very low resistivity value (106 Ω -m) around the suspected back-filled railway route. This low resistivity region is denoted by letter 'A' on the inverted section, it indicates the presence of clayey material which extends from 39m to 45m and extends to a depth of about 3m. The less resistive unit is encompassed by high resistive material (>450 Ω -m -1182 Ω -m) on the either side, indicating a saturated region being enclosed by unsaturated units. This geologic material is presumed to be contributing to the foundation failure observed along the suspected backfilled rail route. Profile 3 (Figure 4) is characterised by pocket of low resistive (232 Ω -m) material occurring between station 12m and 24m, which extends to a depth of less than 4m. The observed resistivity value within this region corresponds to clayey sand material. This geomaterial is apparently unable to

Figure 2: Resistivity distribution generated from the inverted section along Profile 1

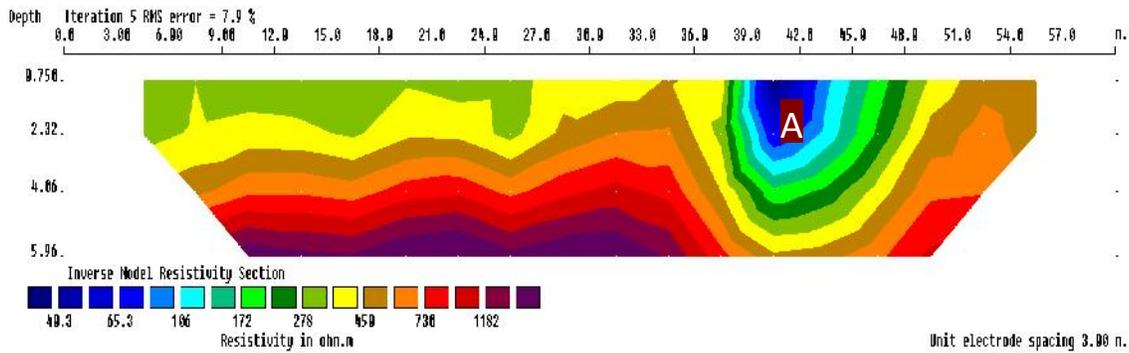
Figure 3: Resistivity distribution generated from the inverted section along Profile 2

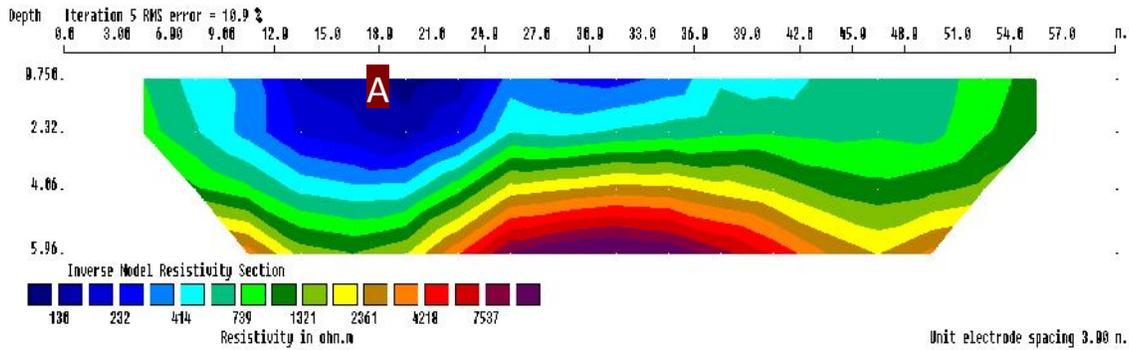
Figure 4: Resistivity distribution generated from the inverted section along Profile 3

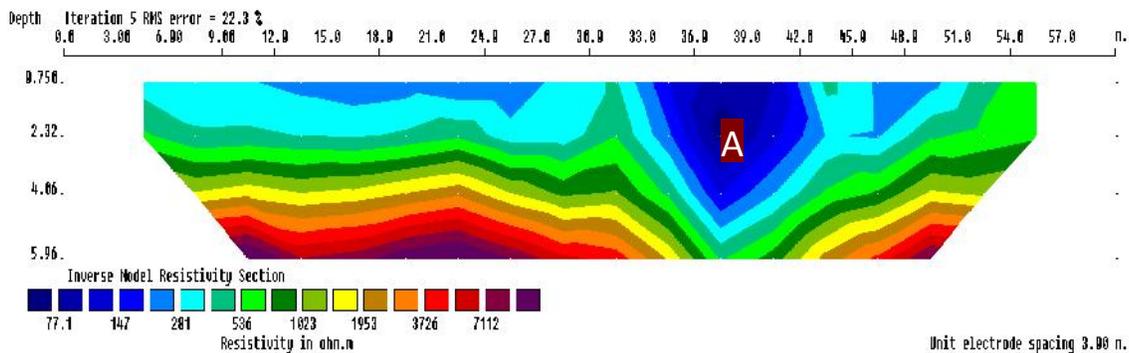
bear the load of the erected structures leading to the known failure in this environment. The suspected failed portion is denoted with 'A'. Along profile 4 (Figure 5), low resistivity value (77 Ω -m to 281 Ω -m) is noticed between 33m and 42m, this low resistive region was presumed to be made up of clay and clayey sand materials. These earth materials could be the source of structural failure of buildings located on the suspected back-filled railway route. The inverted section of profile 5 (Figure 6) represents the resistivity distribution obtained from a control line conducted where there is no back-filled railway route. This image line shows that the resistivity of the subsurface materials decreases with depth. There was no localized low resistivities region as observed along Profiles 1-4 where the back-filled railway route passes. It is therefore safe to adduce that the localized low resistivities region observed along Profiles 1, 2, 3, and 4 is as a result of material used in back filling the abandoned route. The clay materials are not permeable but porous, and they exhibit unstable structure because they are subjected to change and alterations. The swelling and shrinking of these clay materials may be suspected as a likely source of the failure. The clayey sand tends to re-arrange its mineral grains as a result of overlying load thereby leading to reduction in volume and tight packing. Certain portion of the foundation that falls on this material tends to settle rapidly compared to the rest portion constructed on stable material.

Figure 5: Resistivity distribution generated from the inverted section along Profile 4

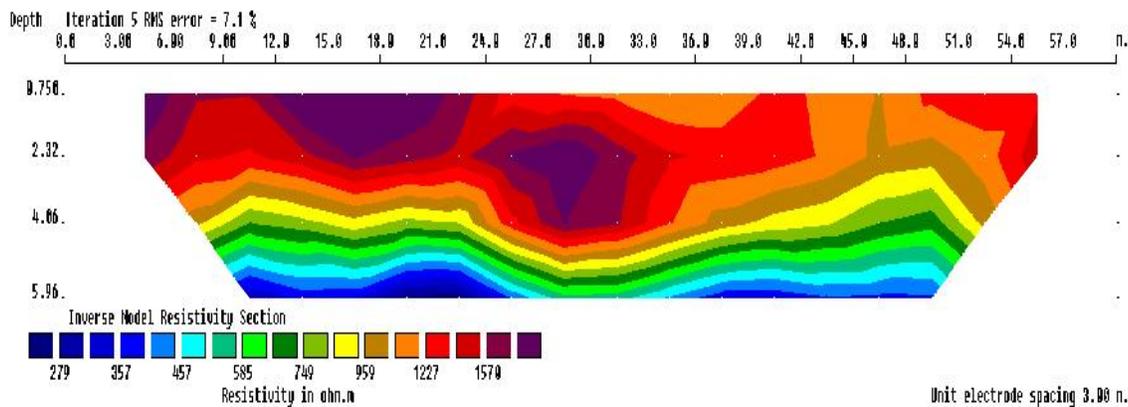
Figure 6: Resistivity distribution generated from the inverted section along Profile 5
