Borehole Rehabilitation: A Case Study in the Dunkwa Mining Town*

¹A. Ewusi and ¹J. Seidu

Ewusi, A. and Seidu, J. (2020), "Borehole Rehabilitation: A Case Study in the Dunkwa Mining Town", *Ghana Mining Journal*, Vol. 20, No. 2, pp. 11-17.

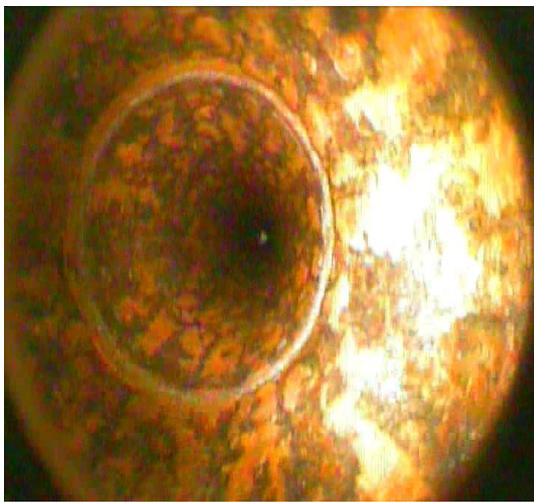
The camera inspection of the Dunkwa BH 1 borehole indicated an open borehole with 10" steel casing up to 32 m. The internal surface of the steel casing is rusted (Fig. 3). No major fractures were identified in the camera inspection. The borehole has a current depth of 75 m. Water was turbid and mud-laden. The borehole required rehabilitation by redevelopment as the silted zone may have sealed the aquifer zones.

Fig. 3 Rusted Casing Material at BH1

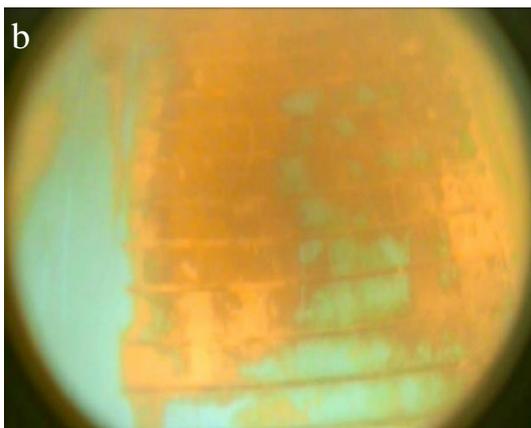
The camera inspection of the Dunkwa BH 3 borehole indicated a composite borehole design with screen positions located between 9 - 21 m, 27 -30 m and 39 - 43 m, and plain PVC elsewhere over a borehole of 45 m depth. The diameter of the borehole is 6". Biofilming was observed on portions of the screen and plain (Fig. 4). Water was slightly sand-laden. The PVC as observed from the inspection showed no indication of compromised integrity.

Fig. 4 Biofilming of the Borehole (BH3)
