JOURNAL OF RADIOGRAPHY

Vol 32, Issue 1, May 2018

Quality Control of Conventional X-ray Tube in Three Tertiary Hospitals in South-East, Nigeria

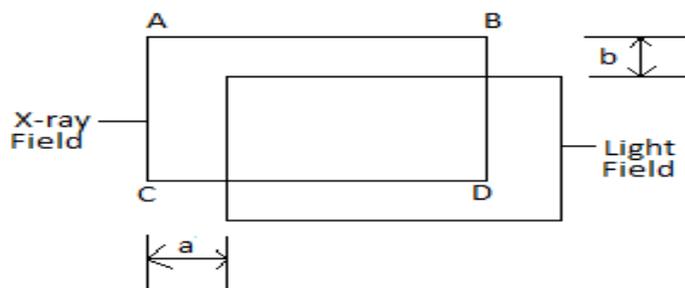
Figure 2c: Diagrammatic representation of misalignment from developed radiograph

As shown in Fig 2, the magnitude of deviation (E) in percentage was calculated as follows:

$$E \text{ in horizontal direction} = \left(\frac{a}{|AB|} \right) \times 100\% \quad \dots (1)$$

$$E \text{ in vertical direction} = \left(\frac{b}{|AC|} \right) \times 100\% \quad \dots (2)$$

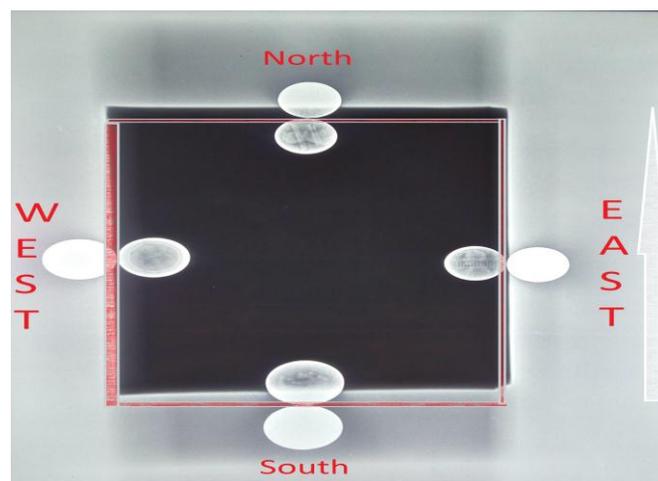
Figure 2d: Processed radiograph showing evidence of x-ray and light fields misalignment. The red perimeter which passes between coins represents collimation prior to irradiation. After processing, it was observed that the radiation field did not coincide with light beam but had a South – North movement as shown by the white arrow. Black portion represents radiation field while white portion within red perimeter represents light field.

X-ray field and light field congruence results presented in this study showed gross misalignment in all the centers surveyed, with sum of misalignment in both orthogonal directions ranging from 7.21% to 9.70% of FID. Similarly, Farzeneh [15] reported that all the nine units studied failed optical field and radiation field compliance test in Sistan and Baluchistan, Iran. In contrast, Nkuba and Nyanda [14] reported that out of sixty x-ray units in Tanzania, 97% of light field and x-ray field measurements were within recommended limits. Also, Kareem et al [16], reported from Malaysia in their measurement using collimation (beam) alignment test tool. In their study, their findings of radiation field and optical congruence tests were within standard limit (0.4%).

This misalignment occurs in the x-ray collimator when the reflecting mirror or the light bulb or both, shift from normal position. It can also occur when the secondary lead collimator blades shifts from its normal position. If the x-ray field and the light field are misaligned the image produced may be off-centered, too small or too large [2]. The effect of x-ray field and light field misalignment is that it would leads to increase in the waste films, waste of resources, time and increase in medical and occupational dose because, additional radiographs will be required to produce good quality image [4].
