## 2D Electrical Resistivity Imaging of Bedrock Fissures in Ogbomosho, Southwestern Nigeria

\* Akinlabi I. A. and Bayowa O. G.

Department of Earth Sciences, Ladoké Akintola University of Technology, P.M.B 4000, Ogbomosho, Nigeria.

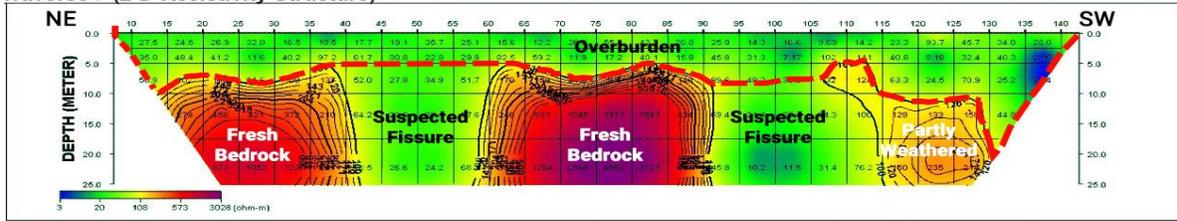
Figure 2: 2D Resistivity section beneath Traverse 1

The 2D resistivity sections beneath Traverse 1 (Figure 2) reveals an overburden with resistivity ranging from 2.0 to 89.6  $\Omega\text{m}$  and thickness varying from 7-11 m. The resistivity of the fresh bedrock ranges from 279 to 4962  $\Omega\text{m}$ . The low values represent the bedrock underlying the southwest end of the traverse which appears to be intensely weathered. The low resistivity zones observed at distances 40-60 m and 90-110 m are suspected to be bedrock fissures.

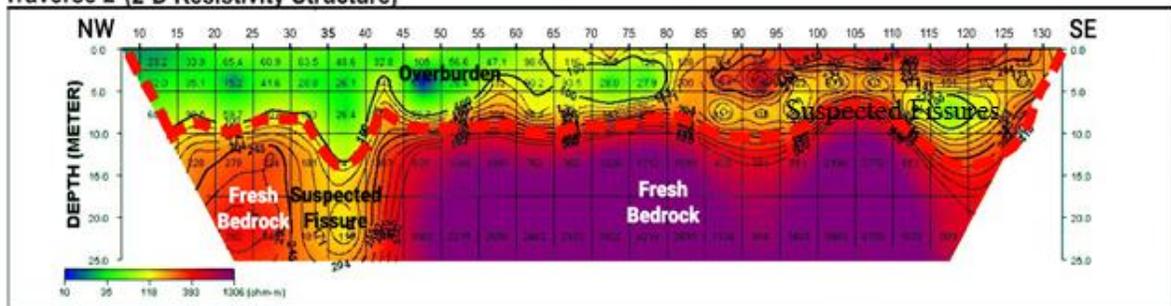
Figure 3: 2D Resistivity section beneath Traverse 2

Traverse 2 is underlain by 7-10 m thick overburden with resistivity less than 100  $\Omega\text{m}$  at distance 0-80 m from the northwest end, and a relatively resistive overburden, about 2.5 m thick, with resistivity 101-360  $\Omega\text{m}$ , from distance 80 m to the southeast end (Figure 3). The bedrock resistivity ranges from 1040 to 4700  $\Omega\text{m}$  and is apparently fissured at distance 30-40 m beneath 13 m depths. The more resistive overburden may have been produced by bedrock fissure suspected to have occurred within the stated intervals (Mandal and Mishra, 2019).

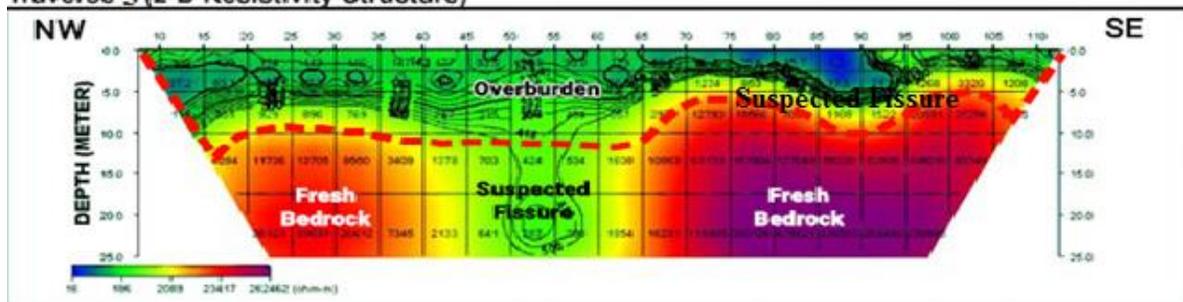
Figure 4: 2D Resistivity section beneath Traverse 3

The overburden beneath Traverse 3 has resistivity ranging from 13.7 to 404  $\Omega\text{m}$  suggestive of clay-sand mixture in varying ratios, while its thickness 5-10 m thick (Figure 4). Resistivity of the fresh bedrock ranges from 4284 to 419621  $\Omega\text{m}$ . Weak zone suspected to be bedrock fissure occurs at distances 40-60 m beneath 10 m depth.

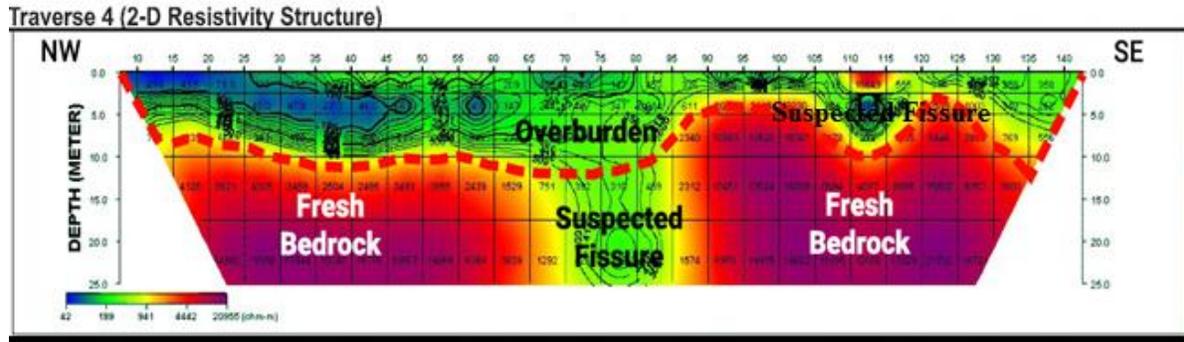
Figure 5: 2D Resistivity section beneath Traverse 4

Traverse 4 is underlain by an overburden with resistivity ranging from 46 to 424  $\Omega\text{m}$  and thickness varying from 2.4 m to 10 m (Figure 5). Resistivity of the fresh bedrock beneath the traverse shows resistivity values ranges from 951 to 9096  $\Omega\text{m}$ . The low resistivity zone occurring at distances 65-70 m and 105-120 m beneath 11 m and 2.5 m depths respectively, are suspected bedrock fissures.

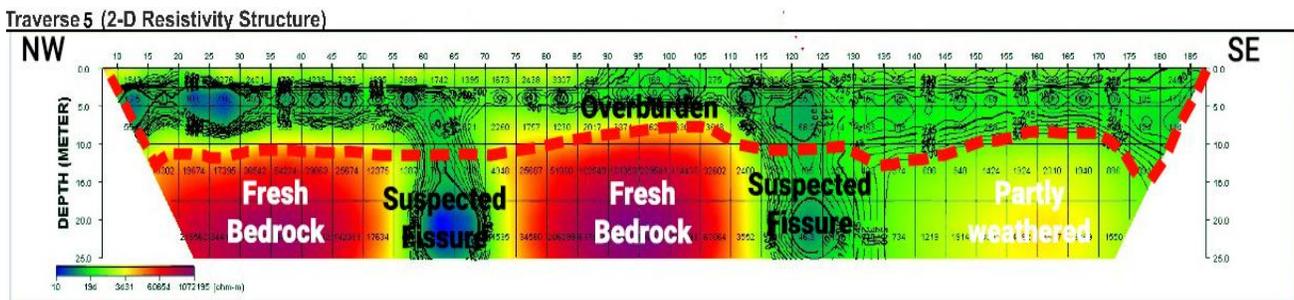
Figure 6: 2D Resistivity section beneath Traverse 5

The 2D resistivity section beneath Traverse 5 (Figure 6) reveals an 8-15 m thick overburden comprising sand-clay mixture of resistivity 7-275  $\Omega\text{m}$  overlain by lateritic hardpan of resistivity 1235-4625  $\Omega\text{m}$  in the top 2.5 m from the northwest end to distance 85 m, and underlain by partly weathered bedrock of resistivity 1040-4625  $\Omega\text{m}$ . Resistivity of the fresh bedrock ranges from 32602 to 84462  $\Omega\text{m}$ . The anomalously low resistivity zones observable at distances 55-75 m and 115-135 m within the bedrock are suspected to be distressed zones occasioned by fissuring.

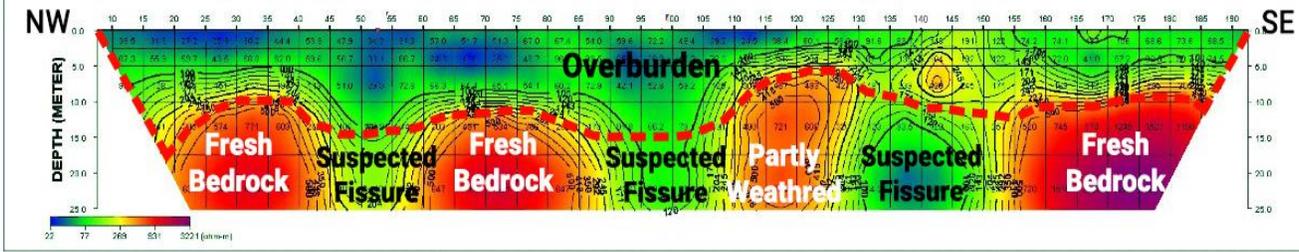
**Figure 7: 2D Resistivity section beneath Traverse 6**

The 2D resistivity section beneath Traverse 6 (Figure 7), reveals an overburden, 7-19 m thick with resistivity 11-100  $\Omega\text{m}$  typical of clay. Resistivity of the bedrock ranges from 574 to 5244  $\Omega\text{m}$ . The vertical anomalous low-resistivity zones delineated within distances 40-60 m, 90-110 m and 130-155 m are suspected to be fissures.

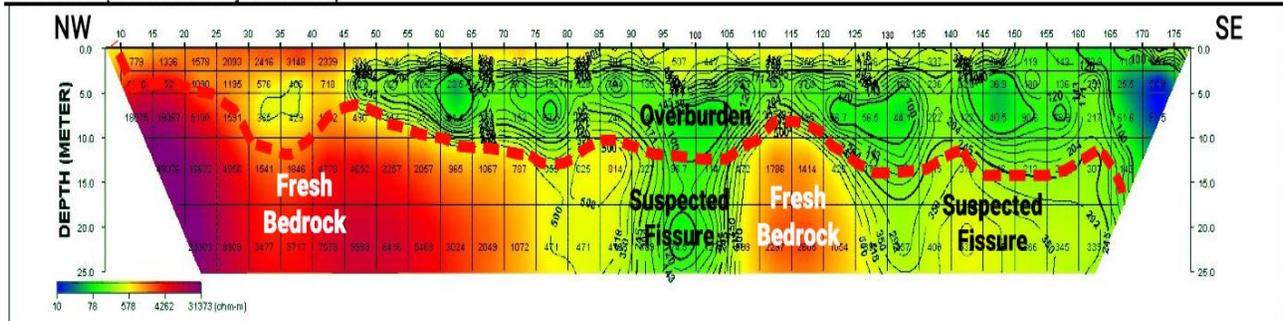
**Figure 8: 2D Resistivity section beneath Traverse 7.**

The 2D resistivity section beneath Traverse 7 (Figure 8) reveals lateritic topsoil with resistivity 709-2709  $\Omega\text{m}$  and thickness of about 2 m underlain by weathered layer with resistivity values generally  $<100 \Omega\text{m}$  typifying clay with average thickness of about 10 m. The partly weathered bedrock has resistivity varying from 787 to 1414  $\Omega\text{m}$ . The overburden thickness varies from 3 to 15 m. Resistivity of the fresh bedrock ranges from 2297 to 43076  $\Omega\text{m}$ . The low-resistivity zones between distances 90-105 m and 125-140 m are suspected to be weak zones cutting deep into the basement up to depths beyond 25 m.

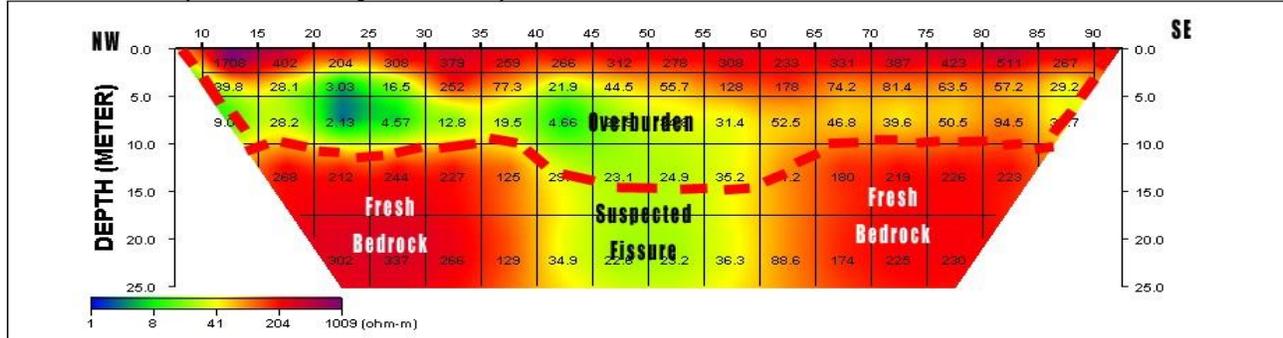
**Figure 9: 2D Resistivity section beneath Traverse 8**

Traverse 8 is underlain by lateritic topsoil about 3-5 m thick with resistivity ranging from 267 to 1708  $\Omega\text{m}$  (Figure 9) and a weathered layer with resistivity varying from 2 to 95  $\Omega\text{m}$  and thickness of about 6 to 11 m. The overburden is about 10-13 m thick. Resistivity of the bedrock ranges from 174 to 337  $\Omega\text{m}$  and indicates hydration. The weak zone at distance 40-60 m beneath 13 m depth is suspected to be bedrock fissure.

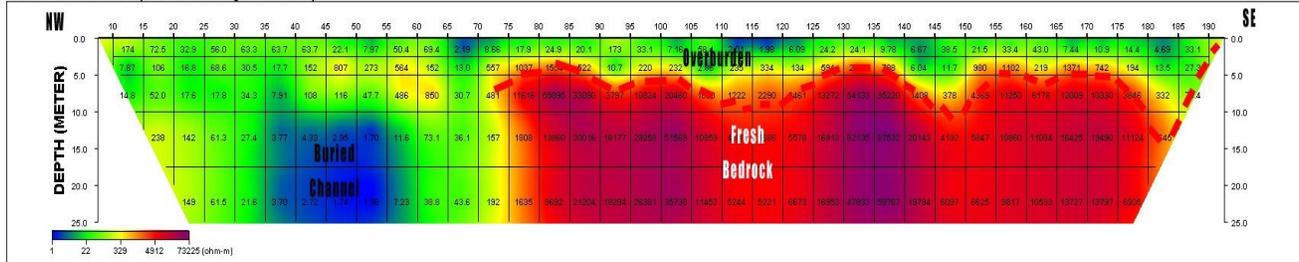
**Figure 10: 2D Resistivity section beneath Traverse 9**

The 2D resistivity section beneath Traverse 9, established close to the fence of the College of Health Sciences, Ladoke Akintola University of Technology, Ogbomosho reveals an overburden with resistivity generally less than 100  $\Omega\text{m}$  characteristic of clay, and thickness greater than 25 m, beneath lateral distance 75 m from the northwest end (Fig. 10). It becomes thinner (3-13 m thick)

beneath lateral distance 75-190 m at the southeast end of the traverse and is underlain by fresh bedrock with resistivity ranging from 3846 to 59767  $\Omega\text{m}$ . The zone with anomalously low resistivity (less than 10  $\Omega\text{m}$ ) observed at distance 35-60 m may have resulted from water saturation due to a suspected buried channel from which groundwater springs onto the road. There is no field evidence that the bedrock fissures have impact on foundations of buildings in the premises of the College of Health Sciences as there are no cracks possibly precipitated by settlement.

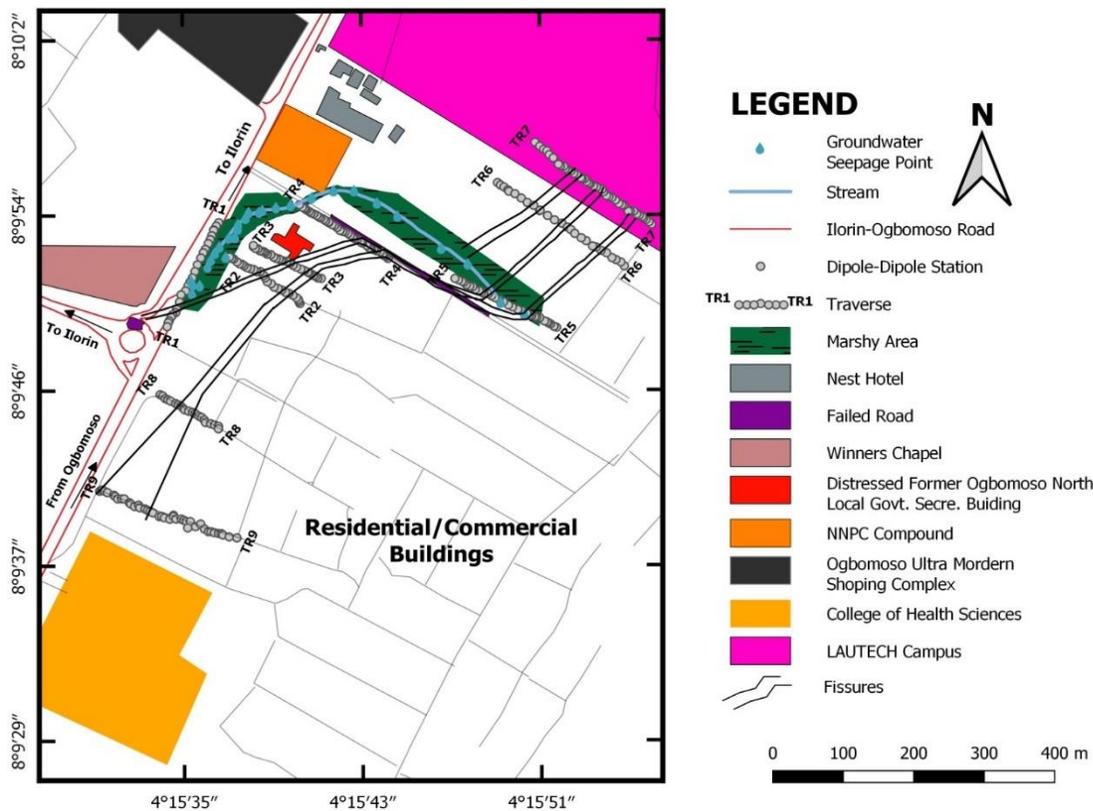
Figure 11: Structural map of the study area indicating the trend of the bedrock fissures

Figure 11 presents the plan of the suspected bedrock fissures delineated across the nine traverses established in the study area. The failure of the foundation of the distressed uncompleted former building of Ogbomosho North Local Government Secretariat (now demolished) could have been precipitated by settlement enhanced by the suspected network of bedrock fissures in agreement with the result of Sangodigi and Olorunfemi (2013). In addition, the incessant failure of the road portions and groundwater seepages experienced around the area over time may be attributed to the underlying bedrock fissures (Bayode and Akpaoarebe, 2011; Onoja and Osifila, 2015; Mandal and Mishra, 2019).
