## **GEOPHYSICAL INVESTIGATION OF THE CAUSES OF HIGHWAY FAILURES IN NIGER DELTA SEDIMENTARY BASIN (A CASE STUDY OF THE EASTERN PART OF EAST- WEST ROAD), NIGERIA.**

**O. G. Emujakporue**

*Department of Physics,  
 University of Port Harcourt  
 Port Harcourt  
 Owin2009@yahoo.com*

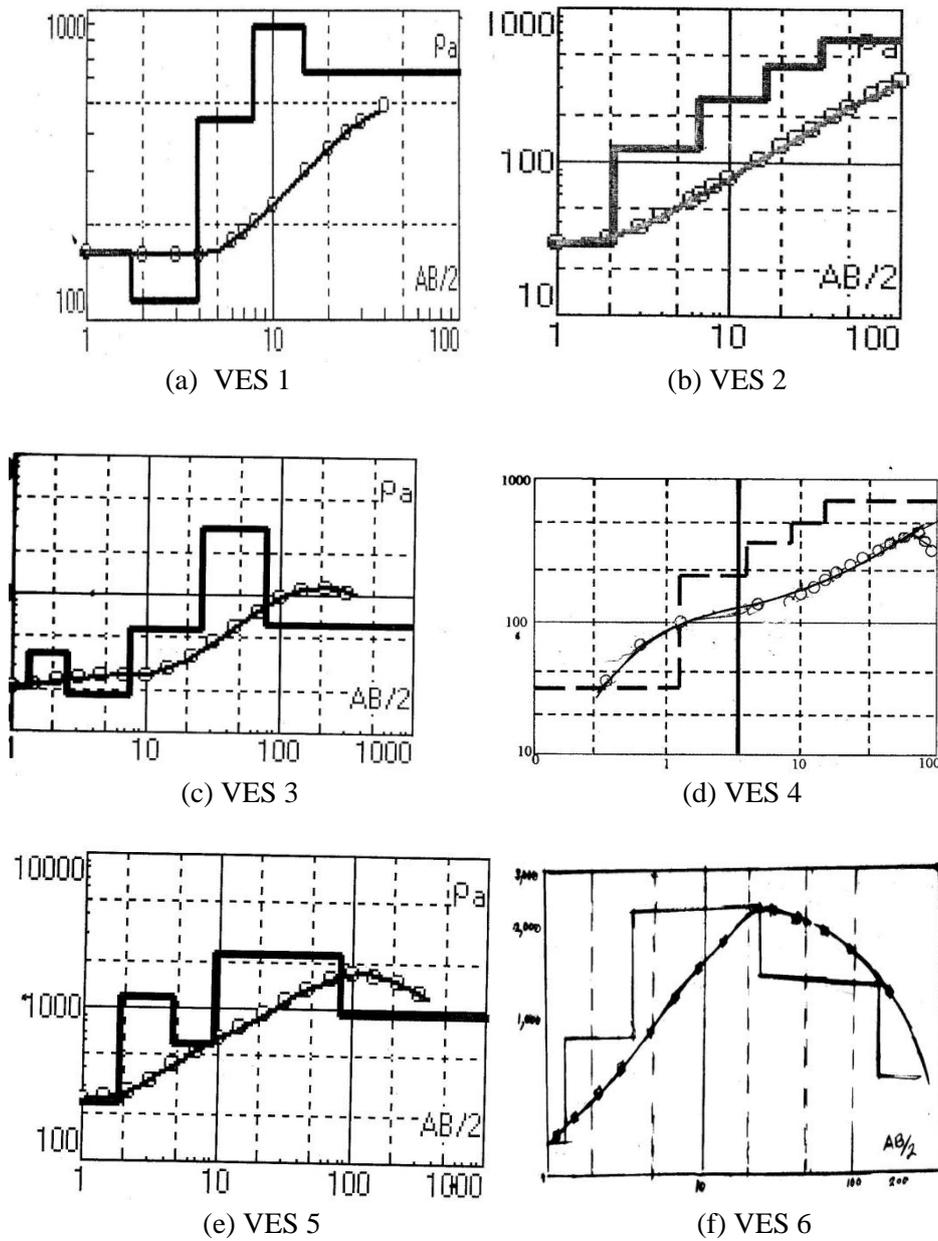
Fig. 3 a-f: Interpreted Vertical Electrical Sounding Curves of the Study Area.

The results of the study are presented as depth sounding curves, table and geoelectric section. The curves types identified ranges from HAK, AAA and AKQ. The AAA curve type dominates. The VES curves obtained in the area are shown in Figure 3a-f. These curves are modelled into five geoelectric layers. The interpreted parameters of the subsurface layers are listed in Table 1. The correlation of the geoelectric parameters (resistivity and thickness) of the resulting layers with the geological succession from nearby boreholes (Fig.4a and b) led to the identification of five layers. The horizontal and vertical distributions of the layers are illustrated as geoelectrical cross section in Figure 5. The succession of the geoelectric layers from the ground surface is as follows:

The first layer (Topsoil) comprise of clay to sandy-silt. The apparent resistivity value varies between 28.8 $\Omega$ -m at VES2 (failed portion) and 348.47  $\Omega$ -m at VES6 (stable portion). The thickness varies between 1.01m at VES6 and 2.11m at VES2. The topsoil resistivities within the failed segments (28.8-164  $\Omega$ -m) are less than those obtained (209.6-348.47  $\Omega$ -m) within the stable zones.

The second layer which is made up of clay and silt-sand has resistivity which varies between 108.1  $\Omega$ -m at VES4 (Failed portion) and 1247.9  $\Omega$ -m at VES6. The thickness ranges from 1.88m at VES6 to 6.62 at VES2. The resistivities of the second layer within the failed segments (108.1-120.5  $\Omega$ -m) are also less than those obtained (372.8 to 1247.8  $\Omega$ -m) within the stable segments.

The third layer consists of fine to medium sand. The resistivity ranges from 237.5 $\Omega$ -m at VES4 to 2977.2 $\Omega$ -m at VES6. The thickness varies between 6.15m at VES4 and 16.18m at VES6. The resistivity values of the third layer within the failed portions (237.5-442.6  $\Omega$ -m) are far less than those obtained at the stable segments (567-2977.2  $\Omega$ -m).

The fourth layer which consists of medium to coarse sand has resistivity which varies between 418  $\Omega$ -m and 1419.08  $\Omega$ -m. The thickness ranges from 8.57 to 118.97m. The resistivity of the failed segments (418.3-884.9  $\Omega$ -m) are lower than those obtained within the stable portions (562-1419.04  $\Omega$ -m). The fifth layer consists of coarse sand with resistivity which varies between 511.3 and 921.0  $\Omega$ -m.

grade shows that the failed portions are highly associated with low resistivity values than the stable portions for the corresponding five layers. The low resistivity values of the failed portions are mainly due to the presence of high clay contents in the sub-grade at different depths. The clay minerals typically have lower electrical resistivity (higher conductivity) than silt, sand and gravel. However clay minerals also exhibit a wide range in electrical resistivity in particular, swelling clays have a higher capacity for ion exchange which results in much lower measured resistivity than non-swelling clays.

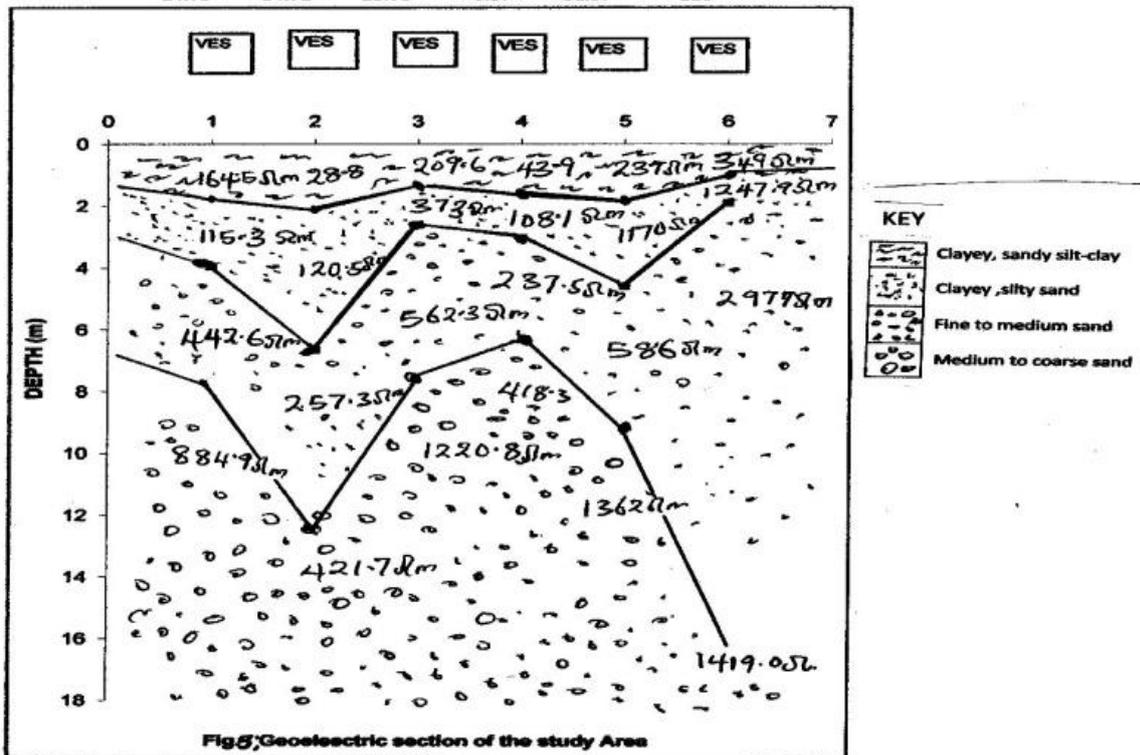
Fig. 5: Goelectric Section of the Study Area.

The results of the vertical Electrical Sounding survey revealed five geoelectrical layers comprising of topsoil, clay to sandy-silt, fine sand, medium sand, medium-coarse sand and coarse sand. Comparison of the results of the Vertical Electrical Sounding survey for the failed and stable portions of the highway sub-

Furthermore, a qualitative comparison between VES data and the failed and stable portions of the highway also shows a good correlative between failed pavements and low resistivity values. Roads constructed over areas of clay are generally subjected to potential differential settlement due to volume changes caused by swell/shrink and low shear strength of the clay resulting from high moisture contents. The clayey sub-grade on which some parts of the road are founded have tendency of absorbing water which makes them to swell and collapse under wheel load stress which subsequently lead to the road failure. This unstable seasonal behaviour of the clay makes pavement to lose its integrity within a short time after road construction.

It is hereby recommended that hydraulic sand fill should be used for the road embankments and for the replacement of the weak, incompetent and compressible clay materials. The ongoing construction work should be well supervised and monitored by competent government agencies in order to ensure that high standards and specification are maintained by the construction company. Proper drainage system should also be included to remove flood water from the road.
