Improving the efficiency and sustainability of disinfection at a small rural water treatment plant

MNB Momba^{1*}, N Makala¹, Z Tyafa¹, BM Brouckaert², CA Buckley² and PA Thompson³

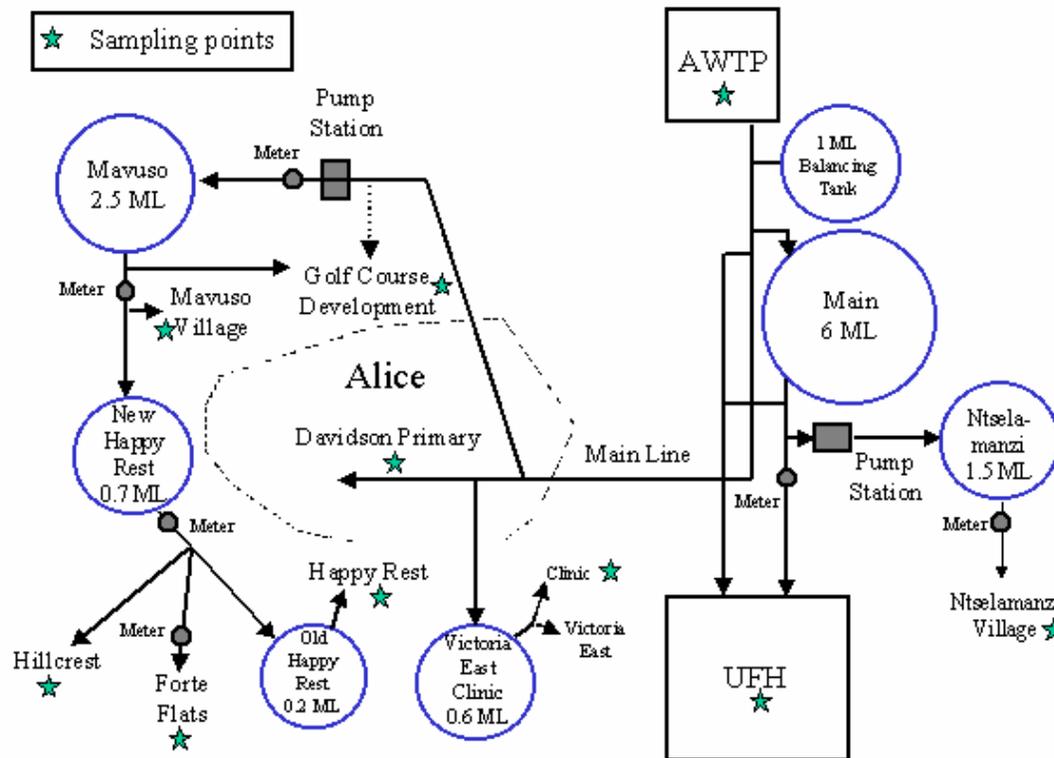
Figure 1
Schematic
diagram of the
Alice distribution
system

Figure 1 shows a schematic of the Alice distribution system developed by the authors with assistance from the municipality's plumbing superintendent. Five of the town's seven reservoirs, including the main reservoir fill up under gravity. Float valves regulate the flows into the reservoirs and they operate at essentially 100% capacity under normal conditions. Pumping to Ntselamanzi and Mavuso is initiated automatically based on the signals from their level sensors.

Table 1 summarises the average hydraulic retention times of the various reservoirs based on flows measured at the meters shown in Fig. 1. Before October 2003, the Golf Course housing development was supplied from the line to the Mavuso pumping station. From October, it was supplied from the Mavuso Reservoir itself, resulting in a huge increase in flow through the reservoir and a reduction in its hydraulic retention time.

Alice's system of storage reservoirs was obviously designed with future demand in mind and provides much more storage capacity than is currently required. This has a negative impact on the water quality particularly in those areas supplied by the two Happy Rest Reservoirs and in Victoria East. Preliminary water quality monitoring results found that these areas always had low to negligible chlorine residuals and poor bacteriological quality whereas the water quality at Fort Hare, Ntselamanzi and Davidson Primary School (drawing from the Main Alice supply line) was more dependent on the treatment plant performance (Momba et al., 2003a; b).

The one outstanding issue is however, the reservoir supplying Victoria East clinic. This reservoir used to also supply the Old Happy Rest reservoir and it probably had a substantially lower retention time in the past. The best solution in this case would be to lower the reservoir level. This could be achieved easily and cheaply simply by lowering the float which closes the inlet valve.

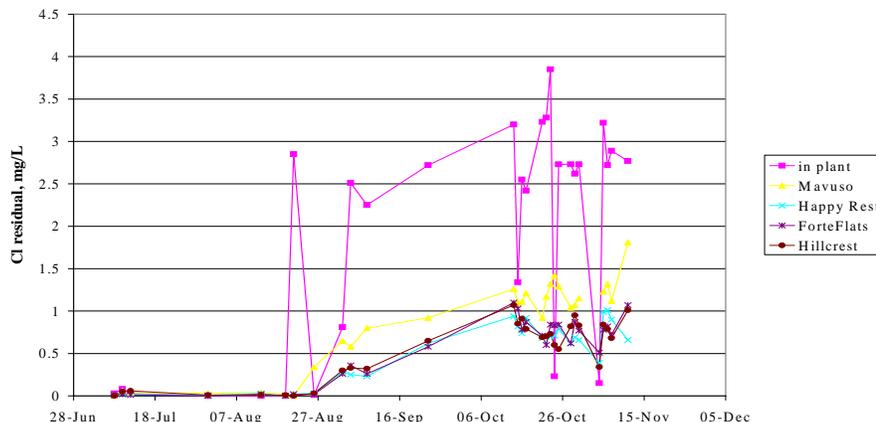
Figure 2
Chlorine residual at various points July-November 2003

good chlorine residuals and microbial quality could be established and maintained even at the three most distant points in terms of retention time (Hillcrest, Happy Rest and Forte Flats) as long as chlorine was dosed consistently at the plant for a sufficiently long period. This is shown in Fig. 2. The problem with these results was that when the chlorination system was functioning, chlorine was generally being overdosed. Therefore it was not immediately clear that Happy Rest, for example, could enjoy good microbial quality without central Alice, the University and Ntselamanzi Village suffering from excessive chlorine levels.

It was found that if all the results in Fig. 2 were scaled down by a factor of 2.2 then most of the in-plant residuals fell with the range 1 to 1.5 mg/l while the residuals at the sampling points remained above 0.3 mg/l. If the decay of the chlorine is assumed to be approximately first order, then the chlorine concentration in water at any point in the distribution should be proportional to its chlorine concentration when it left the plant. Therefore it appears that the chlorine residual can be maintained at a reasonable level in all sites without booster chlorination.

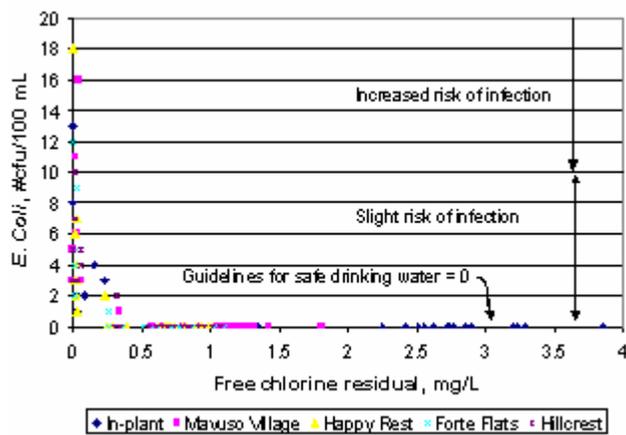
Figure 3

In order to resolve this issue, it was first necessary to establish the minimum residual required ensuring acceptable microbial quality. Figures 3 to 6 show the microbial quality results plotted against chlorine residual and compared with the guidelines for drinking water quality (DWAf, 1996). It appears that the guidelines for microbiological safety can generally be met if a residual of at least 0.3 mg/l is maintained at all points in the distribution system.

E. coli counts versus chlorine residual July-November 2300

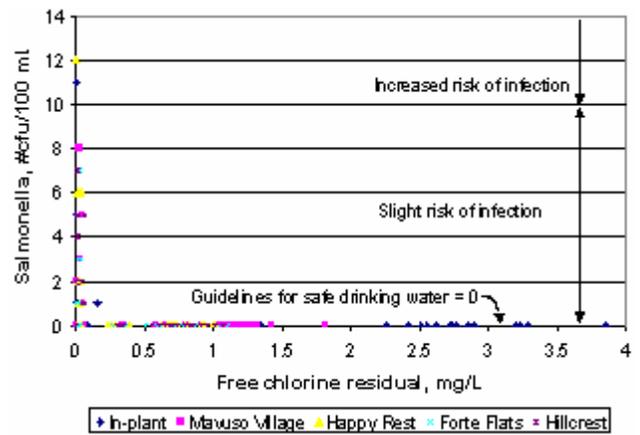
Figure 4

Salmonella counts versus chlorine residual July-November 2300

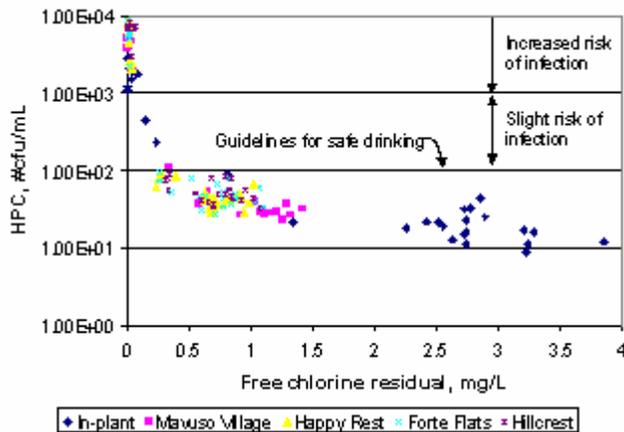
Figure 5

Heterotrophic plate counts versus chlorine residual

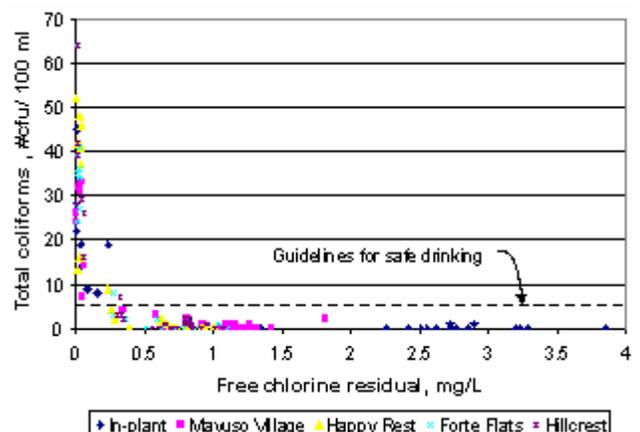
Figure 6

Total coliform counts versus chlorine residual July-November 2003
