Integrated Geophysical Investigation of the Causes of Road Pavement Failure along Ibadan-Lagos Dual-Carriage, Southwestern, Nigeria.

^{*1}LAYADE, GIDEON O; ²ADEGOKE JAMES A; ²OYEWOLE, IGE TEMITOPE

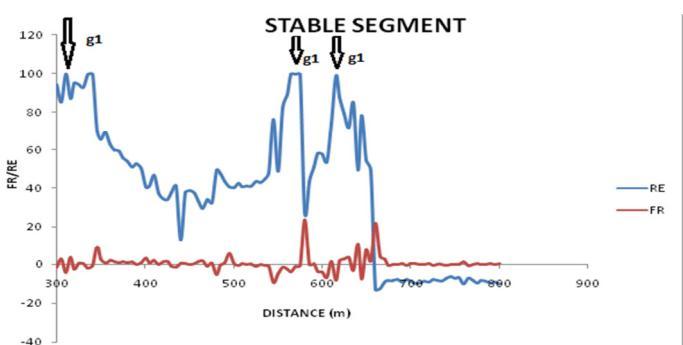
Fig 3:Graph of VLF-EM data (raw real and filtered real) of the most stable segment

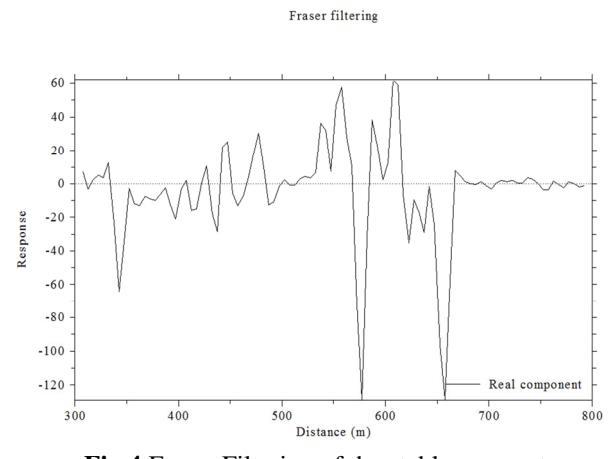
Fig 4:Fraser Filtering of the stable segment

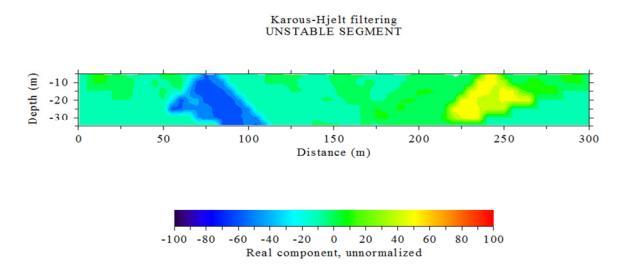
The basement relief presented in Figures 6-10 of the unstable segment (a) are generally uneven, with high depression at VES 3 (Figure 6). The VLF-EM 2-D model (Figure 7) identifies linear features having a depth extend to 2 m from the surface to about 25 m at the distance between 225 m to 260 m, this can be indicative of geological features (g_2 of figure 7) such as fractures and faults. The road failure along this

segment may have been precipitated by a combination of conductive clayey subsoil, and network of near-surface and subsurface linear features suspected to be lithological contact such as faults, fractures and consequence absorbed by the clay topsoil. This lithological contact serves as weak zones that may increase the porosity and fluid permeability of the sub-soil and hence decrease the load bearing capacity of the road pavement (Adiat *et al.*, 2009).

Fig 7: VLF-EM 2-D Inversion model of the unstable segment (a)

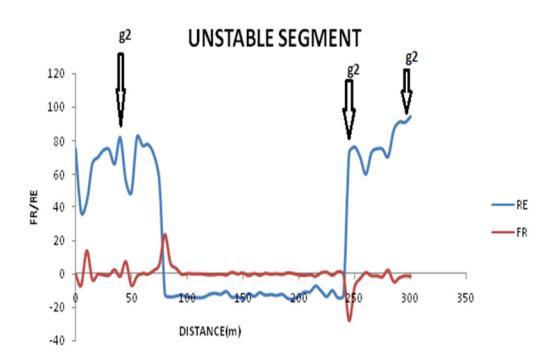
Fig 8: Graph of VLF-EM data (raw real and filtered real) of the unstable segment (a)

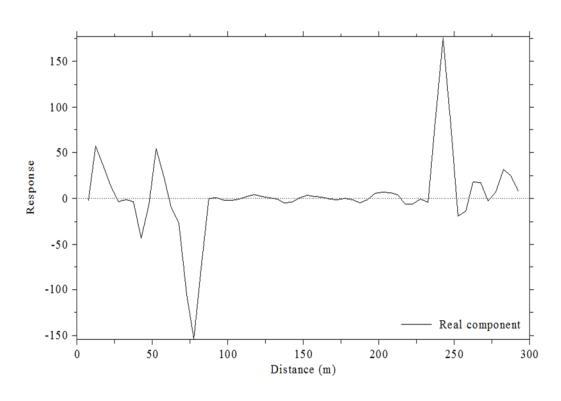
Fig 9:Fraser filtring of the unstable segment (a)

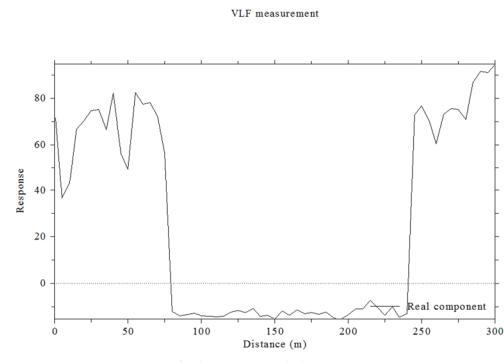
Fig10: VLF measurement of the unstable segment (a).

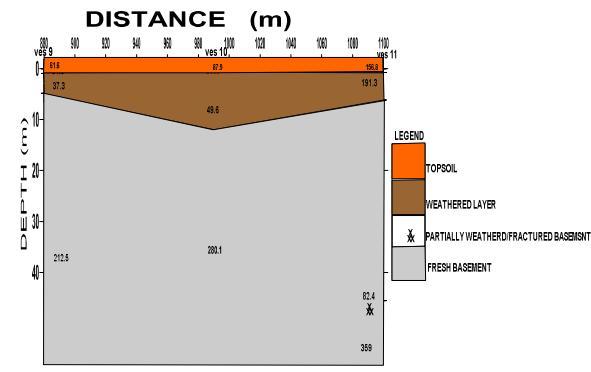
A suspected confined basement fracture is located between distance of 850 m to 1100 m in the 2-D model which shows high conductivity along the road pavement as this can be seen as red and yellow colour coding of the 2-D inversion model (Figure 12) and this falls within an intensively failed segment of the road. Fractured basement bedrock was delineated between distance of 900 to 1100 m on the geoelectric

section (Figure 11). The drifting of water from the fractured basement can be absorbed by the clay topsoil, the contraction and expansion of clay can cause failure in the stability of the road pavement.

Fig 11: Geoelectric section of the unstable segment (b)

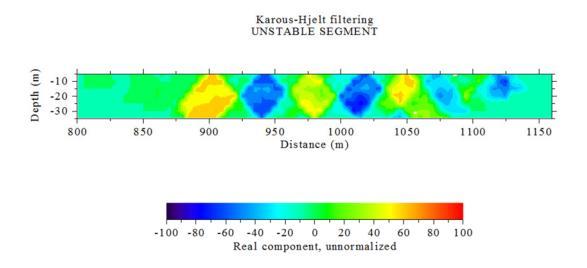
The unstable segment (b) (Figures 11 - 15) has clay at VES 9 and VES 10 at the upper thin topsoil with resistivity value generally less than 100 Ω m and clayey sand at VES 11 (Table 1). The underlying weathered layer is predominately clay at VES 9 and VES 10 with resistivity less than 100 Ω m, and sandy clay at VES 11 with a resistivity value of 191.3 Ω m (Figure 11) with its basement relief uneven. Both the topsoil and weathered layer in the upper 0-12.1 m of segment (b) are composed of clay and sandy clay beneath the pavement with resistivity value generally less than 200 Ω m (Figure 11). The low conductivity of clay soil was revealed by the 2-D inversion model of VLF-EM, this was indicated by the red and yellow colour code in figure 12.

Fig 12: VLF-EM 2-D Inversion model of the unstable segment (b)

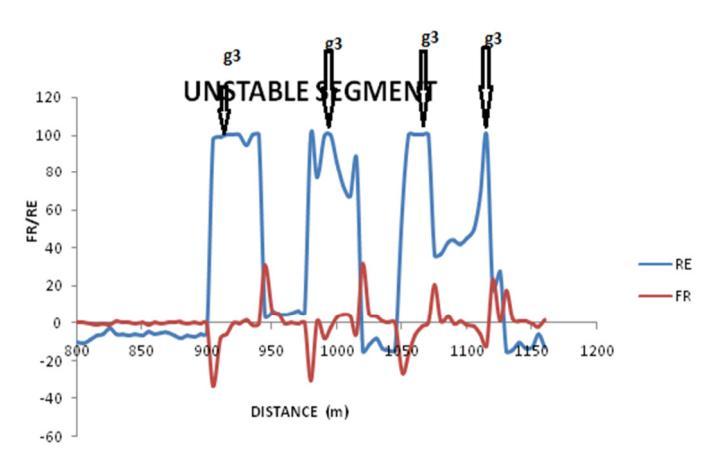
Fig 13:Graph of VLF-EM data (raw real and filtered real) of the unstable segment (b)

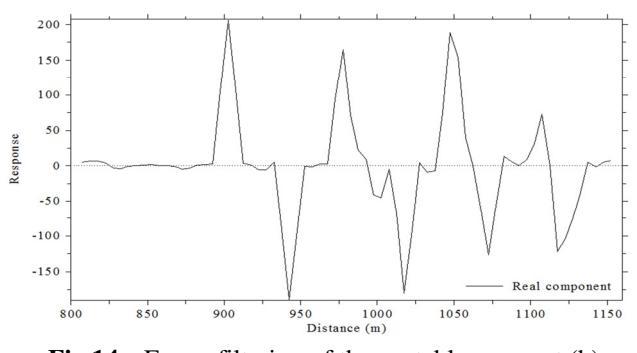
Fig 14: Fraser filtering of the unstable segment (b)

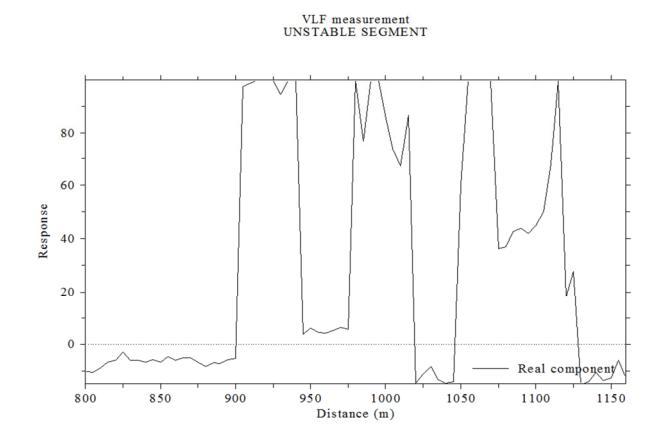
Fig 15: VLF measurement of the unstable segment (b).
