Assessment of Radiation Safety Measures in Select Radio-Diagnostic Centres in Kaduna State, Nigeria

Objective: To assess the radiation safety precautions taken in five radio-diagnostic centers in Kaduna State, Nigeria

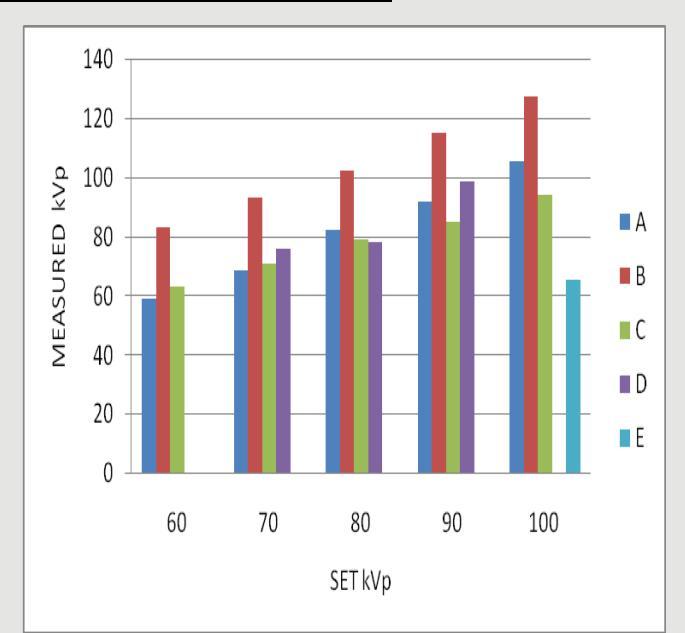
Figure 1: Kilovoltage peak (kVp) accuracy test

Tube potential (kVp) accuracy is a key component of optimization of x-ray beam and this minimizes patient dose [14]. This test should be performed annually and the result should be within 5% of the value set on the machine [15]. Out of the five centres studied, only A and C showed moderate compliance in kVp accuracy.

Regular quality control tests should be performed annually in every x-ray diagnostic center by certified experts.
