IMPLICATIONS OF CLIMATE CHANGE ON HUMAN COMFORT IN BUILDINGS: EVIDENCE FROM NKONTOMPO COMMUNITY OF SEKONDI-TAKORADI, GHANA

S. Amos-Abanyie
*Department of Architecture
Faculty of Architecture and Building Technology
College of Architecture and Planning
Kwame Nkrumah University of Science and Technology*

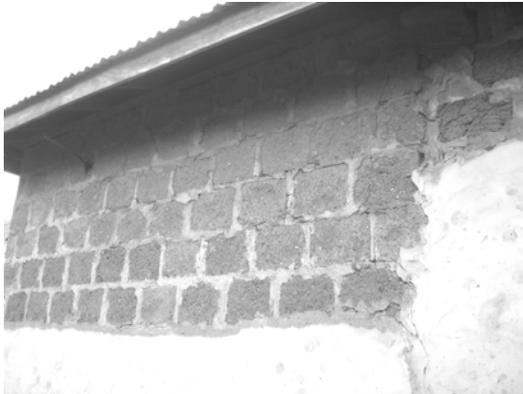
Fig. 2a: Landcrete wall with cement-sand mortar finish

The community occupies an elevated coastal plain which covers a land area of approximately 27 acres, with about 915 buildings. The basic building form is rectangular or square form. Walls are either constructed of sandcrete or landcrete blocks with the former forming about 62% of the total. The walls generally have a cement-sand mortar finish (Fig. 2a). The high income landlords in the community add a touch to the walls by painting them. However some of the buildings do not have any finish.

This condition exposes the blocks to so much moisture that influences the thermal condition in the internal space.

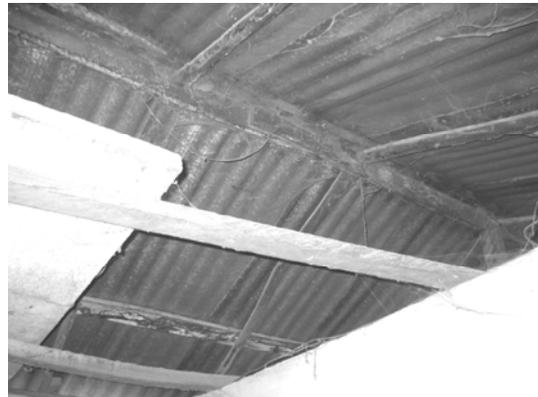
Fig. 2b: Rafter-purlin-aluminium sheet roofing system with no ceiling

Ceilings are not a common feature in the buildings in Nkontompo (Fig. 2b). The few buildings with ceiling found there are constructed of 6mm thick plywood boarding on a 600mm grid system.

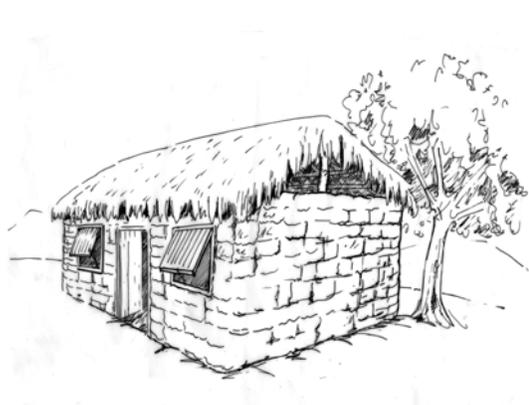
Fig. 3a: Sketch of a building at Nkontompo with thatch roof

The design of the roofing system as well as the materials used is varied throughout the community. However, hipped and gabled roof types are the basic roof systems used with a pitch of between 20° and 35°. The rafter-purlin system is employed in constructing the roofing structure (Fig. 2b). The roof covering is usually made of corrugated aluminium or asbestos sheets. About 9% of the buildings, mainly of landcrete blocks, have thatch finish (Fig. 3a).

It was revealed through key informant interviews in the community that the thatch provides an excellent source of insulation. It has been realized that the thatch roof requires frequent maintenance in the span of three to four years due to rodent attack and decay. As a result of this, a trend has evolved where all new buildings in the community have corrugated aluminium roofing sheets. Also the roofs of some of the old buildings have been replaced with aluminium sheets. This is because it is more durable and requires little or no maintenance. On the contrary, the aluminium sheets create less tolerable conditions because lack of insulation causes more heat radiation into the interior space.

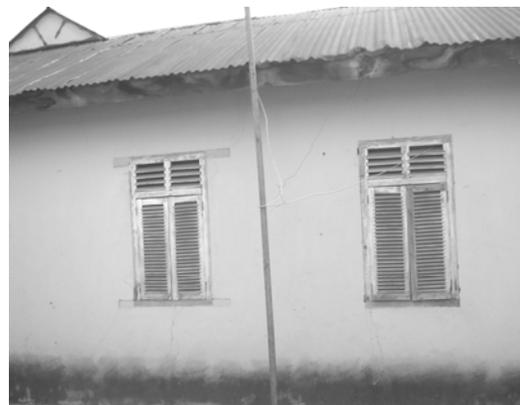
Fig. 3b: Landcrete wall with jalousie window

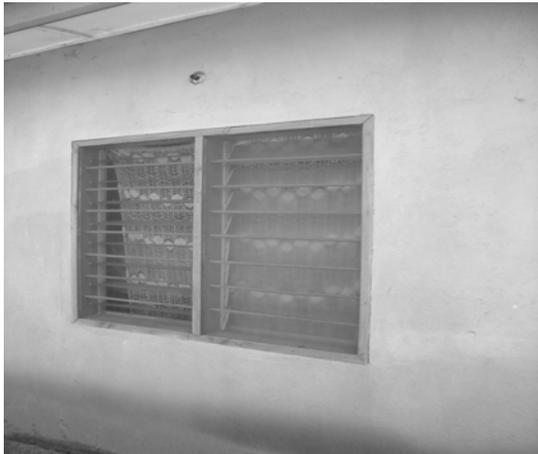
Fig. 4a: Sandcrete wall with louver blades window

The thermal behaviour of a building is basically a function of its form, choice of materials, climate conditions (both macro and micro), and its use (Gut et al., 1999). A typical building structure in the study area consists of many components of different thermal conductance arranged variously in series and parallel. For example, the sides of a house had portions of sandcrete block or sun-dried brick wall into which are inset timber window frames fitted with jalousie or timber battened windows (Fig. 3b). Thus, there were some parts where rooms are separated from the outside by only jalousie timber battens or louver blades (Fig. 4a), in parallel with some parts that had a layer of sandcrete block or sun-dried brick, with coating of plaster (Fig. 4b). The overall thermal performance of the wall is a function of all of these.

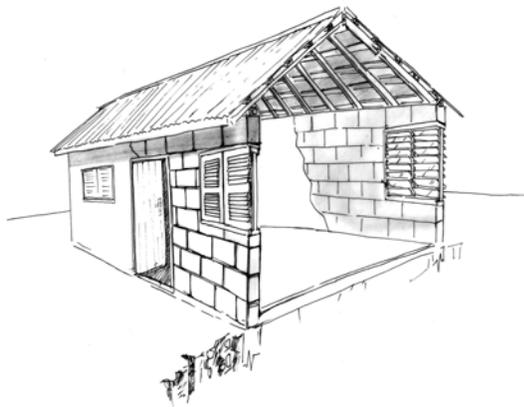
Fig. 4b: Sun-dried bricks with coating of cement-sand finish in parallel with openings
