## CASE REPORT

# Re-osseointegration of loosened implant in a splinted fixed prosthesis

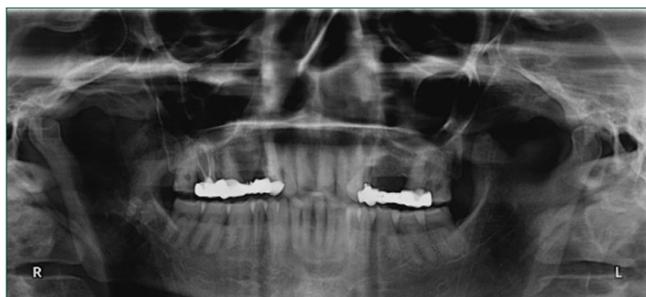
**Figure 1:** Orthopentograph showing infected 24 supporting the loosened fixed bridge

partial denture in relation to 24 and 27 as abutments, replacing missing 25 and 26, of which 24 abutment tooth was mobile. Radiographical findings showed fracture of endodontically treated left first premolar with periapical lesion surrounding the tooth [Figure 1]. The situation was explained to the patient that the mobile abutment tooth has to be extracted and that the existing prosthesis will be not of any use. After locally anesthetizing the area with 2 ml of lidocaine (lignox Warren Pharmaceutical, Mumbai, India) the prosthesis was removed and the fractured premolar was also extracted. The socket was curettaged to remove the granulation tissue at the apex. After debridement, it was found that due to severe bone loss the socket was not favorable for immediate implantation. Hence, endosseous implants were planned in second premolar and first molar edentulous areas, with an anterior premolar cantilever to be designed in the prosthesis. An individual was planned for the second molar which was a prepared abutment tooth of the previous prosthesis.

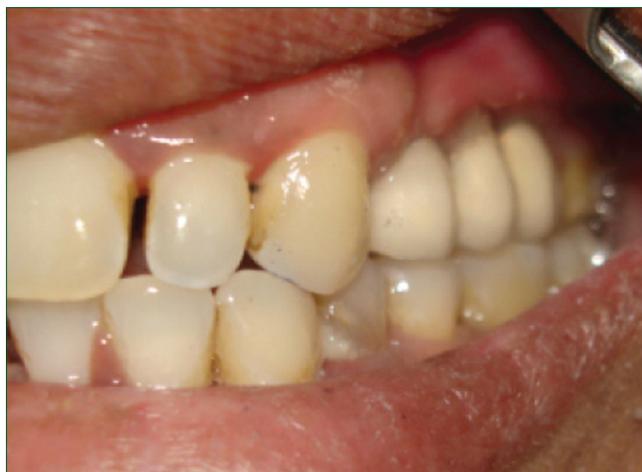
**Figure 4:** Prosthesis in function immediately after cementation
