Valuing the cost of environmental degradation in the face of changing climate: Emphasis on flood and erosion in Benin City, Nigeria

Odjugo, Peter Akpodiogaga-a Ovuyovwiroye

Department of Geography and Regional Planning, University of Benin, P. M. B. 1154, Benin City, Edo State, Nigeria.
E-mail: paoodjugo@yahoo.com. Tel: +2348023718654.

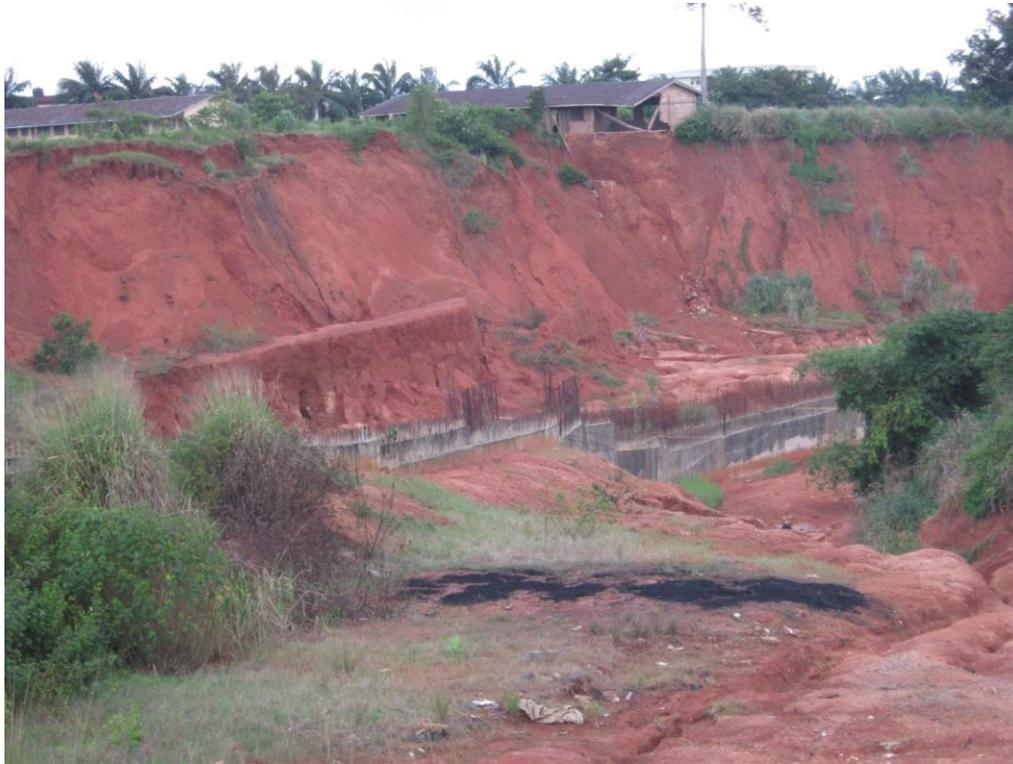
Plate 1. Ogbesan Gully, Benin City showing school building caving in and the failed community effort of drain construction to solve the gully problem.

The number of buildings that caved into the gullies and those abandoned due to the threat of the gullies and sand deposits were 58 and they were estimated to cost ₦650.5 m (\$4.33 m) (Table 2). Out of these 58 building, the Ogbesan Quarters gully erosion has engulfed two blocks of 16 classrooms of Queen Ede Primary School and the third classroom building has been abandoned

since part of it has caved into the gully (Plate 1). The Ogbesan quarters gully has cut two roads into two and the head-on erosion is just 30.4m away from the Benin-Agbor Express Road. If no urgent and serious action is taken now, judging from the rate of head-on erosion (Table 1), the gully will cut the road into two in the next six years. The most worrisome is the University of Benin gully that has claimed one-fourth of the western fence of the University, staff quarters and buildings of individuals of Ekosodin community sharing common boundary with the University. The largest Block of Flats of the University that house both staff and students and other staff quarters are under serious threat. Gully erosion in Benin City has caused a lot of hazard not only to individual property but also to government infrastructure. The total area eroded by the gullies together with the sand deposits measured 560,582 m². This area was converted to building plots of 30 by 30 m (the standard building plot of land in the study area) to ease estimation. The total building plots were 623 and these amounted to ₦1.52 billion (\$10.2 m) (Table 2). Magbemi (2008) and Okechukwu (2010) also mention that buildings worth millions of Naira have been destroyed by gullies in Nigeria, but these works did not carry out detailed study of the number of buildings affected and the cost of gully damage to property in their study areas.

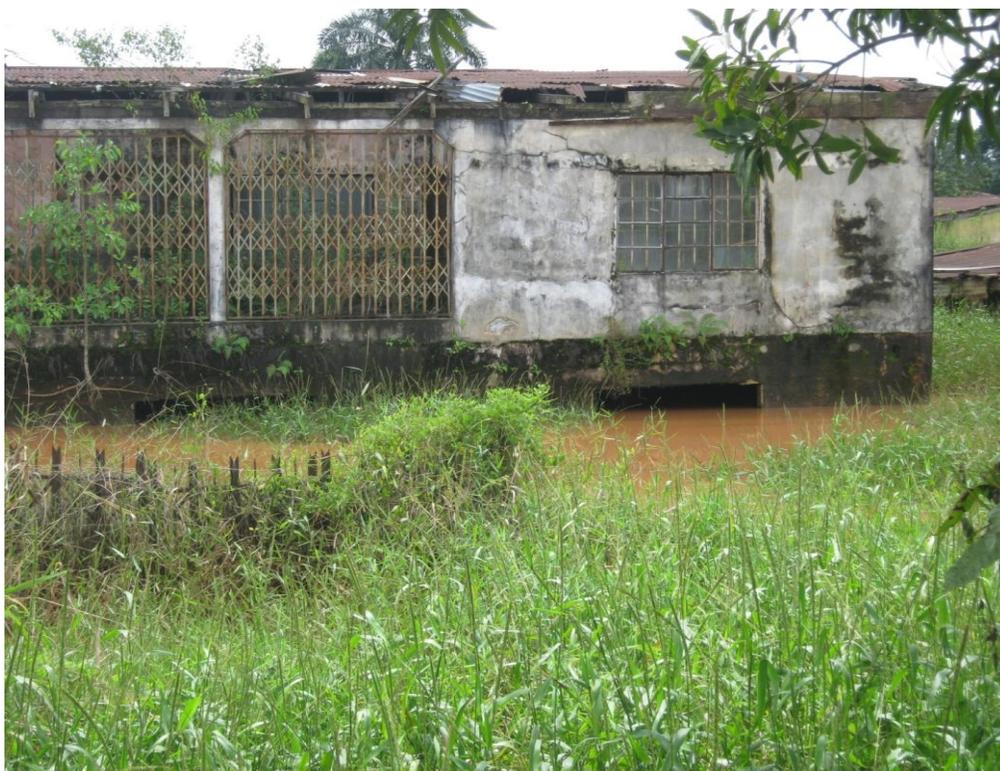
Plate 2. One of the flooded and abandoned buildings along Siloko Road by Teachers' House.

The flooded areas covered 913,313 m² and the number of buildings abandoned as a result of the flood (Plate 2) was 67 and these cost ₦1.05 billion (\$7.02 m) (Table 3). The flood in Dumez Road and Siloko/Uwelu Roads has totally covered the two primary school buildings and the

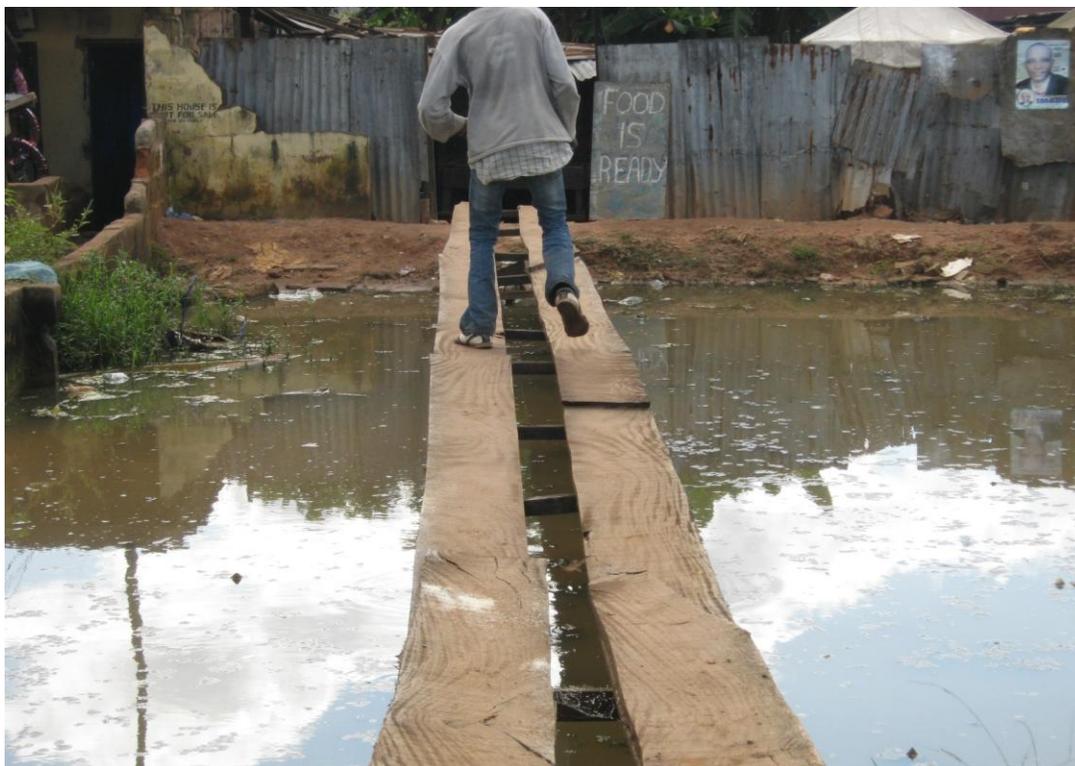
Plate 3. Flood problem: Local effort of bridge construction to get to homes, business centres and eateries.
