## CASE REPORT

# The role of multimodality radiological imaging in extrauterine misplaced IUCD: A case report

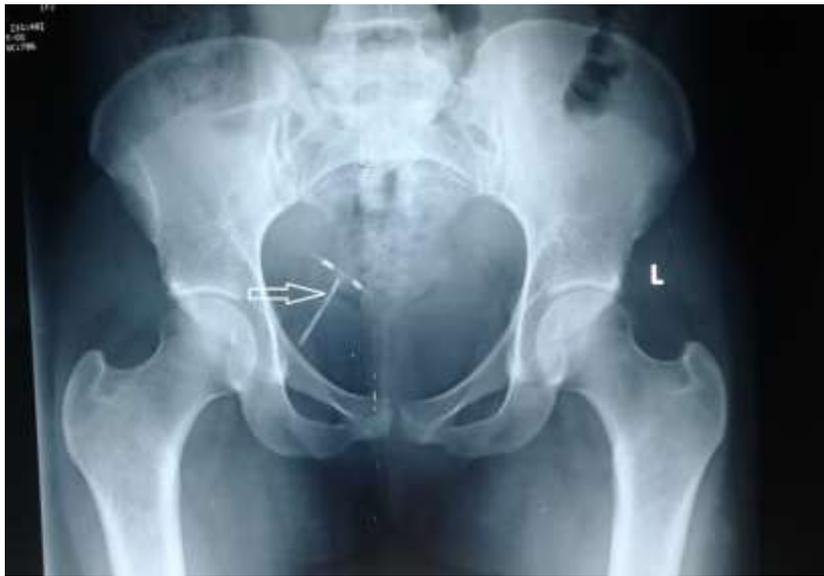
**Figure 1:** Showing right deviation of IUCD (white arrow) in the pelvis on x –ray

An initial pelvic x-ray showed the presence of the IUCD in the pelvis but deviated to the right (Figure 1). A pelvic ultrasound was subsequently performed using both transabdominal and transvaginal approach. This revealed an empty uterus and a linear echogenic structure in the right adnexa, lateral to the urinary bladder with surrounding bowel loops (figures 2.0 and 3.0) which was believed to be the IUCD. A complimentary computed tomography (CT) revealed simultaneous bowel and urinary bladder wall perforation by the migrated IUCD with no pelvic abscess (Figure 4.0).

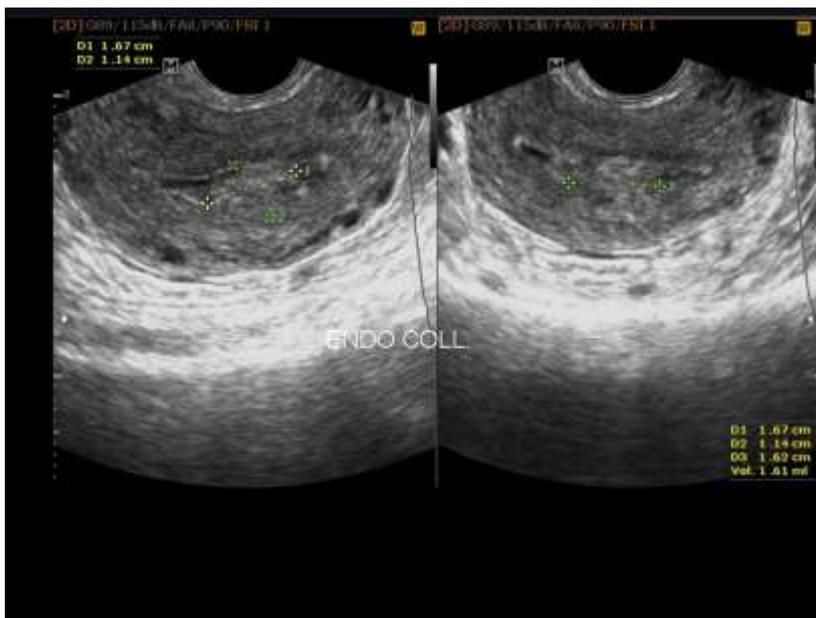
**Figure 2.0:** Ultrasound shows minimal endometrial collection but with absent IUCD in the cavity

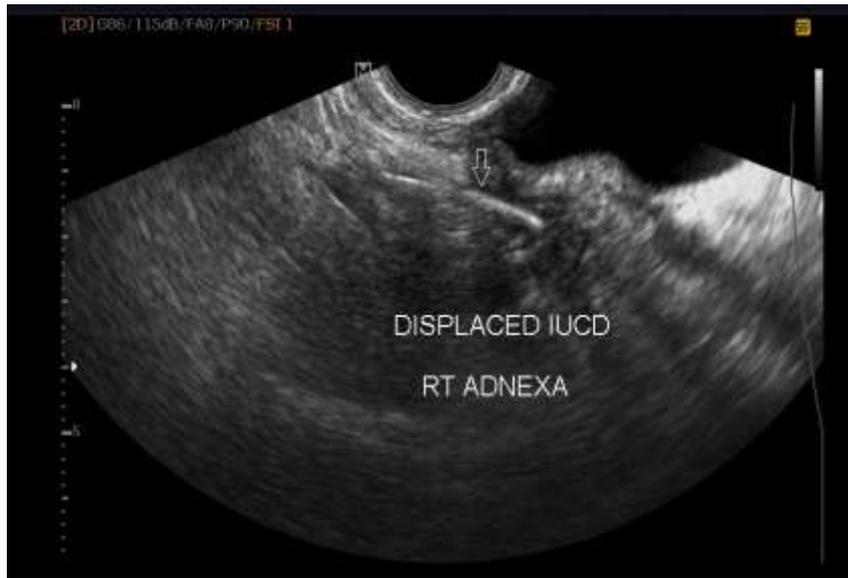
**Figure 3.0:** Transvaginal image showing an echogenic linear structure at the right adnexa suspected to be IUCD (White arrow)

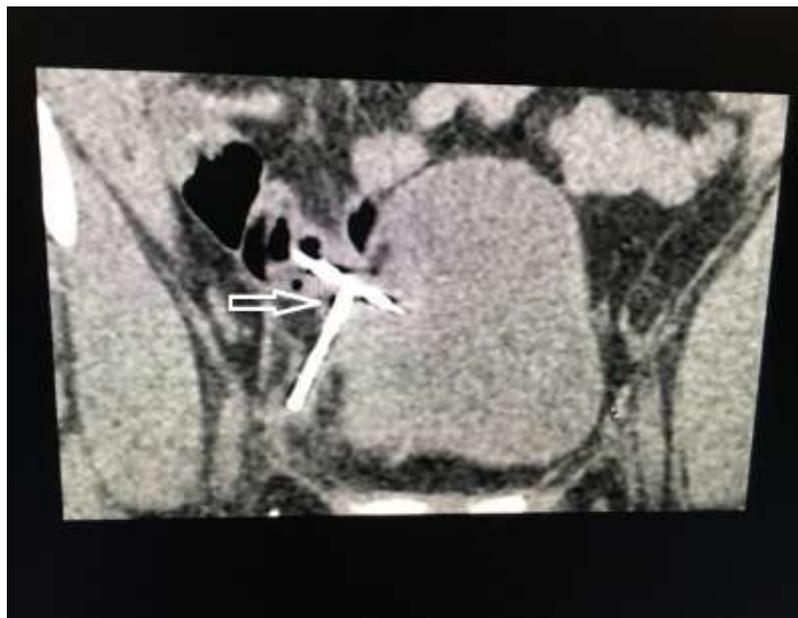
**Figure 4.0:** Showing CT image of simultaneous perforation of small bowel and right lateral urinary bladder wall (white arrow)

In our case report with missing IUCD thread in vagina, the combination of multiple imaging modalities using pelvic radiography, ultrasound, and CT, made it possible for accurate mapping of the location of the migrated IUCD. The revelation of simultaneous perforation of the urinary bladder and the small bowel by the IUCD
