Structural Integrity of A 2-Storey Building Using None Destructive Testing Method

The paper assessed the condition of the existing two-storey building of six classrooms in Government Girls Day Secondary School, Gumel, Jigawa State. The method of Non Destructive Testing (NDT) using a rebound hammer was adopted. Five structural elements (slabs, beams, columns, staircases and foundations) were assessed. The cumulative average strength of the five structural elements was 32.7 RN. Results revealed that despite signs of physical defects on the building such as cracks, exposed column reinforcement bars, etc. it was still considered safe for use. The study recommended that to prevent the building from deteriorating further, periodic structural assessment and good maintenance practice should be carried out. This is to prolong the life span of the building and prevent any threat to the building users and third parties.

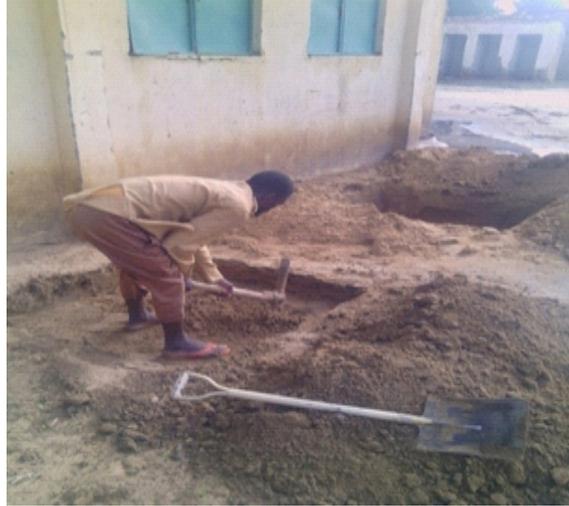
Plate I: Pits to access the foundation

Pits were marked and dug (as shown in Plate I) from the outer side of the building to access the foundations to be tested. The investigation was conducted based on the following chronological sequence:

The digging was conducted carefully so as not to cause any damage to the foundation or any part of the building. The digging did not exceed the bottom of the foundations and the test surface areas prepared were at least 150 mm (6 in) in diameter each as recommended by the test manuals.

pits dug for the investigation were backfilled after all the necessary information from the foundations were taken for further computations and analyses. Accordingly, the removed plasters were replaced after the tests.
