Archaeological Investigations and Conservations at the Mausoleum and the Tomb of False Door, Aksum, Ethiopia

Archaeological investigations undertaken at the Mausoleum and the Tomb of False Door in 2005 in the Main Stelae Field, in Aksum, yielded two Aksumite metal cramps and an Aksumite main entrance to the Mausoleum. Furthermore, the archaeological clearances that were undertaken on the same structures made possible the conservation of the late fourth century AD Aksumite tombs and the opening of an ambulatory to the sealed Mausoleum.

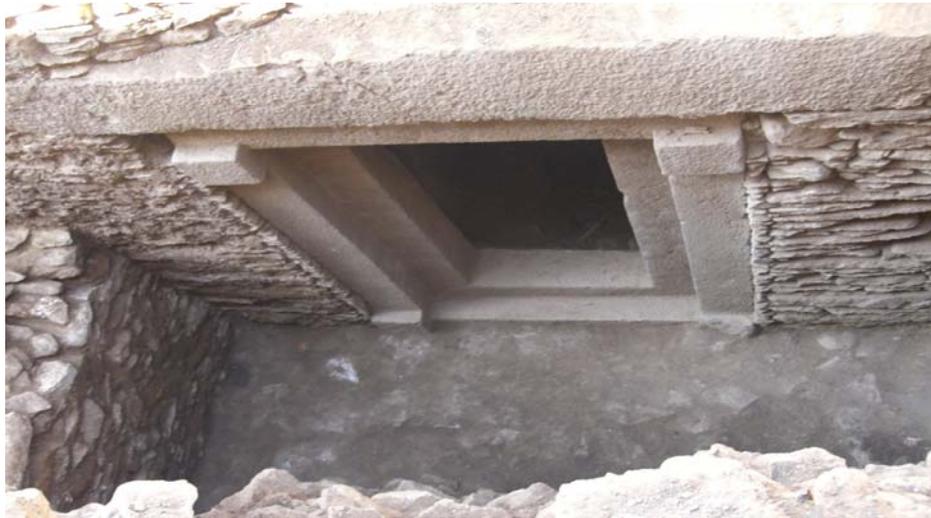
The simplest public access to the Mausoleum would be via the Eastern Portal (Fig. 1). In fact, archaeological excavations also confirmed in 2005 that the main entrance to the Mausoleum was through the Eastern Portal (Tekle Hagos 2008).

Fig.1: The main entrance to the Mausoleum through the Eastern Portal

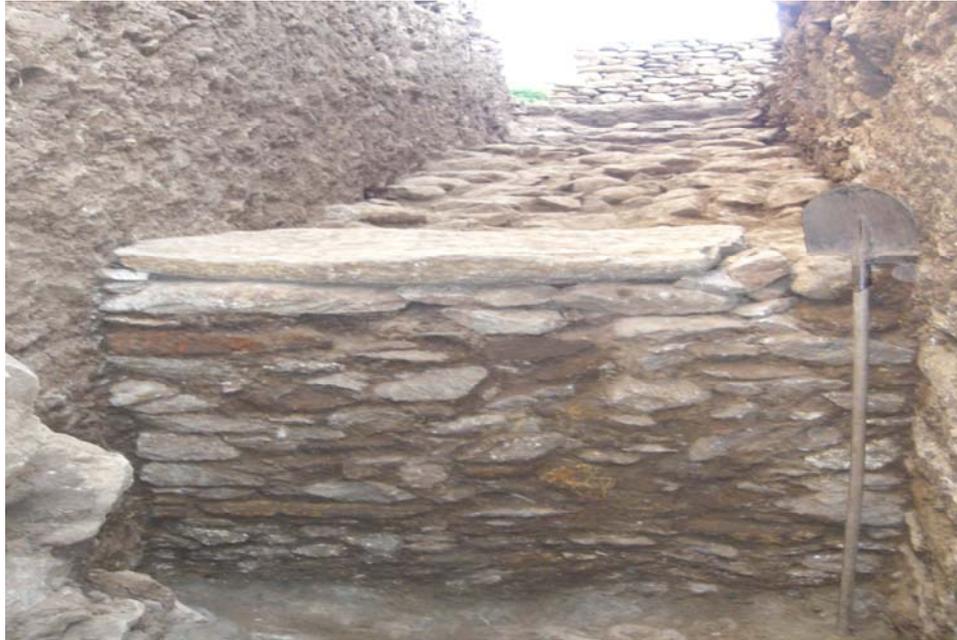
wall excavated 3.20 m depth below the modern ground surface level. This wall is 0.8 m wide, 1.60 m long and 1.50 m high. It stretches from north-east to south-west directions. It is built on top of bedrock beginning from the wall of the Mausoleum in the south-west and extending to the northeast towards Stela-1 facing to The East Tomb and did not continue through the backfill of Stela-1 on the same direction (Fig. 2).

Fig.2: Access to the Mausoleum with an Aksumite wall and a slab.

A piece of decorated classical (middle) Aksumite pottery was found on top of the same wall confirming its Aksumite antiquity. It seems that this wall was part of the Eastern Courtyard. This wall is protected from further excavations. Public access to the same structure would be through this wall and modern stairs were built on top of the same structure without destroying it. Between this Aksumite wall in the north and the modern terraced wall of Stela-1 in the south, there was a backfilled space, 5 m long and 1.7 m wide. Such a backfill was excavated up to the maximum depth of 3.2 m below the modern ground surface. The stone fill below this depth seems to indicate an Aksumite wall collapse. It was cleared and is currently used as public passage to the Mausoleum (Fig.2).

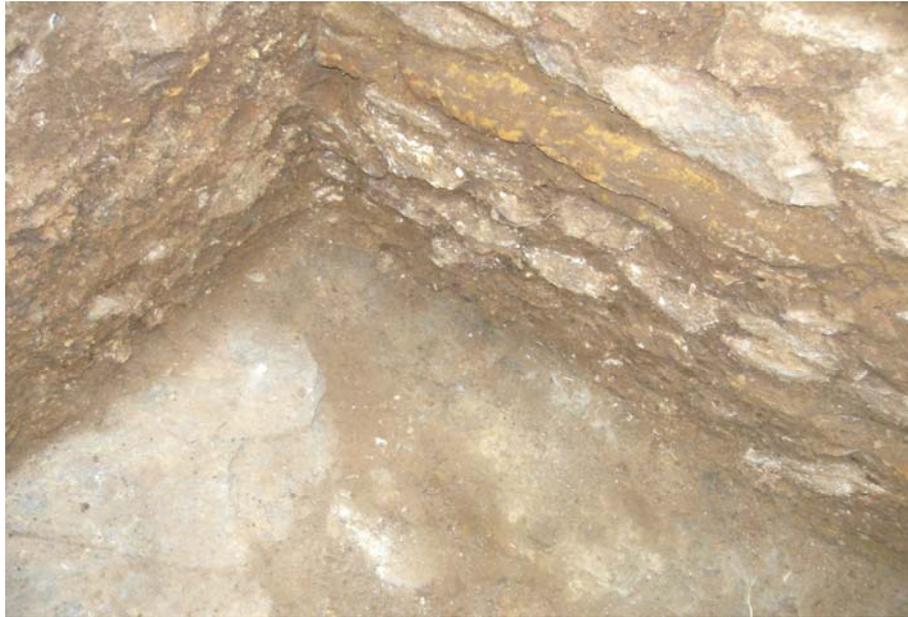
wall, as it would destabilize Stela -1. But, the excavations undertaken in this complex addressed the major research problem raised by David Phillipson who excavated the Mausoleum in the 1990s to locate the main entrance to it (Phillipson personal communication 2005). It is now confirmed that the main entrance to the Mausoleum was parallel to the East Tomb. It seems that these discovered steps may have been the entrances both to the East Tomb and the Mausoleum (Fig. 3).

Fig.3: Steps leading to the Mausoleum (Eastern Courtyard)

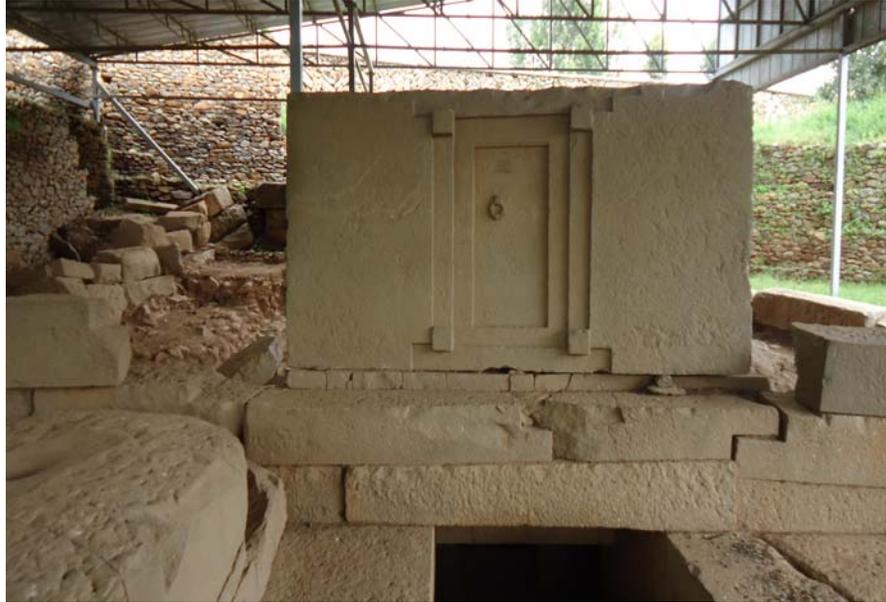
The Tomb of False Door has no structural problem. However, there are very few cracks on its massive dressed granite roof slabs. Ancient robbers disturbed such roof slabs. Although it has been open for visitors, many visitors are not aware of the existence of this tomb (Fig. 4).

Fig.4: The Tomb of False Door

However, in 2005, the disturbed boulders were re-arranged by the author of this article, to make the tomb more attractive to the public. A large dressed rectangular block of stone that rested on top of one of the dressed stone slabs forming the steps leading to the main chamber was moved and included as part of the pavement. Another slab that obscured the original appearance of the pavement was removed. Furthermore, an additional disturbed granite stone, which was placed on top of the stone pavements of the entrance of the tomb, was also moved from its position. In fact, local tourist guides describe this stone as a measurement unit of the Aksumite since it consists of grooves that appear to be scales to them. However, this monument is a roof lintel.

Moreover, additional rearrangements of displaced stones were made on the pavements of the entrance of the tomb. Furthermore, a metal pole that obscured the original appearance of the same tomb was dismantled.

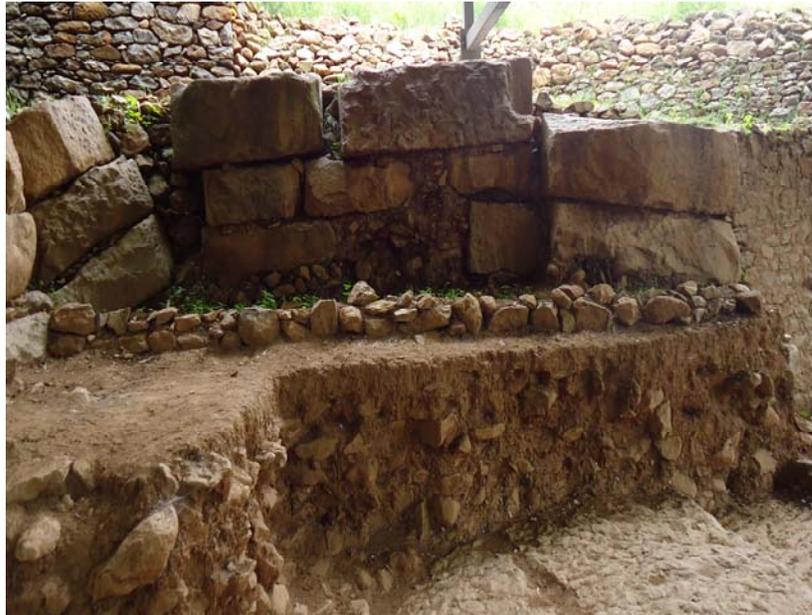
A large space was excavated to expose the roof slabs of the Tomb of False Door. This space was covered by deposits containing red soil and stone (0.90 m thick). This deposit covered the roof slabs of the tomb from the outside. In the course of the excavations, fifteen roof slabs were exposed. These covering roof slabs were not carefully dressed on their external surfaces. They also show wedge and tool marks on the same sides (Fig. 5).

Fig.5: Excavated and consolidated section of the Tomb of False Door

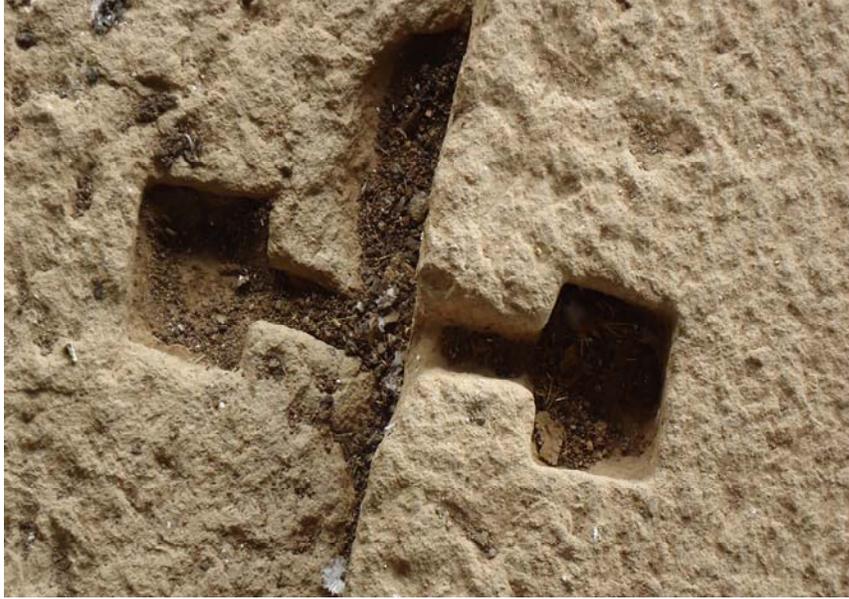
Furthermore, in the course of clearances, two metal cramps, which were not recorded by Chittick, were discovered in 2005 (Fig. 6 and 8). The first one is found in front of the present main entrance to the tomb (fig. 6). The original cramp was 0.30 m long as it can be understood from the size of the edge of excavated boulders. The Aksumites excavated the edge of two boulders at the depth of 0.4 m meters deep to place the cramp to join them together. It was removed in antiquity. However, part of it is still found attached to the boulder. From this evidence, it appears that the Aksumites used a sticking substance to fix the cramp inside the excavated holes of two boulders. In reality, they first excavated the edges of boulders that were intended to be joined together by metal cramps. The second one is 0.21 m long which is less by 0.8 m to that of Chittick's (Fig. 7). It is found on the edge of the entrance to the back chamber in a good condition Fig. 8).

Fig. 6: Metal cramps partially removed from joined boulders

This cramp joined two boulders together. The edges of the same cramp are very sharp indicating that the Aksumite did not heat the metal when they used it for joining boulders. Instead, it appears that a sticking material may have been used to attach the cramps in the excavated holes in the edges of the boulders. Furthermore, it seems that the Aksumites may have used sharp metal picks to carve or excavate the edges of boulders, as it can be understood from the nature of the holes.

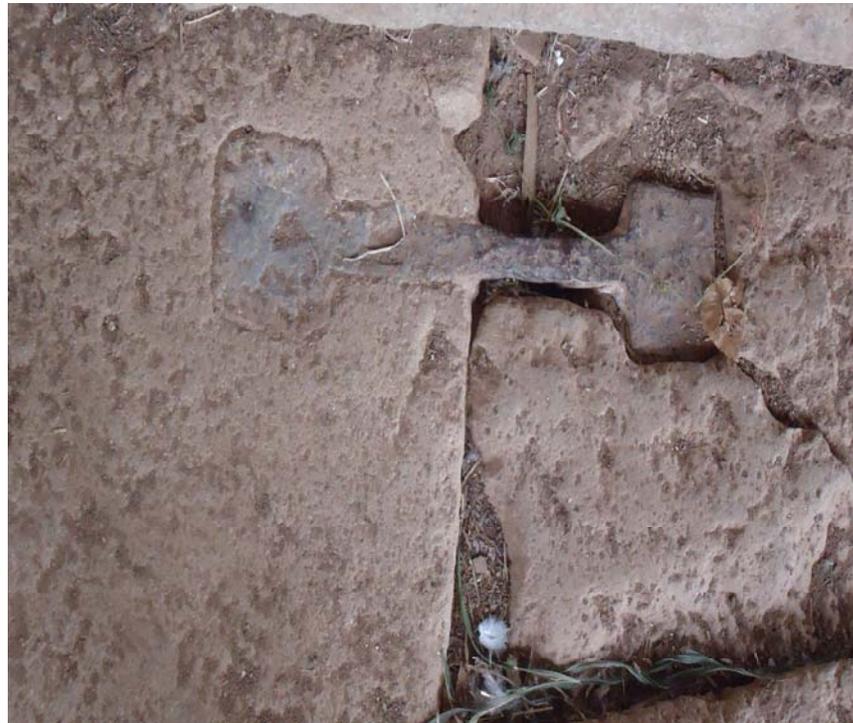
Fig.7: Metal cramp at the Tomb of False Door

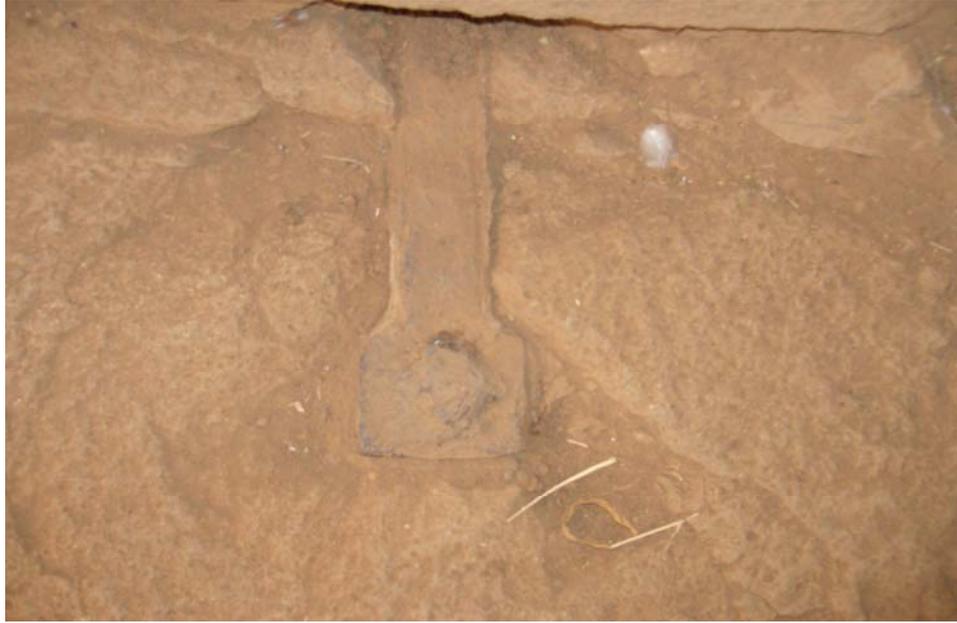
Fig.8: Metal cramp excavated from the Tomb of False Door

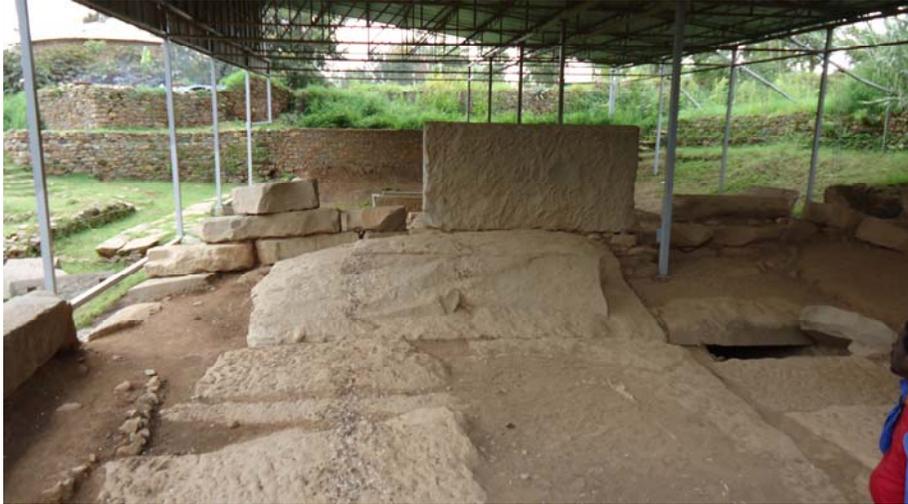
The second entrance, which leads to the large underground chamber, is found beside the first entrance on the western direction. It is covered by a huge dressed rectangular granite boulder, which has two circular basins or shallow depressions probably used for ritual sacrifice for the deceased. It is difficult to open this entrance for two reasons: (1) it is too heavy to remove, and (2) it has many cracks, which are thought to have been caused by robbers' attempt to open it in antiquity. For these reasons, access to this large chamber is through the back of the erected slab, where ancient robbers broke a single roof slab. Neville Chittick excavated the same chamber through this entrance. At present, a wooden ladder is used to go down from the roof slabs to the same room (Fig. 9).

Thirteen displaced granite slabs were moved from the backside of the tomb. Eight of them were placed in a row on the eastern edge to delineate the same tomb on this side while the rest were placed on the western side of the tomb on top of the boulders that delineated the tomb in this direction. The undressed faces of these boulders were exposed towards the massive roof slabs while their dressed sides were exposed to the outside (Fig. 9).

Fig.9: Outer roof-slabs of the Tomb of False Door

These boulders were found above the red soil that rested on the massive granite roof slabs of the tomb, which seem to indicate that robbers displaced them long after the construction of the tomb as it can be understood from the arrangements of disturbed boulders that delineated the Tomb of the False Door. Furthermore, such boulders were removed in 2005 to make the tomb clearer and more attractive and reduce the weight on the roof slabs of the Tomb of False Door.
