**GEOPHYSICAL ASSESSMENT OF TWO COLLAPSED AND CONCEALED SEPTIC TANKS AT A RESIDENTIAL SITE IN ZARIA AREA, NORTH-WESTERN NIGERIA****<sup>1</sup>Egwuonwu G. N., <sup>2</sup>Ibe S. O. and <sup>3</sup>Osazuwa I. B.**<sup>1</sup>Science Technology Department, Federal College of Chemical and Leather Technology, P.M.B. 1034, Zaria, Nigeria.e-mail: [gabneche@yahoo.com](mailto:gabneche@yahoo.com) (corresponding Author)<sup>2</sup>Physics Department, Federal College of Education, Zaria, Nigeria.e-mail: [stphnibe@yahoo.com](mailto:stphnibe@yahoo.com)<sup>3</sup>Physics Department, Ahmadu Bello University, Zaria, Nigeria.**Abstract**

A geophysical study was carried out in the vicinity of two collapsed and concealed septic tanks to delineate the structures responsible for their failure. Two-dimensional resistivity and seismic refraction tomography data were collected along a profile laid across the septic tanks. The data were collected using ABEM Terrameter SAS 4000, aided with LUND imaging equipment and seismograph, Terraloc MK6 respectively. The data were processed using REFLEX-W and RES2DINV software respectively. Pseudosections obtained show that the vicinity of the septic tanks is charact

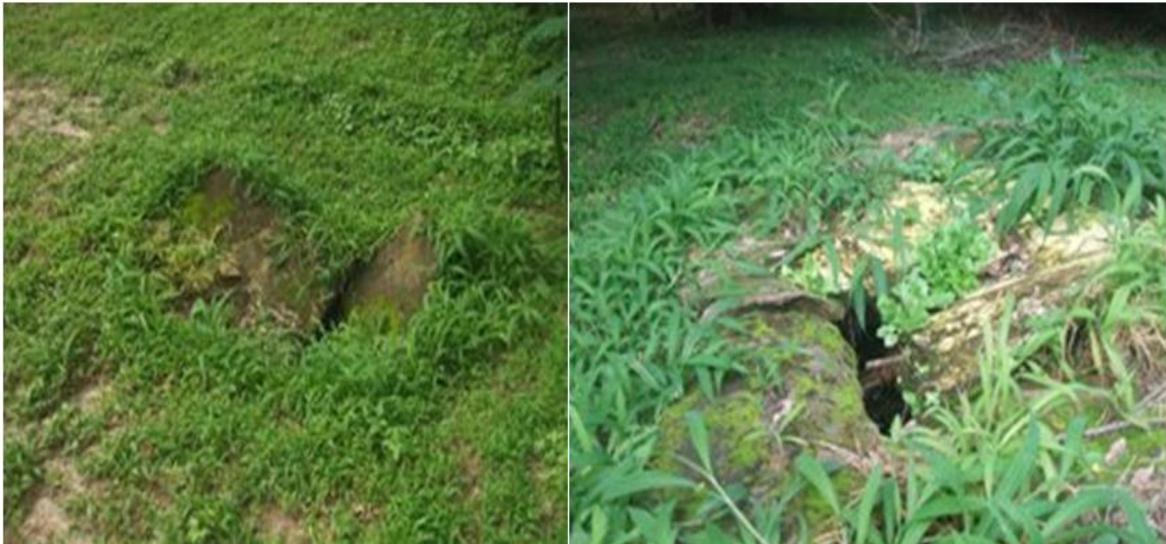
**Figure 1: Photographs of the collapsed tanks partially shown on the ground surface**

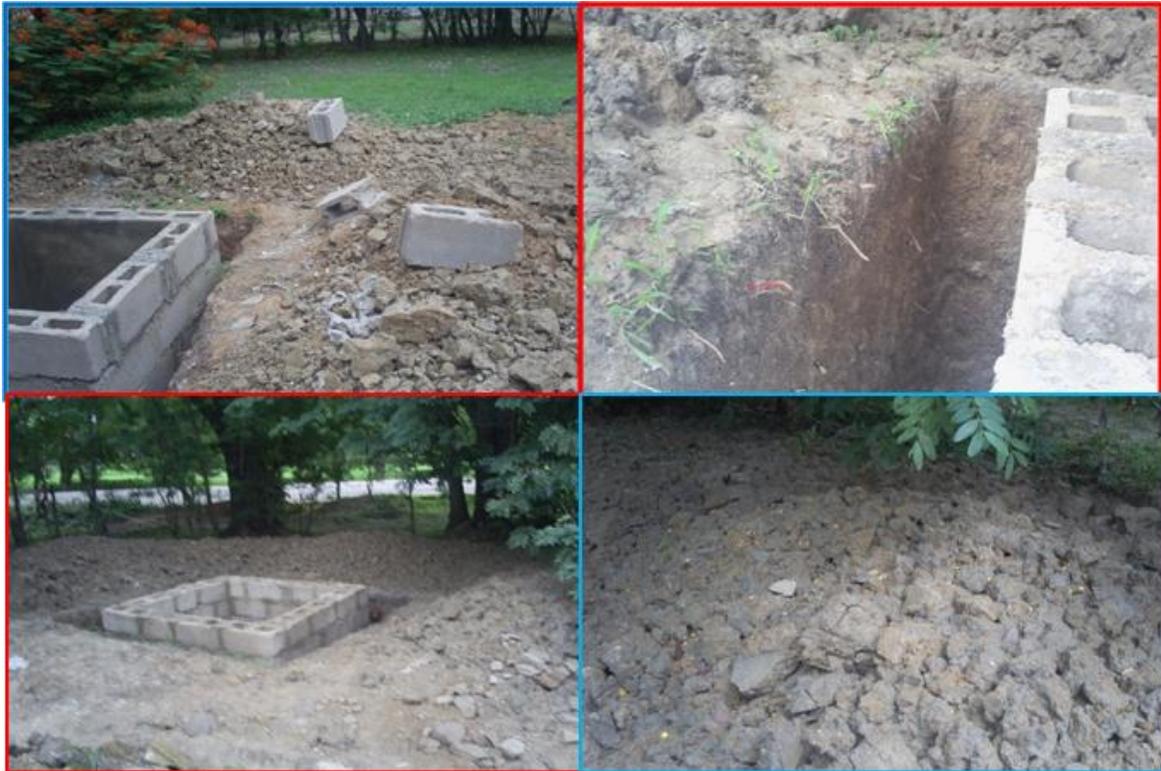
Thus it can be deduced that both the resistivity and seismic refraction tomography have delineated approximately the lateral extents and depth limits to which the inferred collapsed septic tanks (A and B) were sited based on the resistivity and p-wave velocity contrasts shown on the inverted model pseudosections. While the high resistivity ( $> 1000 \Omega\text{m}$ ) is in the range of air-filled column and buried concrete slabs, the low velocity ( $< 400 \text{ m/s}$ ) confirms the air-filled column which probably was trapped during the collapse of the tanks. The low resistivity zones (20-200  $\Omega\text{m}$ ) which are shown and interpreted as saturated clayey zones directly underlying the two tanks and probably due to leakages at the base of the septic tanks are not shown in the seismic section. Both the seismic refraction and resistivity pseudosections are shown to be generally characterized by a very shallow undulating basement with average minimum depth of 11.5 m. The collapse of the tanks could be solely attributed to presence of the expansive clayey soils at shallow depths in its vicinity. Few months after the study, an evidence of the clayey soil was clearly shown (Figure 5) as two new septic tanks about 2.5 m deep were sited to replace the collapsed/abandoned ones.

**Figure 5: Photographs taken during the construction of new septic tanks showing the evidence of clayey soil at shallow depths.**
