ELECTRICAL TREEING IN CERAMIC-BASED INSULATING MATERIALS (BaTiO₃ - SiO₂)

T. M. ABBEY and I. O OWATE

ABSTRACT

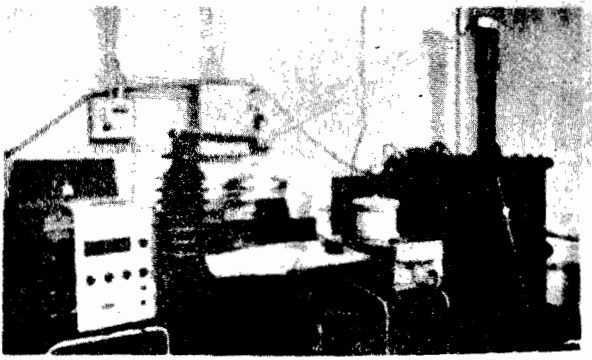
Fig. 2b Control console with a chart and circuit breaker.

the disc specimens were performed in the manner described elsewhere by Owate, and Freer (1991). The specimens were initially polished, cleaned and gold coated. Each sample was then placed between the electrodes system placed in an oil bath as shown in Figure 1. In addition, the tests Console with circuit breakers are shown in Figures 2a and 2b.

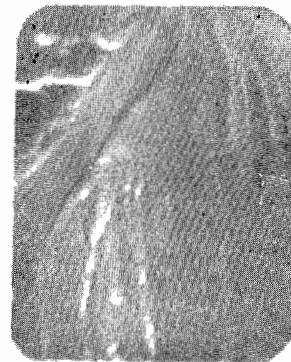
Fig. 7 Treeing in sample A at 50Hz

Table 2 shows that electrical breakdown increases with sintering temperatures and decreases with induced vibration frequencies. Consequently, samples A and B broke down electrically through the initiation of Treeing process (Figure 7, 8, 9, 10 and 11) at specific induced frequencies of 50 Hz and 10kHz. No Treeing structures were observed for samples C and D at all induced frequencies. Also for samples A and B, no tree-structure was noticed at frequencies higher than 10 kHz. This could be due to the poor quality of samples C and D and very high-induced frequencies at 100 kHz and 10 MHz. This observation is very significant because it is an indication that electrical treeing in ceramics depends upon the induced vibration frequencies and the nature of the microstructure of the system. This could be the reason for the different type of Treeing structures at 50 Hz for samples A and B. The structures were of multiple branches of bush-like models that appear to have arisen from thermal destruction stress. Such structure could have been formed by partial discharge inception field (usually low a. c. induced field frequency) (Byoung-chul and Kim, 1988). It has been well known that, with comparatively low a.c. voltages a.c. Treeing process initiates branch-like structures with increasing voltage and frequency. This could develop into a typical root-like tree with a major crack on the condition channel (Suit et al 1977). In addition, figures 9, 10, and 11 indicated similar structures at 10 kHz and equally at breakdown strength's of 19.01, 19.20 and 20.46 kV/mm respectively. These results indicate that the tree-initiation voltages achieved by using induced vibration frequencies are much lower than the breakdown voltages. This might have been caused by the initial introduction of microcracks and pores arising from the induced vibration frequency. Arbab (1999) has in his work on Polythene said that trees developed initially along the interface between electrode and the polymer, and then transferred outwards into the bulk of the polymer thereby creating a belt of damage, which emanated from the metal-solid interface and grow wider as time goes by. This could be why one

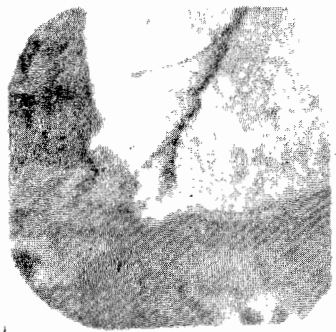
Fig. 10 Treeing in sample B at 10kHz
