# AN ASSESSMENT OF THE EFFECTIVENESS OF TRAFFIC CALMING MEASURES ON ROAD SAFETY IN NYARUGENGE DISTRICT, KIGALI CITY, RWANDA

NTAKIYEMUNGU MATHIEU, JACQUELINE MUHAYEMARIYA, NOAH BYIRINGIRO,  
NOELLA UMUGWANEZA, CLASSIO MENDIATE, BANZIBAGANYE GERALD  
AND MAJORO FELICIEN

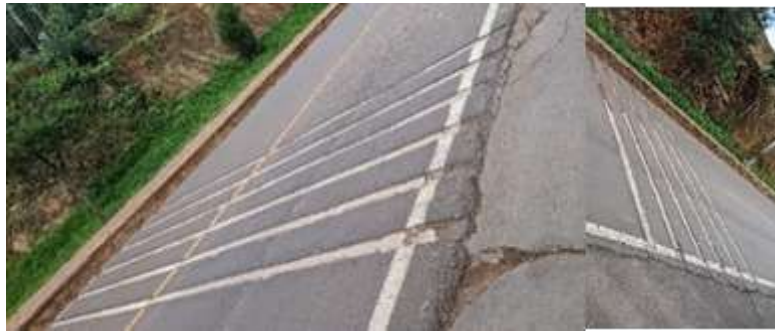
Plate 1: Rumble strips

Five rumble strips were identified along the Metheo–Nyamirambo–Norveji road, refer to Table 3 for more details. Each strip was measured using a tape measure to record its width (perpendicular to traffic flow) and spacing between strips. GPS coordinates were collected for each strip location. The condition of each strip was assessed visually, including pavement texture, marking visibility, and the presence of

advance warning signage. These measurements were compared against RTDA guidelines, which specify that rumble strips should be placed 10 to 20 meters ahead of critical areas such as pedestrian crossings or stop signs (Nkubiyaho 2020). As noted by (Zipori 2022), rumble strips are a low-cost yet high-impact traffic calming measure, particularly effective in curved zones where driver inattention is a common cause of crashes.

Despite their correct placement and good visibility, the overall number is low considering the high traffic volume and multiple accident-prone areas, limiting their potential district-wide impact.

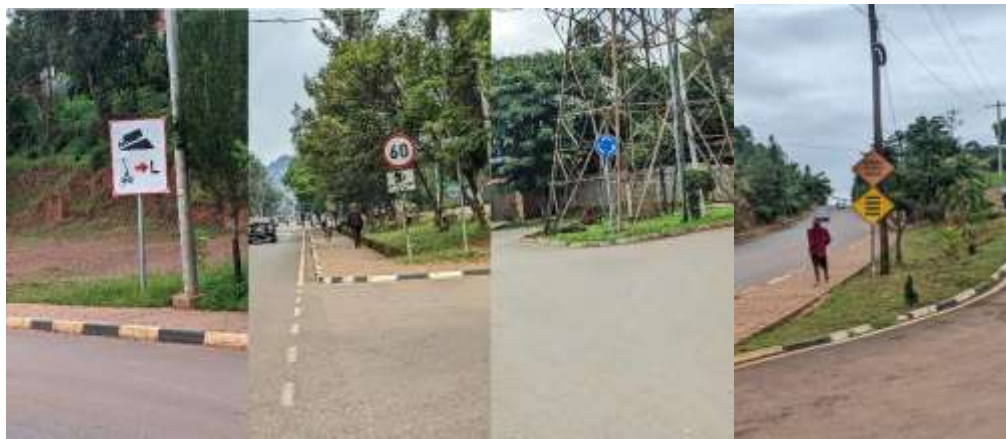
Plate 2: Warning signs and Regulatory Signs

A total of 10 warning signs were observed across the district. The most common types included Rumble Strips Ahead, School Zone, Children Crossing, and Speed Humps Ahead. These signs were typically placed 20–50 meters before the actual calming devices, generally consistent with RTDA placement guidelines. The visibility of most signs was adequate during the daytime; however, some older signs

showed signs of wear and reduced clarity, especially during low-light conditions. Regulatory signs, including STOP, Speed Limit, and Yield signs, were observed at intersections throughout the district, with generally satisfactory visibility and clarity. However, only 62% of Speed Limit signs were clearly visible at night due to faded paint and lack of retroreflective material (Nkubiyaho 2020).

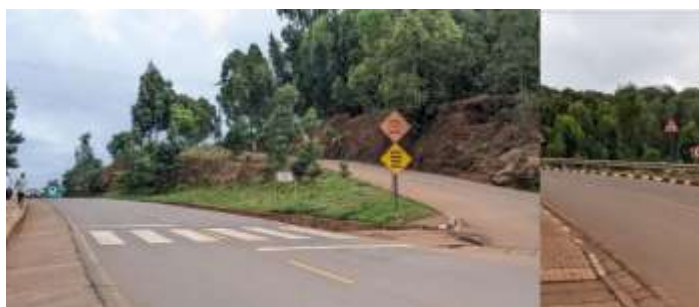
Plate3: Road Markings

Road markings such as lane separators, speed hump warnings, and pedestrian approach indicators were present across most observed areas. However, a significant portion of them were faded, making them

less effective in alerting drivers. According to (Alam, et al. 2024) , poorly maintained markings contribute to unsafe driving behaviors, as drivers are less likely to anticipate changes in road conditions.
