# Pitwall Stability Analysis-Case Studies\*

M. Affam and K. E. Allen

Affam, M. and Allen, K. E., (2009), "Pitwall Stability Analysis-Case Studies", *Ghana Mining Journal*, Vol. 11, pp. 31 - 36.

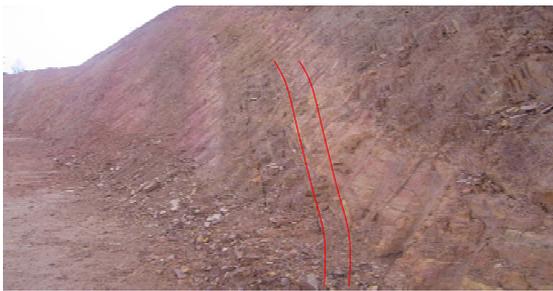
**Fig. 1 Unstable Pitwall showing Tension Cracks (in red) at Initial Excavation Stage**

the Plant North Pit (PNP) of Golden Star Resources, Bogoso/Prestea Mine, Prestea, both within the Birimian environ, required stability assessment of the slope walls. For instance, MP totally failed before the ultimate pit bottom was reached. (Figs.1 and 2). PNP which was expected to reach 4924 m reduced level (RL) began showing signs of possible failure at an initial stage of 5014 m (RL). The observed structural discontinuities are early warning signs capable of triggering eventual macro failure as creep effects are more conducive in environment of numerous tension cracks.

In open pit mining, mineral deposit are mined from the ground surface downward. Consequently, pit slopes are formed as the ore is extracted. It is sometimes difficult to maintain stable vertical slopes or pit walls of substantial height even in very hard and competent rocks. This is because the slope of the surface determines the amount of stress that occurs on the material and therefore the economics of the pit operations are to a large extent linked to the slope geometry (Ross-Brown, 1972). The pit walls must be inclined at some angle to prevent failure of the rock mass. This angle is governed by the geo-mechanical conditions at a specific mine and represent an upper bound to the overall slope angle. Any miscalculation could trigger instability and eventual failure sometime later (Fig.1 and Fig.2). The actual slope angles used in the mine depend upon:

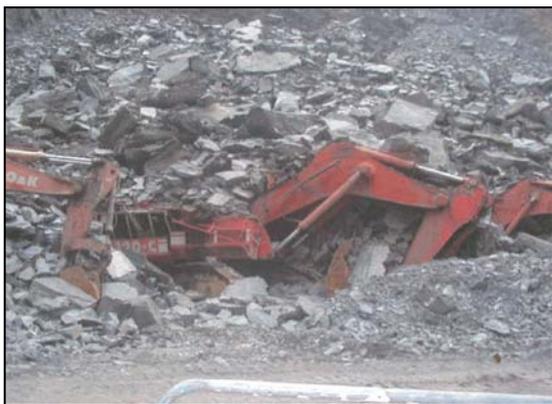
**Fig. 2 Burried Equipment Due to Total Pitwall Failure in Bibiani Main Pit (MP)**

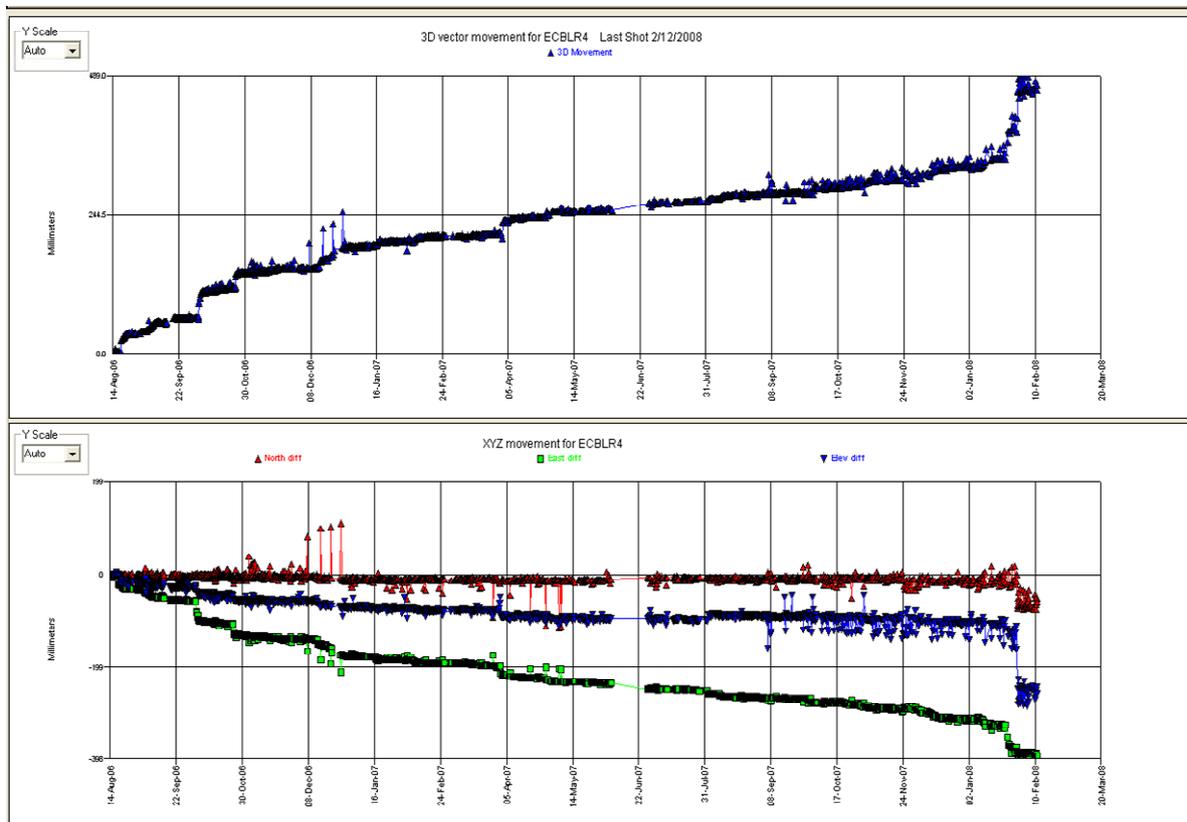
Fig. 3 Graph showing Relative Movement against Displacement Time

readings were picked at regular time intervals for the purpose of monitoring vertical and lateral movement (Fig. 3). The imperceptible slow movement down the slope was dependent on water saturation, stress loading and weak rock material. The plastic strain response depicted secondary creep, reflecting time dependent elastic deformation when stress loading was assumed largely constant.

At a point tertiary creep set in, indicating stress/strain condition in which accelerated sample strain developed. The overall readings from movement verse time curve indicated that rate of movement could near 250 mm/day down the slope face, and with no change in applied stress, it was capable of triggering eminent creep failure.

The observed value for the creep movement nearing 250 mm/day along the Main Pit (MP) pitwall was quite alarming. Careful study of geologic and hydrologic conditions, as well as structural characteristics suggested a need for an immediate creep arrest since it is easier to prevent the creep movement than to control it once it has started.

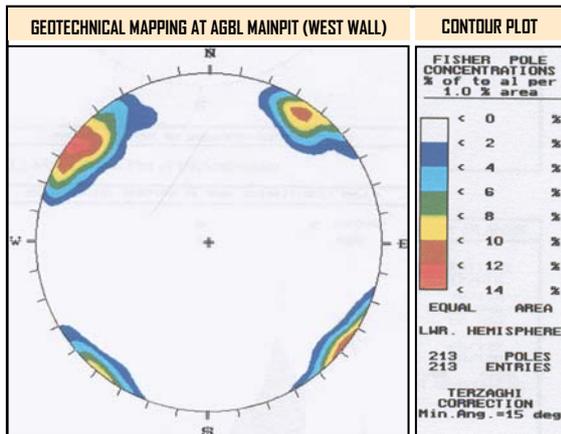
Fig. 4: Weighted Contour Plot of the Main Pit (MP) Discontinuities at the Central African Gold Ltd., Bibiani.

The footwalls and hangingwalls of both the MP and PNP were plotted stereographically using the *DIPS* software. The weighted plot of the discontinuities is as shown in (Fig.4). The major planes of failure were identified as 70°/154°, 80°/046°, 80°/300°, 81°/215°, 85°/127° and 70°/120° (Fig.5). Kinematic slope analysis carried out with the *DIPS* software indicated that potential for localised planar and toppling failure existed along the footwall.

Stability assessment at angle 50° is partially stable (Fig.4).

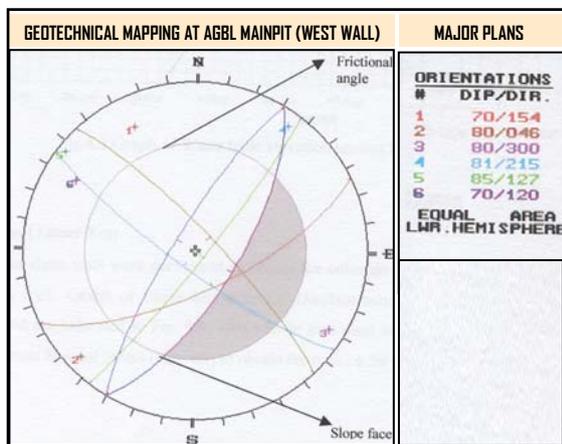
Fig. 5: Stereographic Plot of Discontinuities, Pit Slope and Friction Angle in MP
