RESEARCH PAPER

**EFFECTS OF SHORELINE EROSION ON INFRASTRUCTURE
DEVELOPMENT ALONG THE COASTAL BELT OF GHANA:
CASE OF NKONTOMPO COMMUNITY**

G. F. A. Olympio and S. Amos-Abanyie

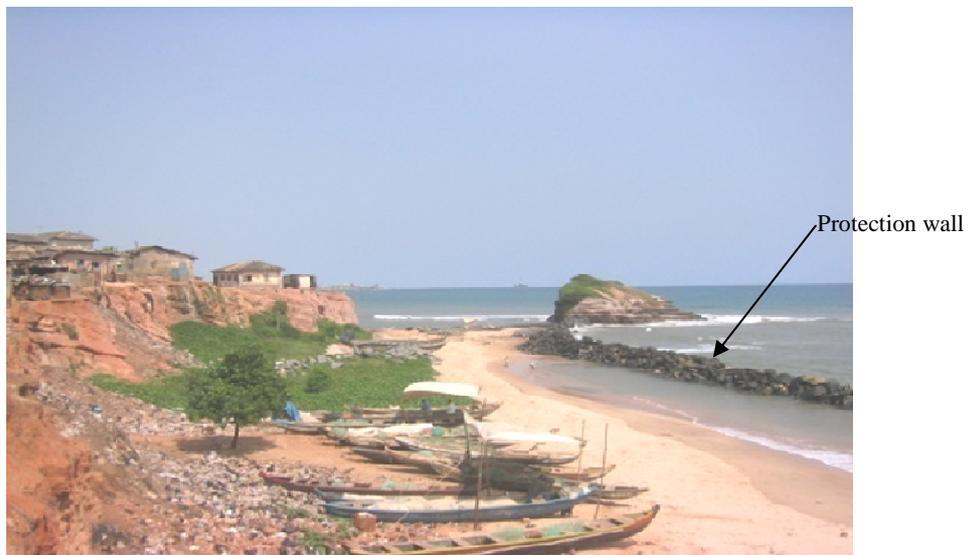
Plate 1: Shoreline has receded beyond the protection wall in place

The physical survey conducted at Nkontompo revealed that possible increase in ocean currents have overwhelmed the revetment wall that was constructed in 1990 (Plate 1). This may be attributed to the sandy nature of the shoreline of Nkontompo which does not provide a sound base. The structure has thus given way. A new revetment wall is being constructed at the cross-section of the receded shoreline. According to the experts involved, the new revetment wall is expected to be wider and higher and more bolder rocks are being used.

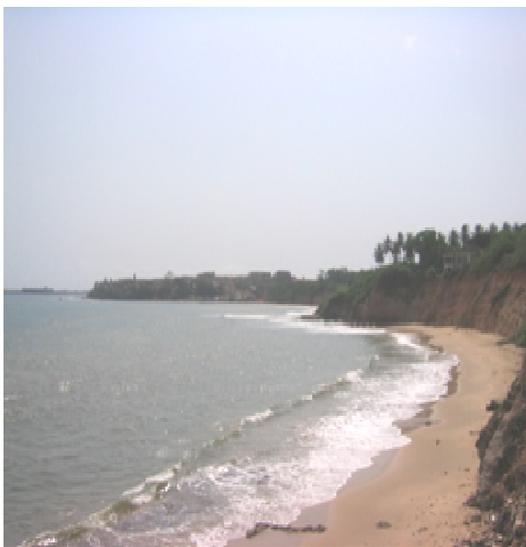
Plate 2a: A large expanse of the community's land is lost as a result erosion

The interpolation made based on the scales of the drawings indicates that between 1979 and 1991 the shoreline had receded by an average distance of 28.3 meters (Plates 2 a&b). This implies that the shoreline has been receding at approximately 1.89 meters annually. The rate of recession for the period beyond 1991 till November 2003 was also assessed. A revetment wall was constructed over the period from the late 1991 to middle of 1992.

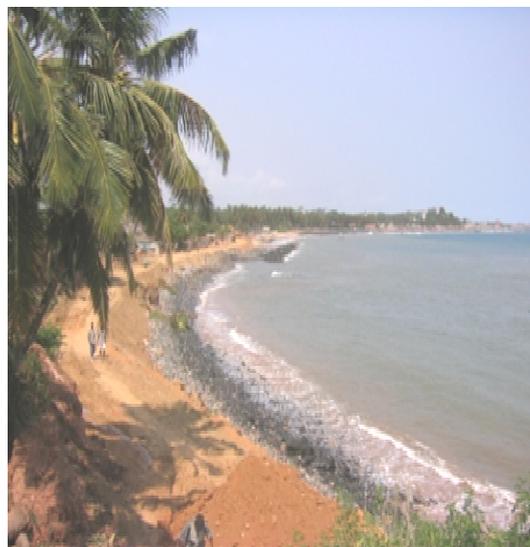
Plate 2b: An eroded street of the community is being reconstructed

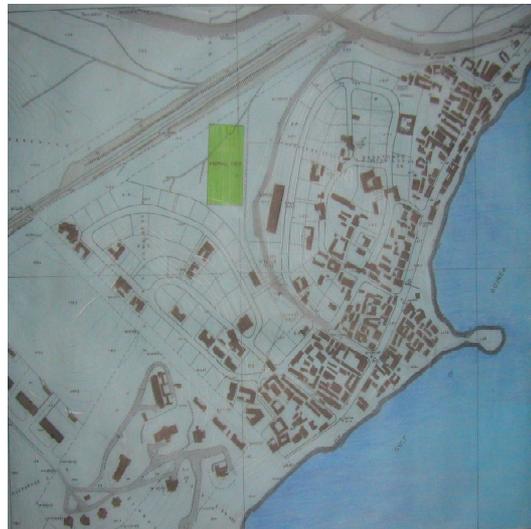
Plate 3: Base map of Nkontompo
(Source: Town and Country Planning Department, Sekondi-Takoradi, 1991)

According to descriptions given by the elderly people who formed about 65% of the respondents about a third of the community's land is lost as a result of shoreline-erosion. From the topographical sheet interpolations and analysis made by the authors, it was realized that approximately nine acres of the built environment, forming a third of the total land area had been lost. These compares well with the estimations given by local residents in the descriptive interviews conducted. The end of the protruding segment into the sea indicates the extent of

the shoreline about 20 years ago. Plates 3 and 4

demonstrate these. The sides have eroded together with the infrastructure that was on it. These include homes, communal buildings, streets, and drainage systems.

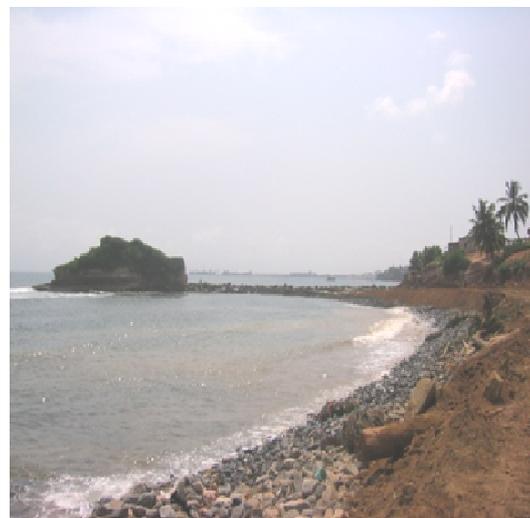
Plate 4: View of the Shoreline of Nkontompo showing the protruding end detached from the mainland
(Source: Photograph from authors' field survey, Nov. 2003)

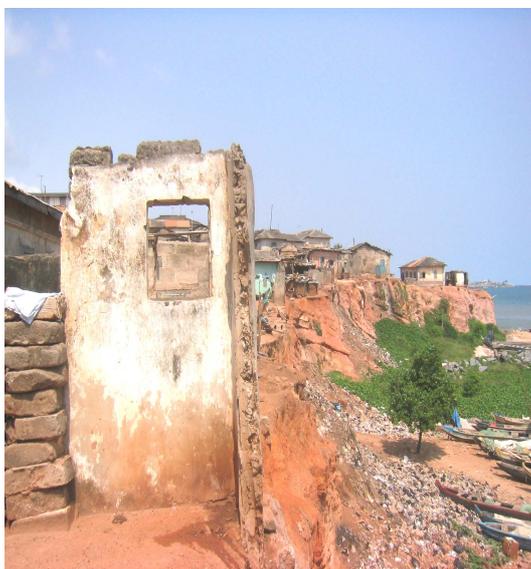
Plate 5: Damaged walls and exposed foundations of buildings

About 30% of the buildings at the beachfront have their foundations exposed, and about 41% have cracks in wall fabric (Plate 5). This could be as a result of differential settlement resulting from land submergence. Owners of properties
