LETTER TO THE EDITOR

A 20-year-old contraceptive device transformed into a calcified mass

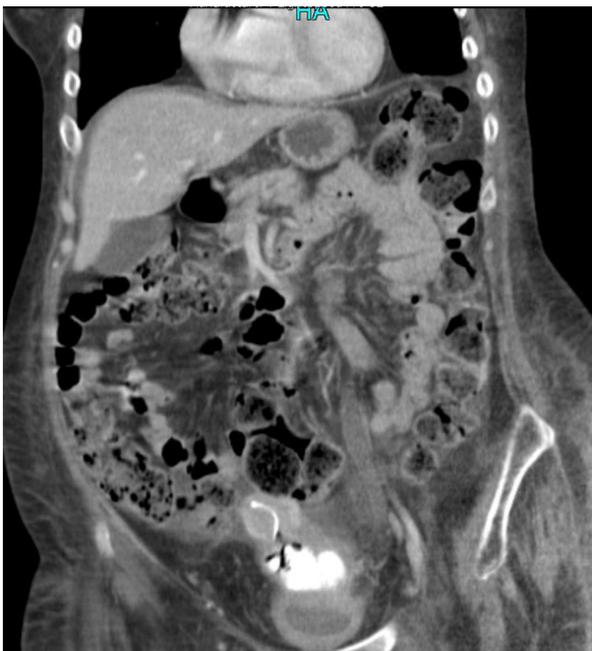
Fig. 1. CT scan showing calcified IUCD.

She had an IUCD inserted more than 20 years ago, and this had not been removed. A large, grey, hard, mass was visualised in the vagina measuring 8 × 5 cm. A CT scan showed a large vaginal stone with IUCD at superior margin, within cavity of atrophic uterus (Figs. 1–3).

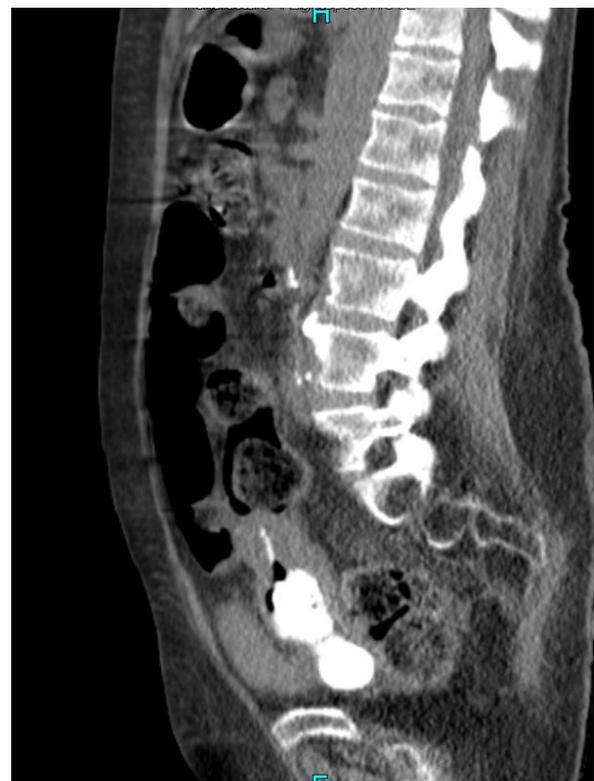
Fig. 2. CT scan showing calcified IUCD.

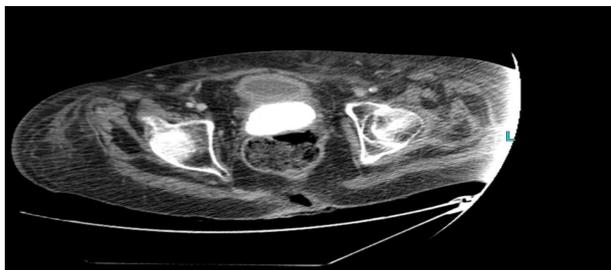
Fig. 3. CT scan showing calcified IUCD.

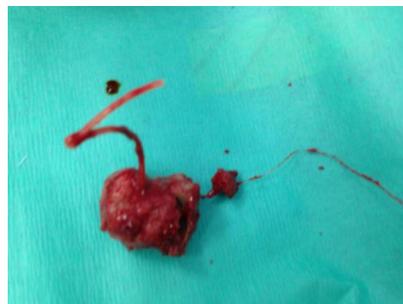
Close examination of the stone demonstrated calcification around a central core of the IUCD and its associated threads (Fig. 4).

Fig. 4. Calcified IUCD after removal.

Calculus analysis had a brown, hard, crystalline appearance and weighed 6,958 mg, consisting of predominantly magnesium ammonium phosphate (88%) and ammonium urate (12%).
