Deterioration and Microstructural Characterization of Reinforced Concrete Beam Buried in Lagoon and Fresh Waters

U. T. Igba^{a,*}, J. O. Akinyele^a, F. M. Alayaki^a, S. I. Kuye^b, S. O. Oyebisi^c

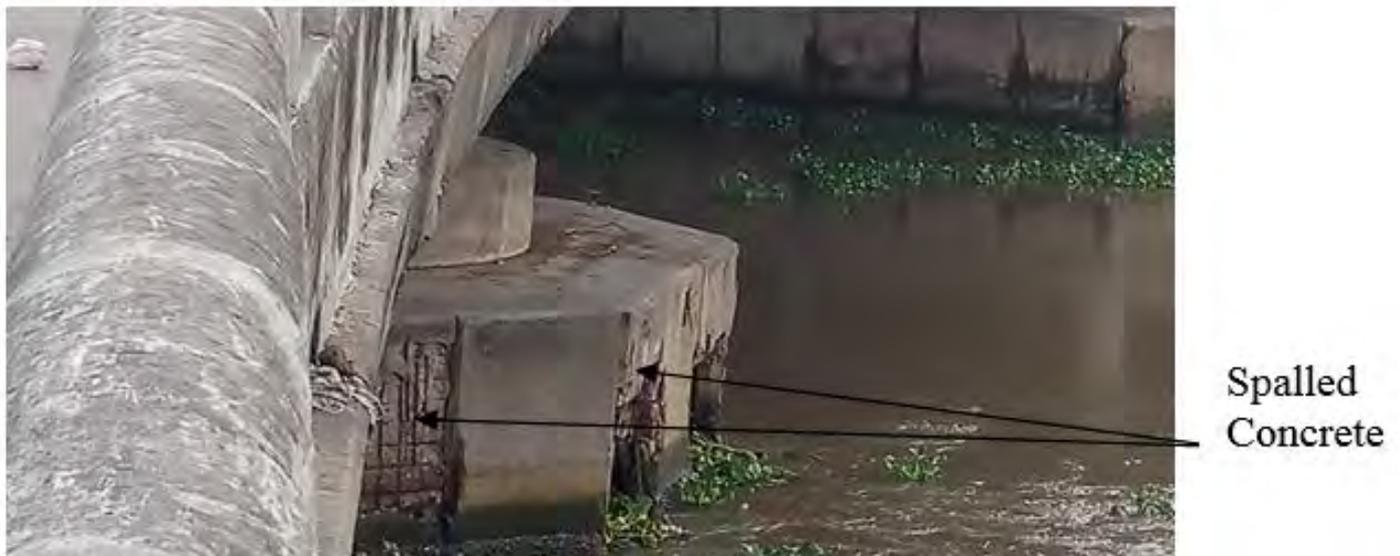
Figure 1: Concrete spalling of the pile cap of Carter bridge in Lagos, Nigeria.

Chemically interacted sulphate ions with cement paste components resulted in cracking, loss of adhesion and expansion of cement hydration products due to thaumasite, gypsum and ettringite formation [12]. Microstructure was an advanced system that changed immensely during concrete hydration process, it was ultimately used to determine the effect of the field transportation of chemical substances on concrete and used to determine their eventual service life [13]. The effect of sulphate attack led to spalling of the concrete and the exposure of reinforcements as shown in Fig. 1 of a bridge pile caps in Lagos Nigeria.

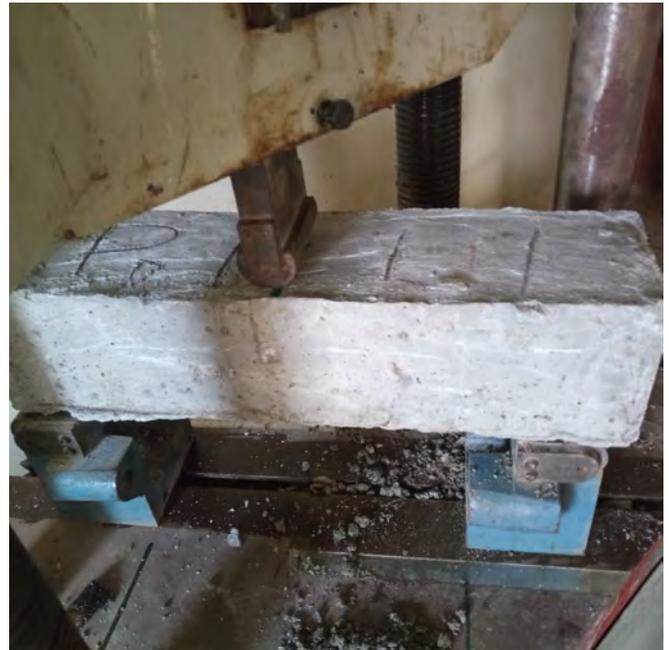
Figure 2: Flexural strength test of reinforced concrete beam not (location map of study areas).

The flexural strength test was carried out on the beam specimen for BL30 and BF30. For the flexural strength performance, a three-point loading test was adopted in accordance with [21] and forces applied to the beams were perpendicular to the failure plane. The beam was then marked where made contact with the supports and the top side that made contact with the point load, the specimen was placed in the testing machine, correctly centered with the longitudinal axis of the specimen at right angles to the casting position, the specimen was loaded until failure occurred, the ultimate load was read and recorded. Also, the flexural strength test was carried out on five samples for each. After the test, the cross-section at each end and at the center was measured. The average height and depth were computed. The average flexural strength of the beams cast was determined by applying the formula illustrated in Eq. (4).

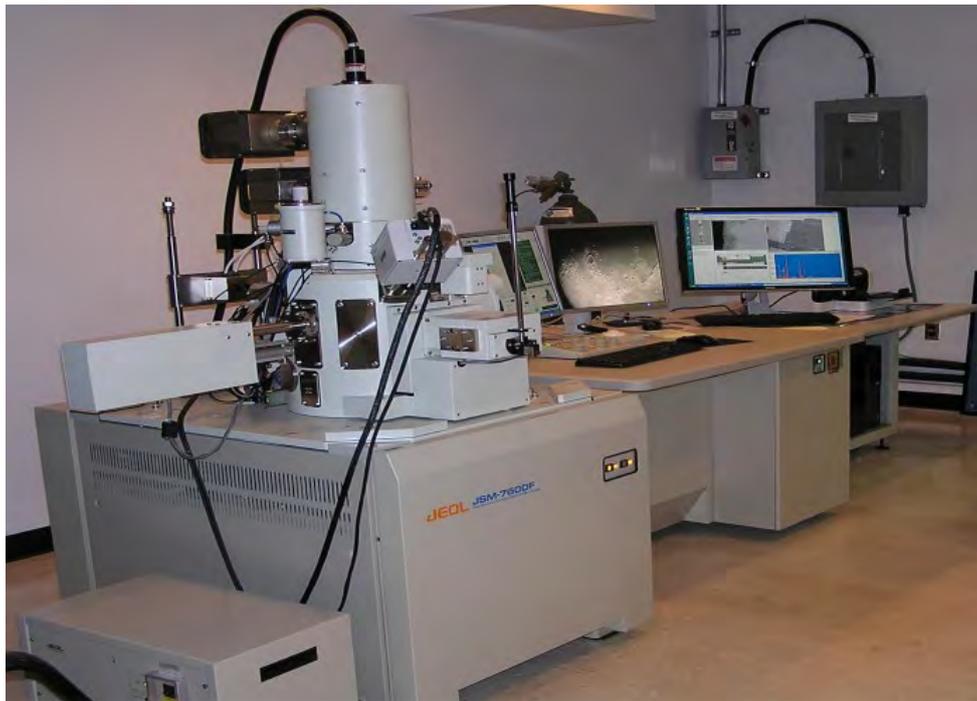
Figure 3: SEM complete system.

The machine used for the Scanning Electron Microscopy (SEM) analysis was JEOL-JSM-7600F field Scanning Electron Microscope, shown in Fig. 3.

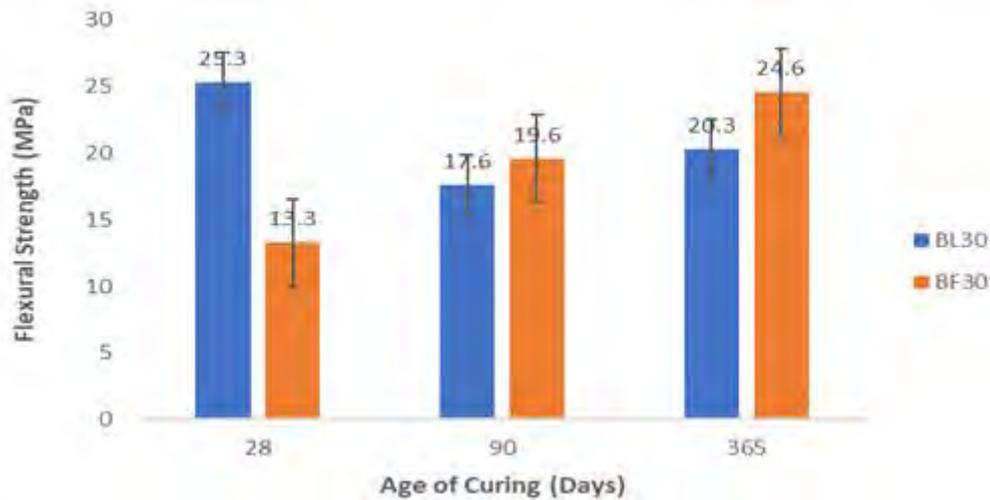
Figure 4: Flexural strength result

The flexural strength of BL30 at 28 days had the optimum average flexural strength of 25.3 N/mm² which was due to the chemical reaction between the lagoon water and the Ettringite, Ca(OH)², and C-S-H gel which were actively generated from an early age.

It was observed that BL30 submerged in the lagoon behaved better at the early stages of curing than the BF30 submerged in fresh water for 28 days. The optimum strength after curing for a period of one year was recorded in BF30 with flexural strength of 24.6 N/mm² compared to BL30 with flexural strength value of 20.3 N/mm², confirming that reinforced concrete beam samples submerged in fresh water over a long period of time performed better than samples submerged in lagoon water with a linear increment from 28 to 365 days. Fig. 4 showed the result of the flexural test carried out on the beams. There was a final decrease in flexural strength from 28 days to 365 days by 19.76% for BL30 while there was a rise in strength from 28 days to 365 days by 84.96 % for BF30. The rise and fall of the flexural strength of reinforced concrete sample buried in the salty lagoon water over a period of 365 days showed the activity of sulphate. This was evident that due to the prolonged sulphate attack on the reinforced concrete beam buried in lagoon water for a period of 365 days, there was a final reduction in flexural strength compared to reinforced concrete samples buried in fresh water which strength kept increasing geometrically. The reasons for the decrease in

flexural strength were as a result of poor interfacial adhesion between the concrete and the reinforcement, due to the presence of sulphate and chloride attacking both the concrete and the steel reinforcement, and also the distortion in the microstructure caused by penetration of lagoon water and porous morphology of the lagoon water in the reinforced concrete beam.

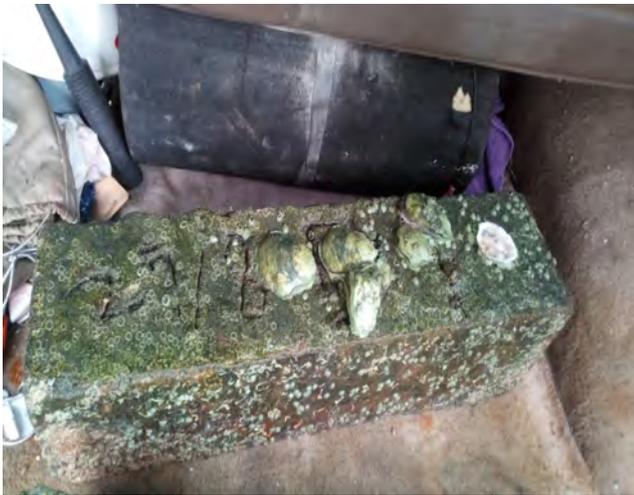
Figure 5: Beam buried in Lagoon water after 1 year.

Figures 5 and 6 below showed the physical appearance of reinforced concrete beam after a period of 365 days by visual examination of the reinforced concrete beam, the deterioration of a reinforced concrete beam from the external ingress of sulphate ions BL30 was dark grey and greenish in appearance, the reinforced concrete beam without any sign of deterioration BF30 was light grey/whitish color.

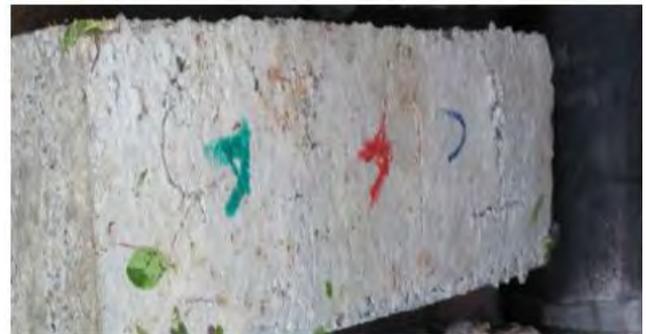
Figure 6: Beam buried in Fresh water after 1 year.

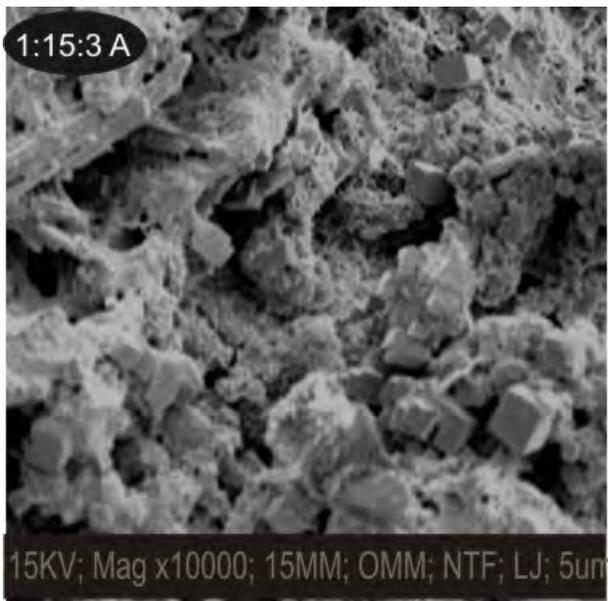
Figure 7: BL30 at 28days.

Many parts of small hydrating crystals and large holes existed for BL30 as seen in Figs. 7, 9, and 11 having large micro holes. The key explanation for this was the small volume of hydration crystals and their unequal distribution in the cement matrix, resulting in the formation of very large pores and an overall decrease in the strength when compared to samples buried in fresh water.

The dark dolomite rim (BL30) seen in Figs. 7, 9, and 11 were wide, dark-colored and occurred near the outer margin of the coarse aggregate particles. The rim was darker and more porous

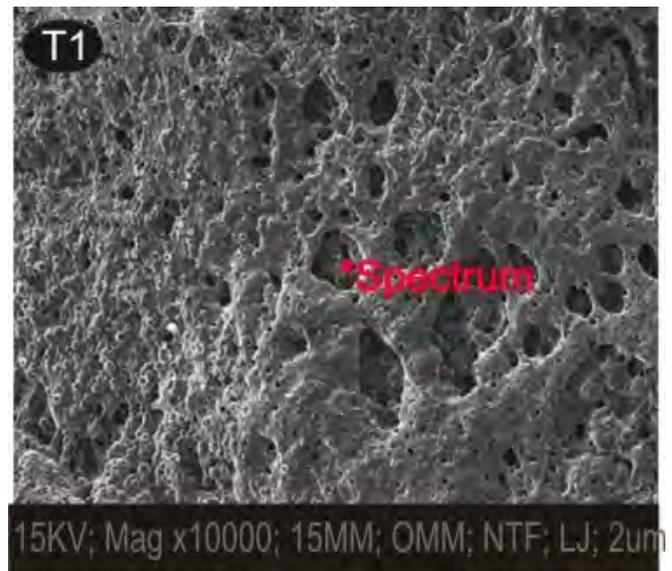
Figure 8: BF30 at 28 days.

In Figs. 8, 10 and 12 samples of concrete microstructures were observed. It was found that

the internal hydration substance, primarily calcium hydroxide, had a widely dispersed structure near the concrete micro-pores and micro-fractures. Similarly, a lot of fibrous and flocculent hydrated calcium silicate but no apparent corrosion or micro-damage products were found as there were no record of external sulphate ion concrete penetration.

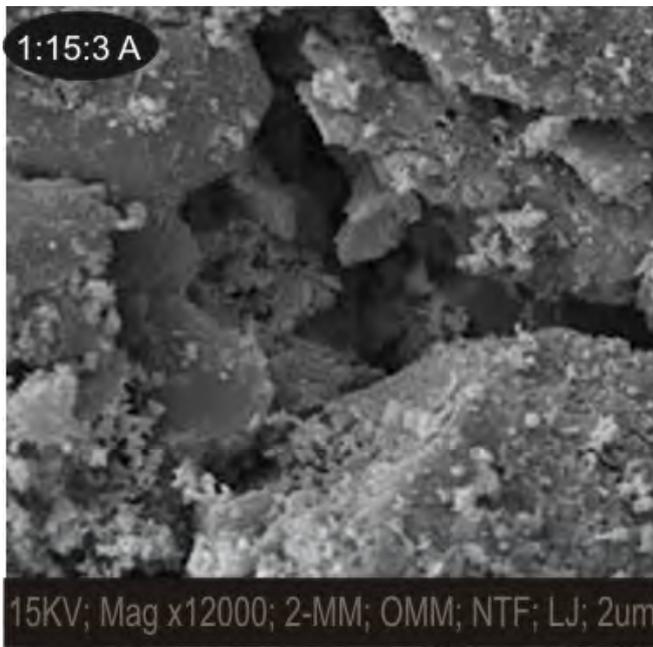
Figure 9: BL30 at 90 days.

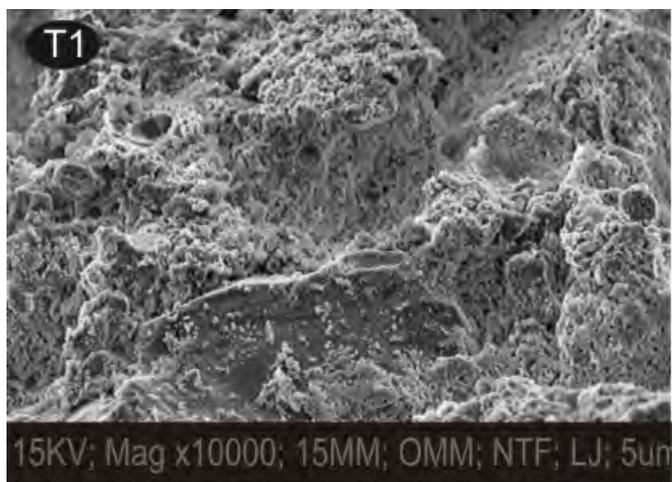
Figure 10: BF30 at 90 days.

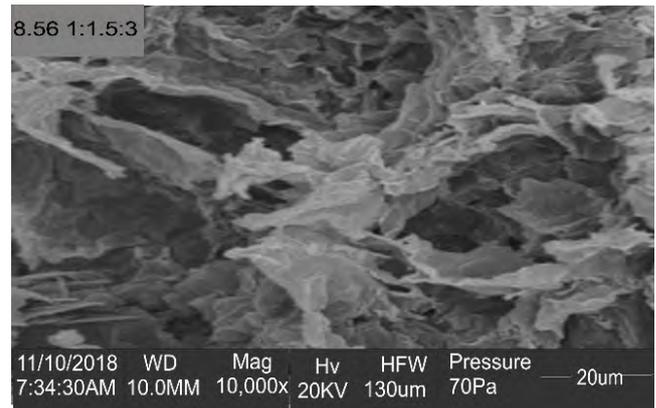
Figure 11: BL30 at 365 days.

At 365 days, it was observed that due to the fully submergence of samples buried in the lagoon water, samples ended having a microstructure with more defects, a lot of macro pores with decreased flexural strength were noticed in BL30 at the 365th day showing the vulnerability of sulphate damage of the concrete buried in lagoon water by physical salt weathering which depended on the pore structure which was similar to the research by [33] where the presence of small pore increased the capillary rise and also increased the surface area of evaporation which led to higher supersaturation of the pore solution that caused more damage.

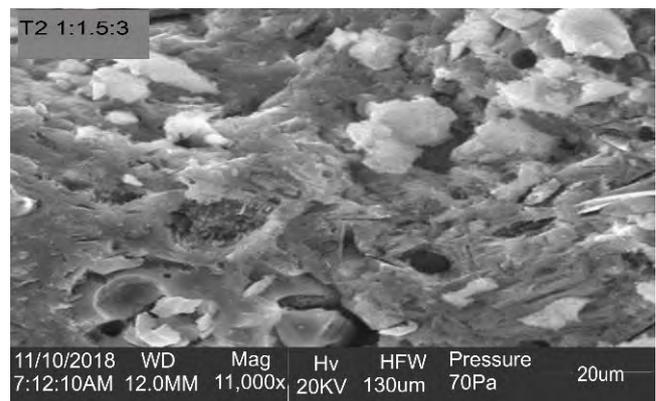
Figure 12: BF30 at 365 days.
