Images in medicine

Misplaced left internal jugular venous catheter with an exceptional location

Pan African Medical Journal. 2016; 24:305 doi:10.11604/pamj.2016.24.305.10424

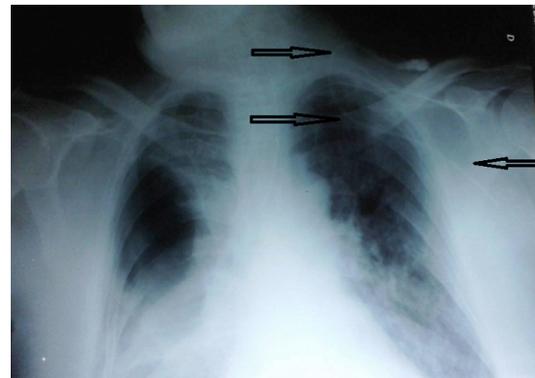
Figure 1: Chest X ray showing an aberrant position of a left internal jugular vein catheter in the left axillary vein

Large numbers of central venous catheters (CVCs) are placed each year in the intensive care units and misplacement occurs frequently. Many critically ill patients require central venous catheterization for multiple and varied reasons. Internal jugular vein (IJV) catheter is one of the most frequent central venous catheters in intensive care units not only in Africa but all over the world. The right position of the catheter should be always verified by chest X ray after each catheterization even when it is ultrasound-guided. Acquired abnormalities such as stenosis or thrombosis of the central veins can be problematic. Catheters can also be misplaced outside veins in a patient with otherwise normal anatomy with potentially disastrous consequences. We report in this work an exceptional image of chest X ray showing an extremely rare misplacement of an internal jugular vein central catheter. This occurred in a 73-years-old man admitted to our intensive care unit for an acute respiratory failure due to right pulmonary complex contusions due to a traffic accident which required intubation and mechanical ventilation. The chest X ray presented in this work shows an axillary location of the central catheter. It was documented that the catheter was inserted into the left axillary vein. Interestingly, there was no problem for infusion of fluids via this catheter. However, we removed the

catheter without further complications and IJV cannulation was performed successfully via left. With regard to misplaced CVCs, in the short term, a useful aide memoir is: "if in doubt, don't take it out".
