## Carbon dioxide: making the right connection

Carbon dioxide has been used in anaesthesia since the late 1920s, principally to stimulate breathing after a period of hyperventilation in the era before routine use of capnography. The authors' tertiary academic hospital still has the infrastructure for pipeline delivery of carbon dioxide. A case is reported of accidental administration of carbon dioxide to a patient under anaesthesia, who was found to have end-tidal carbon dioxide (EtCO<sub>2</sub>) concentrations of greater than 25 kPa immediately after induction. This was confirmed on arterial blood-gas analysis. After successful resuscitation using an alternative oxygen source, it was discovered that the high concentrations were due to misconnection of gas pipelines during the refurbishment of a theatre. This highlights safety issues concerning pipeline provision of carbon dioxide, and that it is of utmost importance to confirm correct gas connections and supply before a new theatre is commissioned.

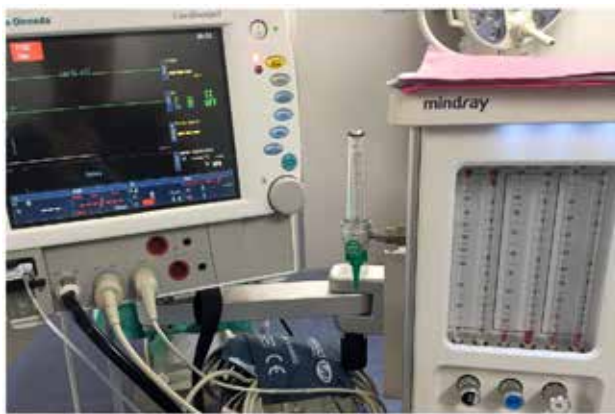
Figure 1: Anaesthesia workstation being tested after the event; connected to faulty wall gas outlet and ventilating a test lung. While supplying only medical air, note the lack of oxygen or other gas on the analyser display, subtle high flat line EtCO<sub>2</sub> trace and lack of capnograph reading.

The capnography on the anaesthetic monitor did not display numerical values during most of the incident, as the value was well above the normal reference range. On close inspection during re-enactment of the scenario, it could be seen that the capnography trace displayed a flat line at the top of the screen,

but this was very difficult to observe, as demonstrated in Figure 1. When the soda lime was replaced, a carbon dioxide trace was seen briefly, before disappearing again, as the soda lime became overwhelmed by the high flows of carbon dioxide. This case highlights the necessity of checking installed gas pipelines in any newly commissioned theatre, and checking each gas individually during a machine check.

A post-incident investigation was initiated, during which gas analysis was performed using the original wall gas outlet and both anaesthetic machines. When a mixture of air and oxygen was selected, persistently high values of CO<sub>2</sub> (up to 27 kPa) were obtained. This resolved when oxygen and nitrous oxide were selected. Connecting the anaesthesia machine to the two other sets of wall gas outlets in the angiography suite showed no aberrant behaviour. As neither medical oxygen nor medical grade air should contain any carbon dioxide, it was then suspected that the third set of wall gas outlets was contaminated with CO<sub>2</sub>.

Access was obtained to the interfloor service level containing the gas pipelines supplying the angiography theatre. On inspection, it was found that during the installation process, a new set of outlets had been installed, providing a total of three sets for the theatre. To save costs and avoid drilling new holes, the existing carbon dioxide pipeline had been disconnected, and then reused for the new medical air outlets. Two of the three were correctly connected and repainted, but the third was accidentally reconnected to the carbon dioxide supply. Although repainted grey to designate its new planned role to carry medical air, specks of green paint revealed its original nature (see Table 1 for

pipeline colour standards). This was not apparent inside the theatre to the anaesthetic team. When pure oxygen was administered during preoxygenation, the patient was indeed receiving 100% oxygen. However, when an oxygen/air mixture was selected, the patient received a mixture of oxygen and carbon dioxide instead.
