Delayed post-surgical sepsis from Teflon felt: The diagnostic value of CT scanning, and a reminder for theatre staff

AngloGold Ashanti Health, Western Deep Levels Hospital, Carletonville

Rupture of an ovarian artery aneurysm following normal vaginal delivery

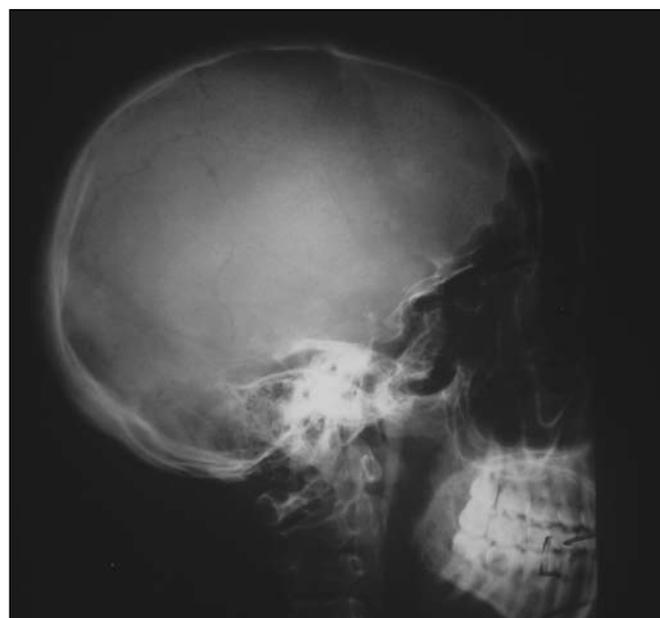
Fig. 1a. Lateral skull radiograph. Teflon felt is not visible

No abnormality was visible on plain film radiographs of the skull (Fig. 1a). A CT scan of the brain, however, demonstrated a large, folded, radio-dense foreign body within the soft tissues of the scalp in the left temporo-parietal region (Fig. 1b). At surgical exploration under general anaesthetic, two felt-like foreign bodies were removed with difficulty from ingrowing tissue. These were subsequently identified as Teflon felt.

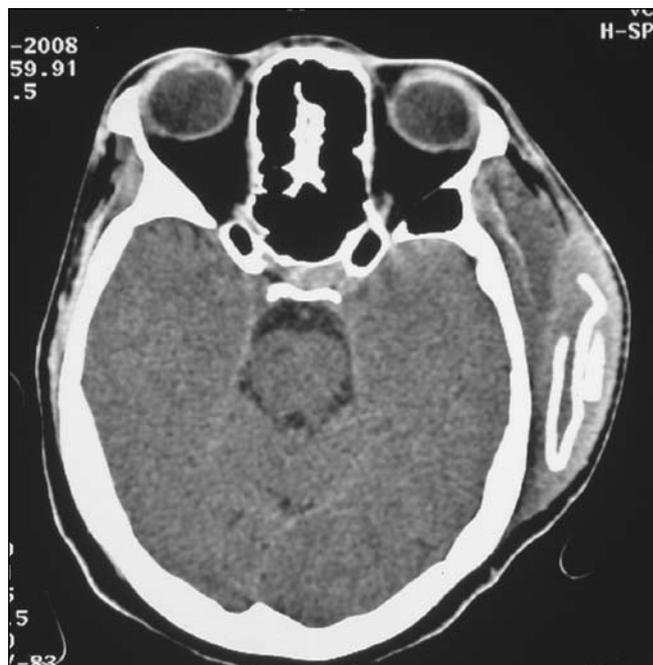
Fig. 1b. CT image showing Teflon felt in soft tissues of scalp.

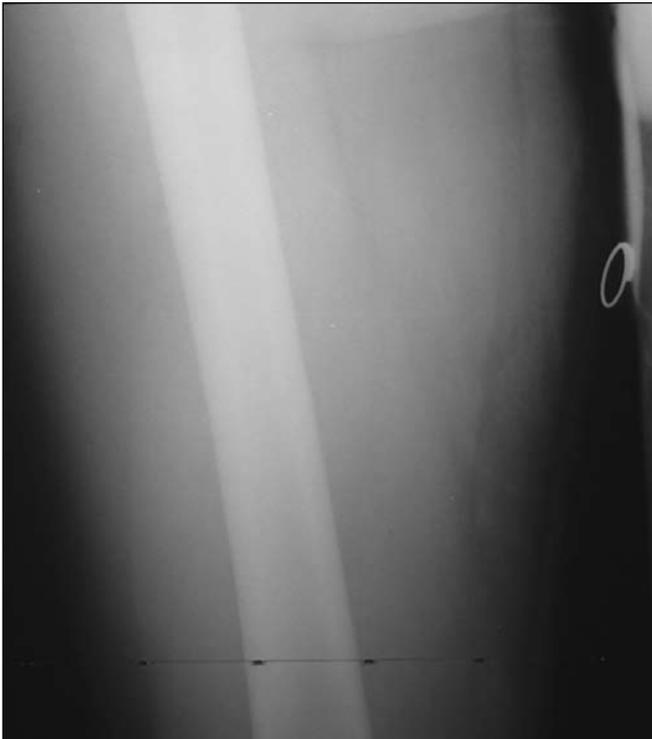
Fig. 2a. Right thigh with circular metallic skin-marker; Teflon felt not visible.

The patient was re-admitted in March 2008 for drainage of a right thigh abscess. He subsequently developed chronic wound sepsis. Radiographs of his thigh showed no visible abnormality (Fig. 2a). Wound swabs grew *Proteus mirabilis*, methicillin-resistant *Staphylococcus aureus* and methicillin-resistant *S. epidermidis*. The wound sepsis settled with

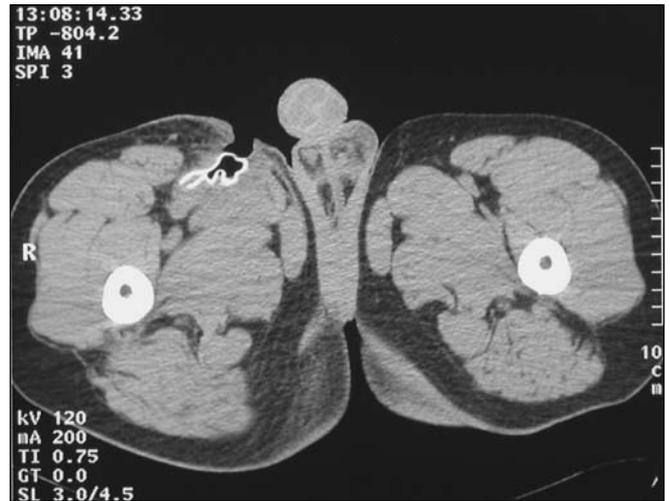
Fig. 2c. CT scan image through upper thighs shows Teflon felt in base of ulcer. Ulcer crater contains air; this accounts for the fine linear lucencies visible within the soft tissues of the right medial thigh on the pelvic radiograph.

A radiograph of the pelvis including the upper thighs was obtained. This showed faint linear lucencies within the soft tissues of the medial thigh on the right (Fig. 2b). No radio-dense foreign body was visible. A CT scan of the right inguinal region and thigh was then performed and this showed a folded, radio-dense foreign body, extending over a long segment of the upper thigh (Fig. 2c). At surgical exploration under general anaesthetic, a 6 x 4 cm piece of Teflon felt intimately associated with the old femoral artery repair was removed and the wound closed. The patient subsequently made a full recovery and returned to work.

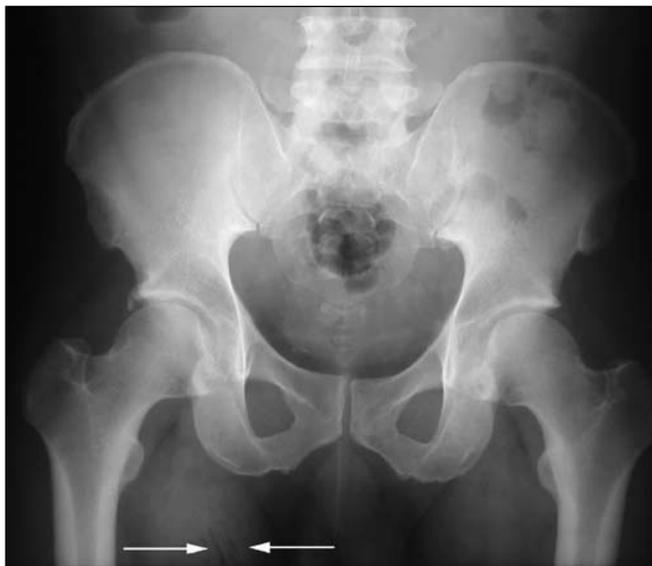
Fig. 2b. Teflon felt not visible in pelvic X-ray; note air lucencies in right medial thigh (arrows).

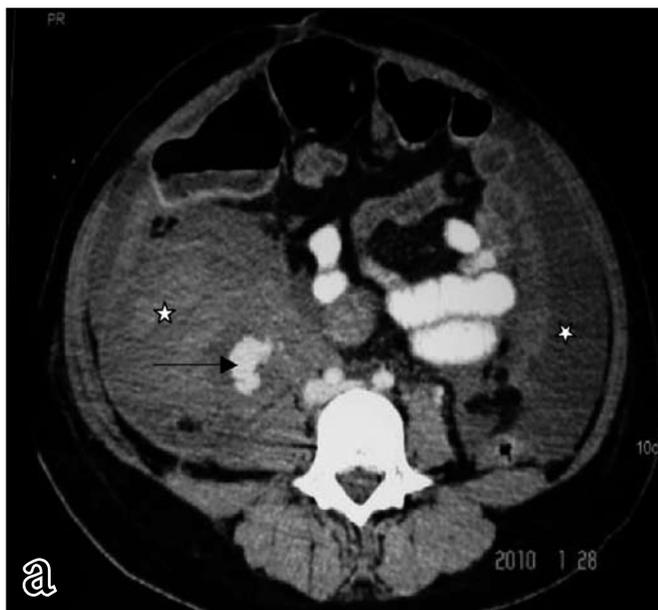
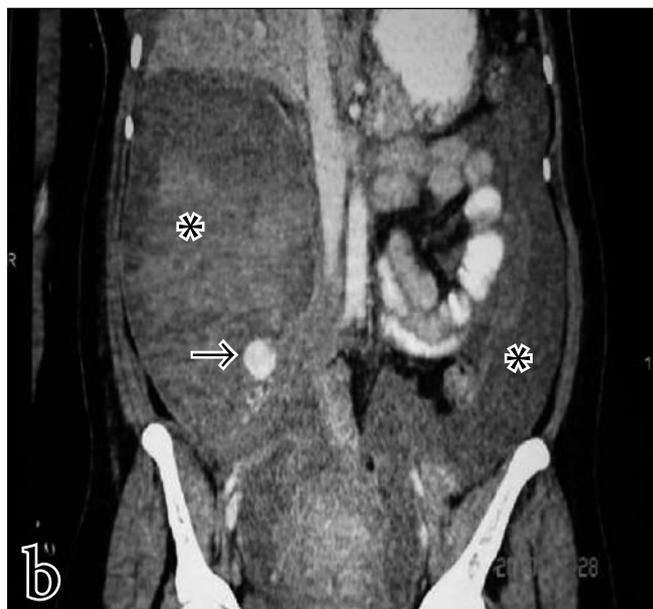
Figs 1a and b. Axial and coronal contrast-enhanced CT image of the abdomen demonstrating large right retroperitoneal abdominal and pelvic haematoma (stars) with right-sided focal area of contrast extravasation at the expected location of the right ovarian artery (arrow). Ascites also present.

Abdominal ultrasound revealed a large abdominal fluid collection; a CT scan was therefore requested. A contrast-enhanced CT scan demonstrated a large homogenous retroperitoneal fluid collection in the right flank, with a 25mm rounded, intensely enhancing focus located close to the inferior border of the collection (Fig. 1). The collection displaced the bowel to the left and inferiorly, and the liver superiorly.
