Restoring one's smile - Anterior restorations: Three cases attended at Muhimbili National Hospital

Restoring one's smile – Anterior restorations: Three cases attended Muhimbili National Hospital. *Tanz Dent J* 2011, 17 (1):15-19.

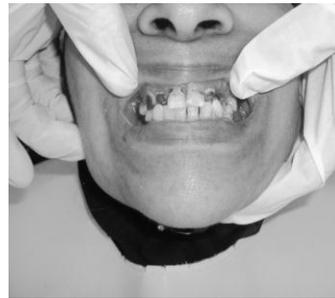
Fig. 1a: Case No. 1 before treatment.

An old female patient presented with rampant caries, mostly affecting the upper teeth.

On examination, teeth number 11 & 21 had dental caries mostly cervical, with spared coronal parts. Teeth 12, 13 & 22 were grossly carious leaving only root stumps

Tooth 14 had a deep occluso-distal dental caries involving the pulp.

Teeth 24, 33, 34, 43 & 44 had deep dental cervical caries (Class V).

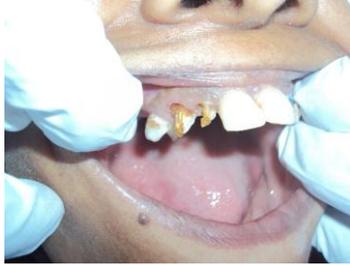
Fig 1b: Case No 1 during treatment

Root canal treatment was done to the above four teeth (12, 13, 14 & 22). Thereafter screw posts were inserted, and Glass Ionomer Cement (GIC) cores were built upon.

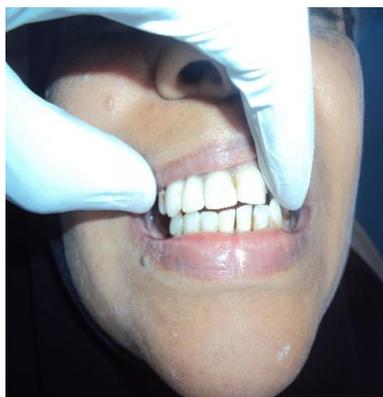
Fig 1d: Case No. 1 after completion of treatment

Composite crowns were then built up and all other carious teeth were restored.

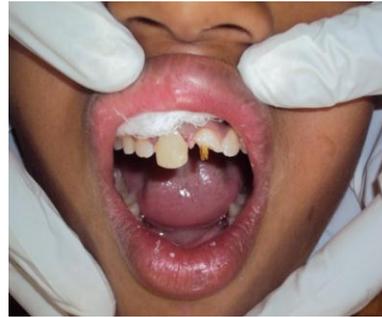
Fig 2a: Case No 2 before treatment

Clinical examination and a periapical x-ray were taken, which revealed a stable root of 21 an ill-restored acrylic post-crown of 11 with a leaky gingival-crown interface with crown fringes overlying the gingival tissue causing localized gingivitis.

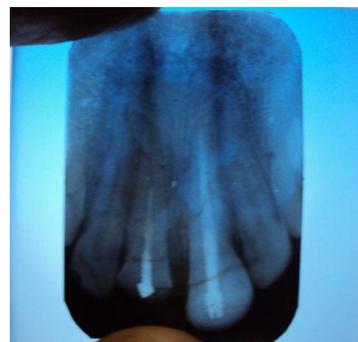
Fig 2b: Picture of an x-ray of teeth No 11 and 21.

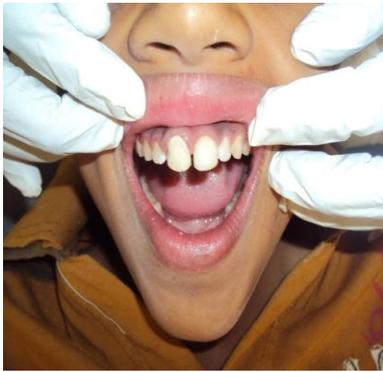
Fig 2c: Case No 2 after treatment

Root canal treatment of tooth 21 was re-done and completed in a single visit.

Post pin was inserted and a composite crown incrementally built-up.

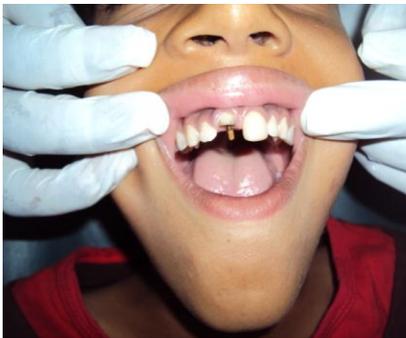
Fig 2d: Case No 2 Treatment of tooth No. 11

Several months later, the patient came with a dislodged crown 11, leaving a loose bent post.

Periapical x-ray that was taken earlier showed a severe hypo-obtured canal of #11, with the post hanging less than a ¼ of the root length.

Root canal treatment was therefore repeated.

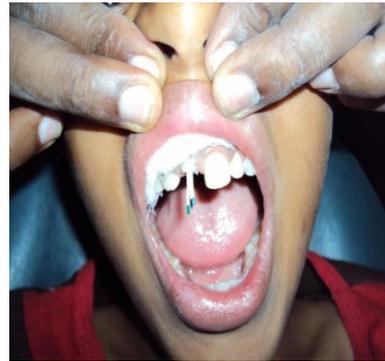
Fig 2e: Case No 2 during a second course of treatment

A longer, thinner, gold plated screw post (1-long) was inserted to reach approximately 1/3 of the root length.

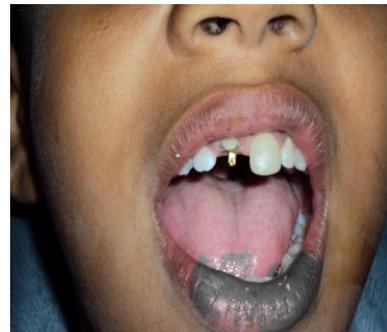
Fig 2f: Case No. 2 during a second course of treatment

The tooth was cored with GIC, then a composite crown was incrementally built up to match the opposite and adjacent teeth.

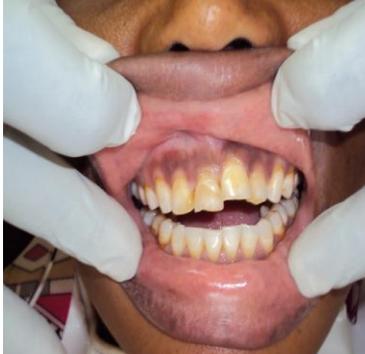
Fig 3a: Case No 3 before treatment

On dental examination, she was found to have dental fluorosis with intrinsic stains of all the teeth at varying degrees. She also had a malocclusion due to labially displaced and slightly intruded tooth 21 due to trauma at her early age. Tooth 22 was slightly displaced palatally due to an accident. The upper teeth were more discolored than the lower teeth.

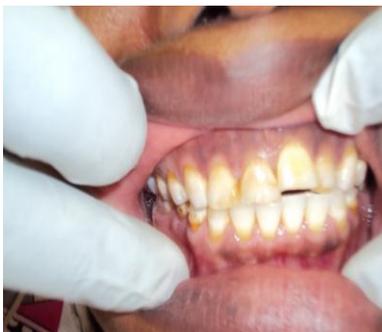
Fig 3b: Case No 3 during the course of treatment

Under Local Anaesthesia, veneering and restoration / correction of upper anterior teeth (14 – 24) were done on several visits.
