## SHORT COMMUNICATIONS, NOTES AND REPORTS

### **Bird-strike of a Cinereous Vulture *Aegypius monachus* in the Balearic Islands, Spain**

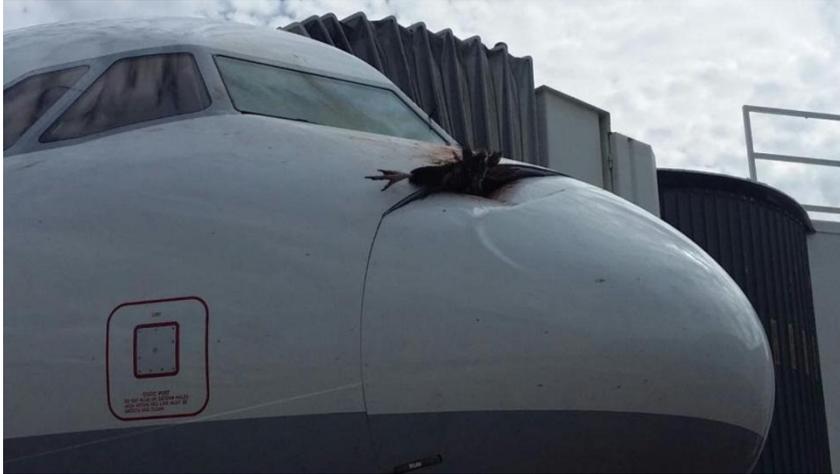
On 15 September 2016 a Lufthansa flight *en route* from Munich (Germany) to Palma de Majorca (Balearic Islands, Spain) was on its final approach and descent at 11h55 when a Cinereous Vulture *Aegypius monachus* smashed into the radome causing enough damage to cancel the return flight (Figure 1). The remains of the vulture were collected by the Airport Falconry services and stored at the Balearic Island Rehabilitation Center (COFIB) for examination. Species identification and age diagnosis was made based on the remains: the right thigh, tibia, tarsus, claws, toes and feathers, in comparison with other live birds.

**Figure 1:** Cinereous Vulture remains smashed in the radome of the Lufthansa flight in Majorca on 15<sup>th</sup> September 2016.

The rest of the body was not recovered. The remains belonged to an immature bird more than one year old, not a fledgling nor an adult. This incident occurred at an altitude of 5000 feet, (1525 m a.s.l.) and 17 nautical miles from runway 24L. Considering the altitude of the area of around 100 meters, the bird was flying at 1400 m above ground. We have not found any other Old World vulture bird-strike in the bibliography except that of a Rüppell's Griffon in Ivory Coast (Laybourne 1974) and four African White-backed vultures in Kenya (Owino et al. 2004). These latter events are perhaps due to the close
