# Geospatial Assessment of Vegetation Changes around the Odublasi Quarry in Ghana

## Abstract

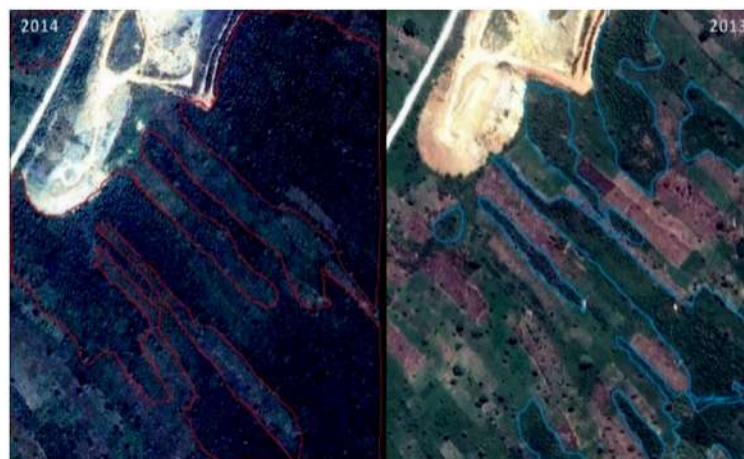
Figure 4: Aerial view of the South Eastern boundary of the Odublasi quarry in 2014 and 2013

while the southeastern boundary is shown in Figure 4. Similarly, the southwestern boundary of the quarry is shown in Figure 5 while the northwestern boundary is shown in Figure 6. Figure 7 illustrates the various land use and land cover types that prevailed around the quarry site in 2007, 2012, 2013, and 2014. It shows a trend in how the vegetation in the area around the quarry site was modified with potential implications on the biodiversity of the area.

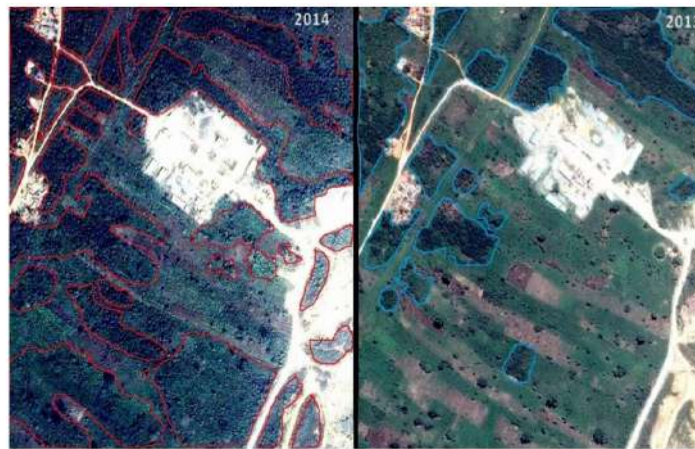
Figure 6 Aerial view of the North Western boundary of the Odublasi quarry in 2014 and 2013

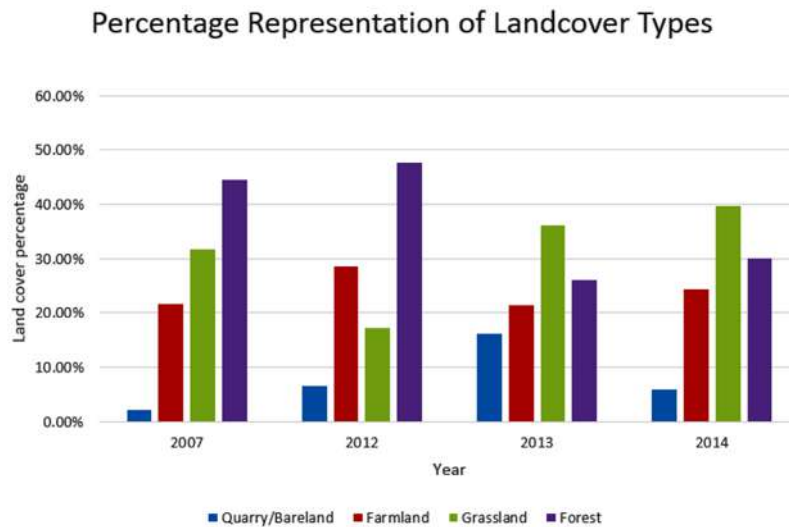
Figure 8 Percentage of land cover types around the Odublasl quarry site from 2007 to 2014

Data in Figure 8 below shows that the percentage of each land cover type around the quarry changed from year to year. In both 2007 and 2012, forest cover contributed the largest land cover type surrounding the quarry site. While in 2013 and 2014, grassland represented the largest land cover type around the quarry site. It is also observed that the area covered by the actual quarry site and areas of bare land (including road network) increased from 2007 through to 2013, before reducing in size in 2014 (Figure 8).

In Figure 7, Figure 8, and Table 2, it is clearly observed that the quarry expanded in size from 2007 to 2014. The size of the quarry increased by as much as 204.58% (114.76 acres) from 2007 to 2012 (Table 3). In 2012 an additional access road was constructed to connect the southern border of the quarry to the main road (Figure 7). It is noted that farms were heavily sited along the two access roads leading to the quarry site, especially in 2012. The roads may have created easy access for locals to exploit

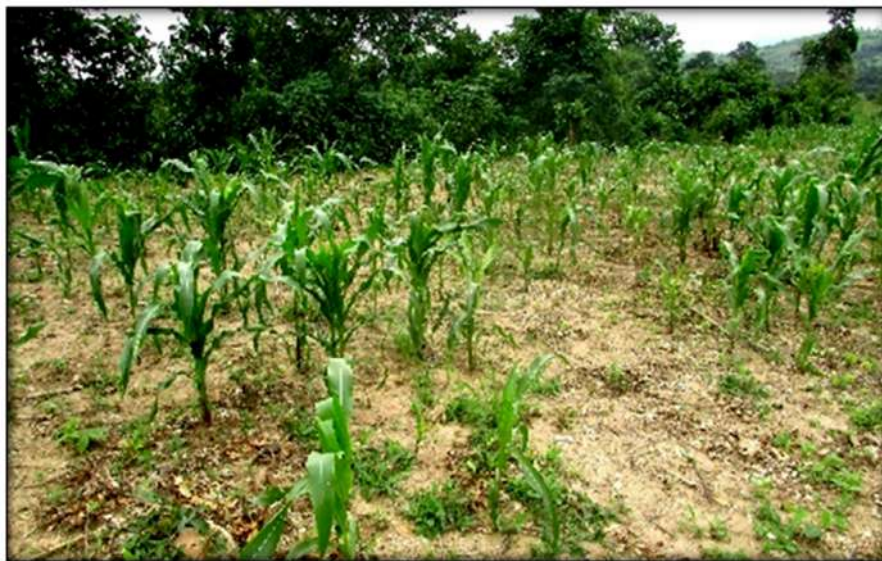
Plate 1 Spotted maize farm around the quarry site

hitherto inaccessible forested areas. Field observations showed farmers in the area often employ unsustainable farming practices like slash and burn, clearing out forest trees and heavy application of pesticides. These may have had potential negative impacts on the vegetation and consequently the biodiversity in the area; the level of diverse lifeforms in the area declined. Negative implications of road constructions on forest ecosystems are cited in literature on a number of occasions (Sonter et al, 2014; Lindenmayer & Fischer, 2013).

Generally, these modifications have been reported to be negative impacts on biodiversity (Phalan, et al., 2011). This was confirmed by the unsustainable farming practices witnessed in the area during field visits, with little consideration for Agri-silviculture for example. In addition, wood logging was observed in the area and is partly used for

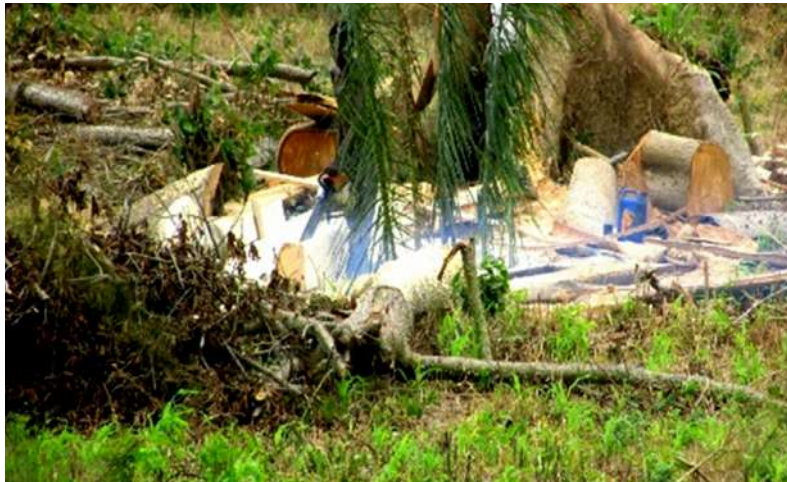
Plate 2 Spotted wood logging activities ongoing around the quarry site

the local construction industry with flooring material (Terrazzo). The acquisition of the quarry site by Ghacem inevitably meant the majority of the community members lost their livelihoods in stone quarrying. Alternatives such as farming, hunting of game, wood logging and charcoal making became new sources of livelihood for the affected people. These alternative livelihoods, however, are considered as strong drivers of vegetational cover change with implications on the biodiversity of forested areas (Norrison, et al., 2010; Gyasi, et al., 1995).

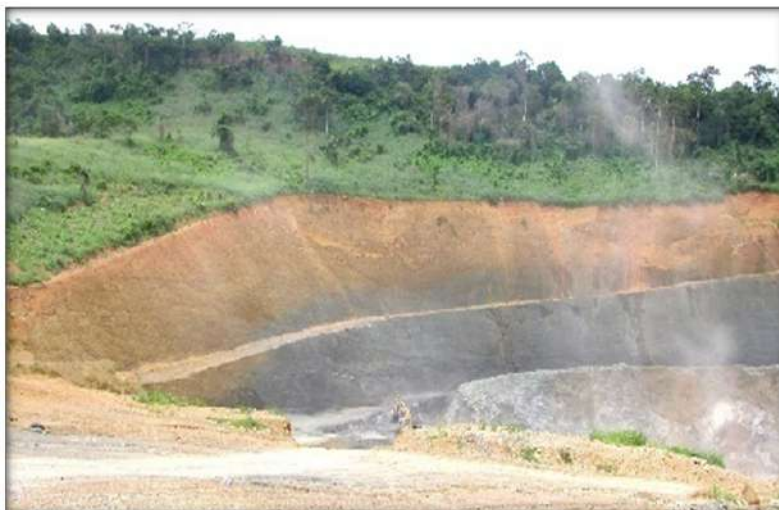
Plate 3 Vegetation cover of the quarry hill

Plate 3 highlights an area which is reasonably inaccessible due to its height above ground and sloping nature. Most people will consider it rather dangerous to venture into those parts around the quarry site. Per this observation, it is expected that plant diversity in the area could remain high and fairly constant

over a longer period of time, due to little or moderate anthropogenic interference. The vegetation may eventually attract animals to it occasionally, but its proximity to the quarry could cause consistent fleeing of animals from it, especially during rock blasting episodes and the generation of loud noise by rock crushing machinery.
