# Morphodynamics of the Manyema Tidal Delta at Kunduchi, Tanzania

**Abstract**—The prevailing northward longshore drift of beach sand on the northern part of Msasani Bay, north of Dar es Salaam, is interrupted at Kunduchi by the tidal flushing of Manyema Creek, a mangrove ecosystem partially developed for salt production. Shoreline changes around the creek mouth in recent decades have eroded coastal land and destroyed buildings, prompting stakeholders to construct protective groynes and revetments. Sand is transported across the delta by the interaction of two forcing processes – currents that flush the creek in response to tidal variation and, more generally, those generated by monsoonal wind-driven waves. A study of the sand morphology of the creek and delta platform together with time-series satellite imagery permitted demarcation of the respective sand transport pathways and morphodynamic changes in the delta over the last decade. The sand transport regime has promoted erosion of the shore to the south of the creek mouth, and has resulted in intermittent delivery of sand to beaches north of the channel. Attempts to stabilise the shore around the creek mouth are described and t

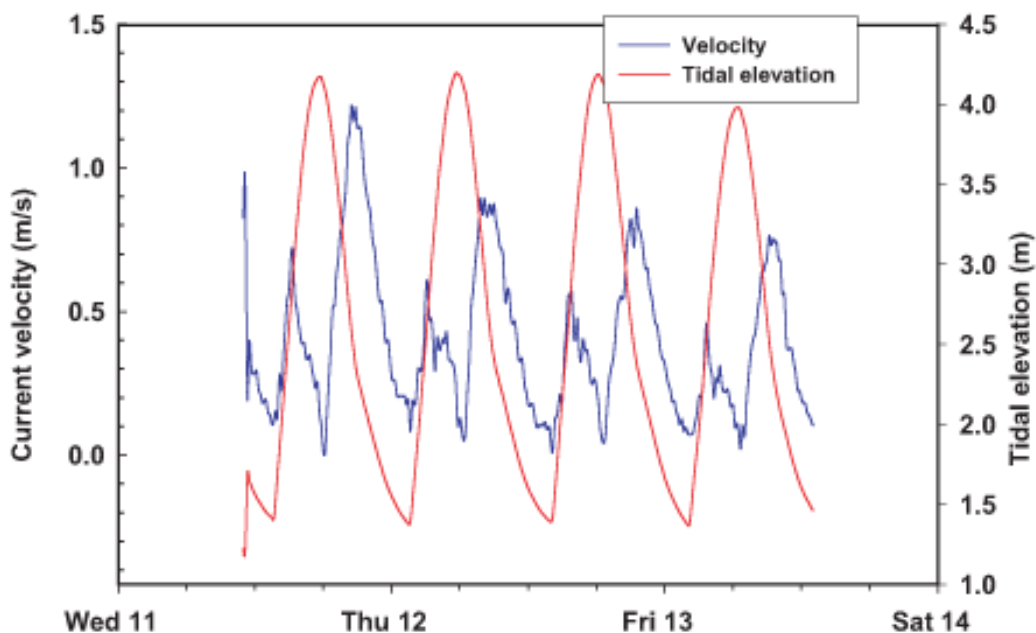
Figure 3. Tidal elevation and current velocities measured during spring tide cycles at the Manyema channel from 11–13, February 2009.

The current meter installed in the main creek channel off the Kunduchi Beach Hotel for the duration of four spring tidal cycles (Fig. 4) recorded a maximum current velocity during the flood tide of 0.7 m/s, and a maximum velocity during the ebb of 1.2 m/s (Fig. 3). The maximum velocities were attained during the middle part of the period of ebb flow within each tidal cycle.

Lower current velocities recorded by the current-meter in the flood tide compared with those in the ebb (Fig. 3) indicated greater strength in the ebb flow. Comparable ebb-current dominance has been reported at Mtwapa Creek near Mombasa in Kenya (Magori, 2004). We interpreted the observed dune bedforms as being formed by currents during the middle part of the ebb tidal discharge from Manyema Creek (Fig. 3), along the main creek channels and within a well-defined tract from the creek mouth across the platform (Fig. 2). Because the platform was submerged by the rising

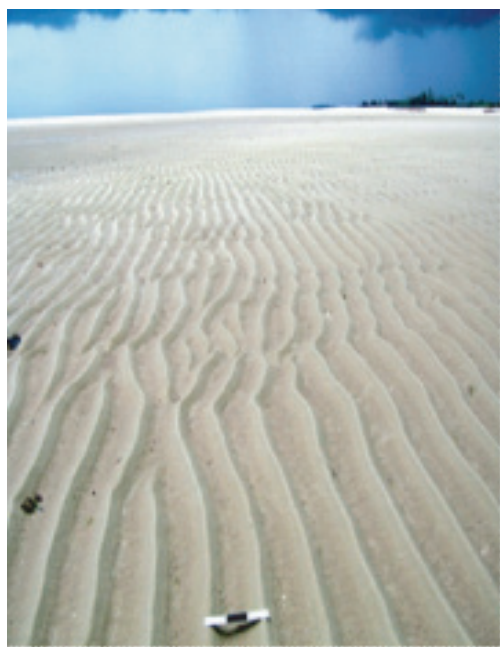
Figure 7. Current ripples on the sand flat north of the creek mouth at low water, 8 April 2008, view to S; leeward faces (in shade) indicate shoreward sand transport. Total scale bar length = 30cm.

The ripples on the sand flats forming the platform to the north and south of the dune tract were aligned NNW, lying generally parallel to the shore. They had wavelengths of 25–35 cm and were asymmetrical in cross-section, their steep leeward flanks indicating shoreward sand transport (Fig. 7). The rippled flats

Apart from the dune tract, the current ripples and swash bars of the platform consistently indicate shoreward transport of the sand except in areas subject to wave diffraction, assuming that they lie perpendicular to the direction of the current which formed them (Fig. 7). The time-series satellite imagery of the northern part of the platform revealed that the swash bars themselves migrate shorewards, as a group *en échelon* (Fig. 8). Intermittent swash-bar welding (FitzGerald *et al.*, 2000) on the northern shore of the creek mouth results in beach sand budgets that are inter-annually sparse or rich.

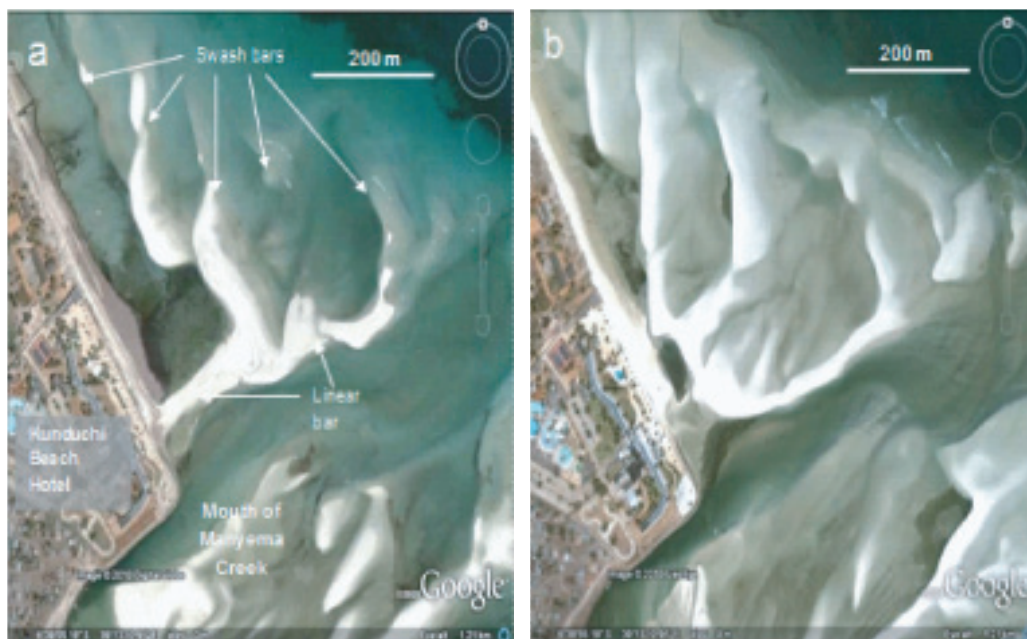
Figure 8. Time-series images of the delta platform off Kunduchi Beach Hotel: a) 20 December 2003 ©2010 DigitalGlobe; b) 8 November 2005 ©2010 GeoEye.

consisted of medium sand, with some locally coarse-grained sand, and were greenish-buff in colour. Their associated swash bars, also mainly of medium-grained sand, were pale buff and had crescent-shaped crests up to two metres above the surface of the flat. The swash bars were typically asymmetrical in cross-section, with their steep, leeward slopes facing shoreward. The swash-bars formed a series on the northern part of the platform *en échelon* between the platform's seaward fringe and the shore. Time-series satellite images captured stages in the morphodynamics of these sand bodies (Fig. 8), illustrating the process by which individual banks migrate and ultimately coalesce with the shore in what is referred to as "swash-bar welding" (FitzGerald *et al.*, 2000). After a period of beach erosion, part of the revetment at the Kunduchi Beach Hotel (Fig. 8) was overwhelmed by sand delivered by this
