Integrated Geophysical Investigation of the Causes of Road Pavement Failure along Ibadan-Lagos Dual-Carriage, Southwestern, Nigeria.

^{*1}LAYADE, GIDEON O; ²ADEGOKE JAMES A; ²OYEWOLE, IGE TEMITOPE

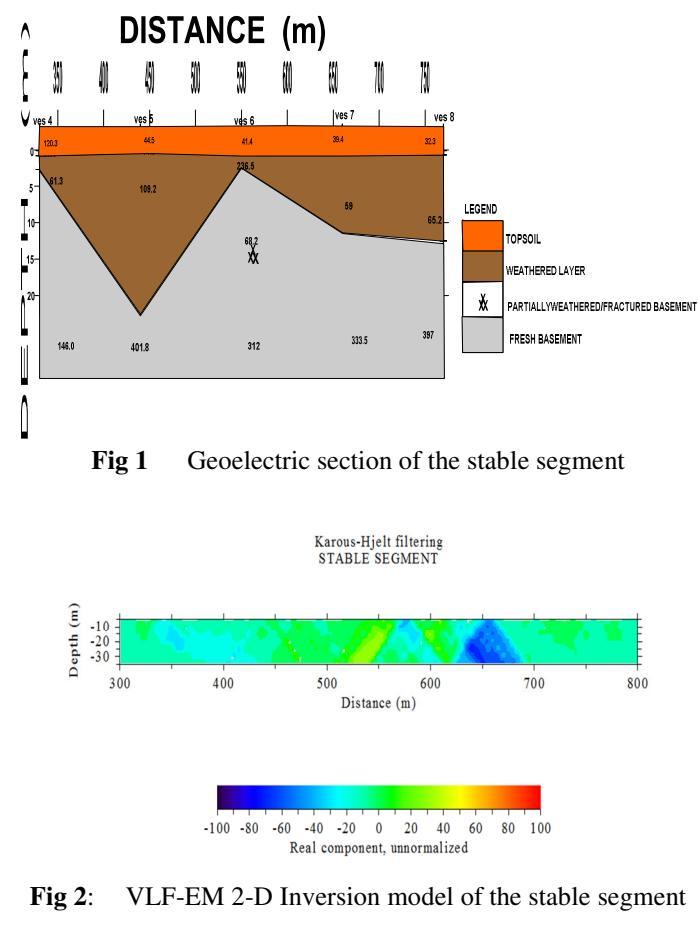
The geoelectric section (figure 1) delineates four subsurface layers which are topsoil, the weathered layer, the fractured layer and the fresh basement at the most stable segment of the road. The topsoil has a resistivity value ranging from $32 \Omega m$ to $120 \Omega m$ corresponding to clay and clayey sand respectively; the topsoil thickness varies between 0.3 to 0.9 m. The VLF-EM 2-D model (Figure 1) identified some linear features which display a fairly conductive medium, this can be seen along 550 to 650 m along the road pavement (yellow and red colour displays fairly and high conductive medium respectively). The identified linear feature along this road segment has a significant depth of about 9.3 m. The stability of the road may have been due to the lateritic soil observed at the second layer (Akintorinwa et al., 2010) (Figure 1). The stable segment of the road is generally devoid of linear geological features such as fractures, faults, lithologic contact as it can be seen in figures 2-5 representing the raw and filtered measured data.
