INFLUENCE OF VIBRATION ON SUB-BALLAST LAYER INDUCED BY LOADING APPLICATION ON A FOULED TRACK BALLAST

Onwube, A. U., Mashros, N., Yusoff, N. A., and Eberemu, A. O. "Influence of Vibration on Sub-Ballast Layer induced by Loading Application on a Fouled Track Ballast", *Nigerian Journal of Technology*, 2024; 43(1), pp. 35 – 43; <https://doi.org/10.4314/njt.v43i1.5>

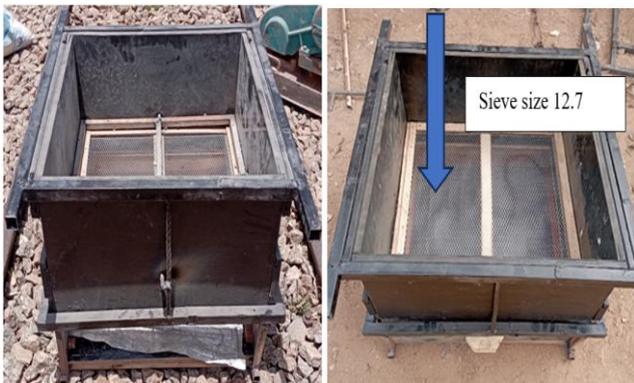
Figure 1: Fabricated ballast box

A track ballast bed encompassing both the main ballast and sub-ballast layers was constructed within a rectangular box (Figure 1). This box, known as the ballast box, has a total weight of approximately 24.5 kg. It was built from rectangular wooden sheets with a thickness of 15 mm. It also incorporated a hollow metal pipe with dimensions of 20 mm by 20 mm and a thickness of 2 mm. The ballast box, as illustrated in Figure 2, was partitioned into two layers, mirroring the arrangement of the main ballast and sub-ballast layers found within a track bed system. The upper layer,

corresponding to the main ballast, had dimensions of 300 mm in depth, 450 mm in length, and 300 mm in width. The lower layer, representing the sub-ballast, had dimensions of 200 mm in depth, 450 mm in length, and 300 mm in width.

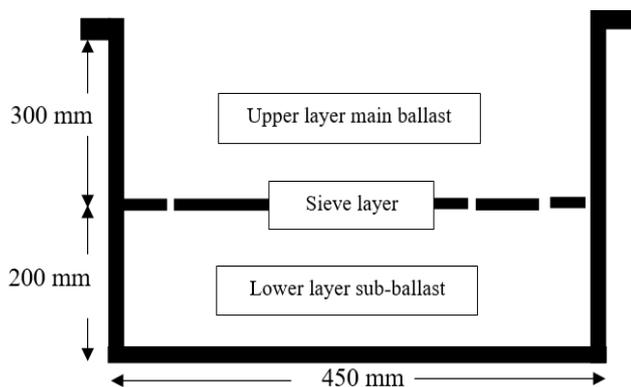
Figure 2: Ballast box layout

These chosen dimensions represented a section of the track and accurately replicated the actual depth of the layers within a track ballast bed along the Abuja-Kaduna standard gauge line. Between these two layers of the ballast box, a sieve with an aperture size of less than 12.7 mm was affixed to the underside of the main ballast layer. This design allowed fouling materials to pass into the sub-ballast layer below during periods of vibration induced by loading. Following Ocholi et al. [29] and NRC Lecture Note [30], a sieve size of 12.7 mm was selected, as any smaller materials are classified as fouling material in Nigeria.

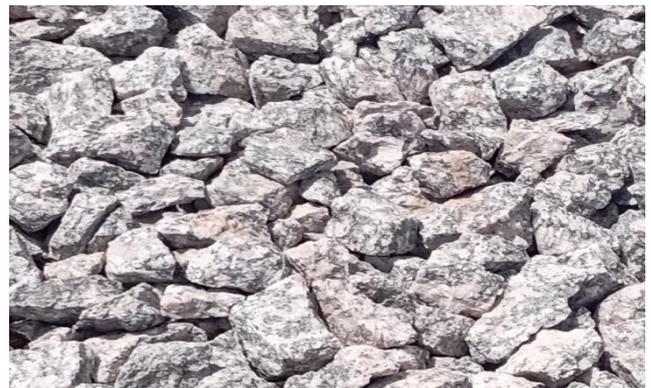
Figure 3: Ballast aggregates

The ballast aggregates shown in Figure 3 below were selected in accordance with the aggregates employed on the Abuja-Kaduna standard gauge track. A total of 100 kg of clean aggregates were carefully sampled from the ballast dump at the rail site and subsequently sieved. This sieving process was employed for a combination of aggregates ranging from 12.7 mm to 50.8 mm according to British Standard (BS 812 Part

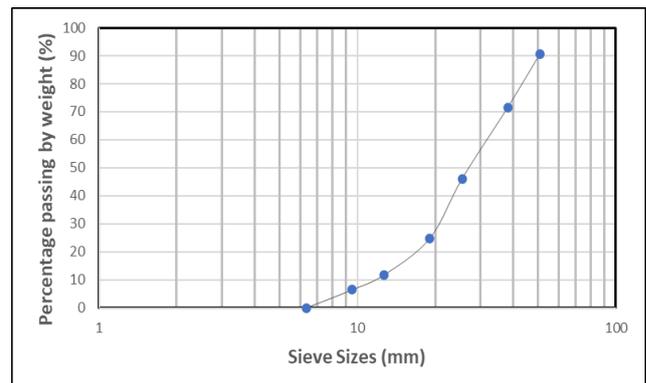
Figure 4: Particle size distribution of ballast aggregates

103.1-1985). The resulting particle size distribution curve is depicted in Figure 4.

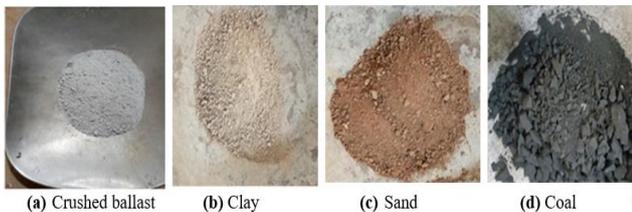
Figure 5: Selected fouling materials

The ballast aggregates were investigated in relation to four types of fouling materials, encompassing crushed ballast stones, sand, clay, and coal (Figure 5). These four fouling materials were selected because they are the common type of fouling material along the selected track study area. The crushed ballast fouling was obtained from crushing ballast aggregates using an impact load machine. The sand fouling was obtained from surrounding track sides, which eventually entered the track bed through the wind effect as trains passed. The clay fouling was obtained from clay deposits not very far from the rail track, and the coal fouling was obtained from a coal mining company that freighted coal through the rail.

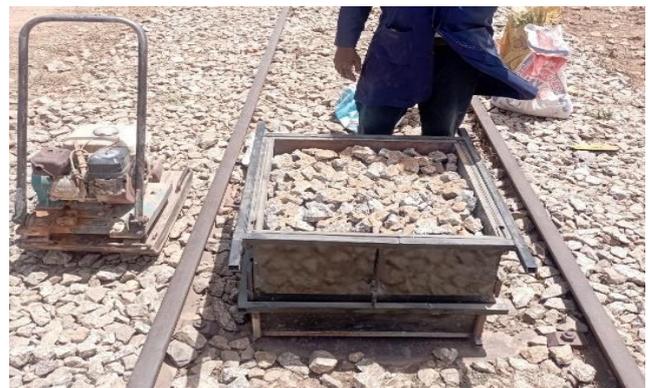
Figure 6: Ballast box filled with aggregates and specific types of fouling materials

The 100 kg of clean aggregates were combined with a specific type of fouling material before being placed in the ballast box. The utilised quantity of fouling material is given in Table 2. This combination, known as a fouled ballast, was placed and compacted on the upper layer of the ballast box using a tamping rod. A ballast box filled with a combination of aggregates and selected fouling materials is shown in Figure 6. The

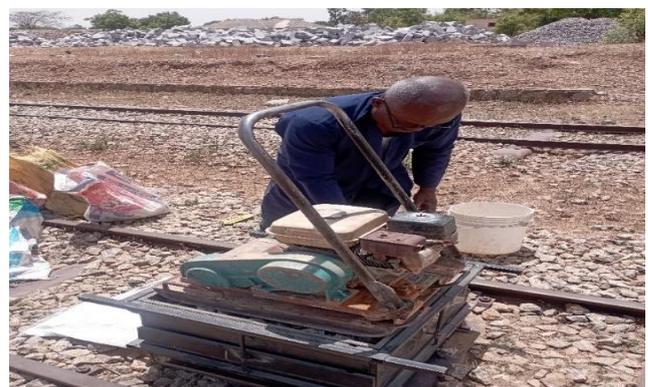
Figure 7: Vibratory compactor machine mounted on ballast box

Additionally, this study utilised a vibrating plate compactor machine with an approximate weight of 200 pounds (91 kg/0.091 tonnes) and the ability to generate around 10,000 vibrations per minute. This machine was used owing to the need to replicate the vibrations induced by passing trains during the application of loads. The vibrating plate compactor machine simulated the behaviour of a 21-ton (21,000-kg) axle on the ballast based on the axle load observed

vibratory plate compactor machine was mounted on the fouled ballast in the ballast box (Figure 7). The vibratory plate compactor machine was utilised in five-second intervals over a period of 30 seconds to facilitate the percolation of fouling materials into the sub-ballast through the voids in the ballast. The fouling materials that infiltrated the sieve with an aperture size of 12.7 mm were gathered every five seconds using a polythene bag laced on the sub-ballast layer. The collected materials were then removed from the ballast box, weighed (Figure 8), and recorded.

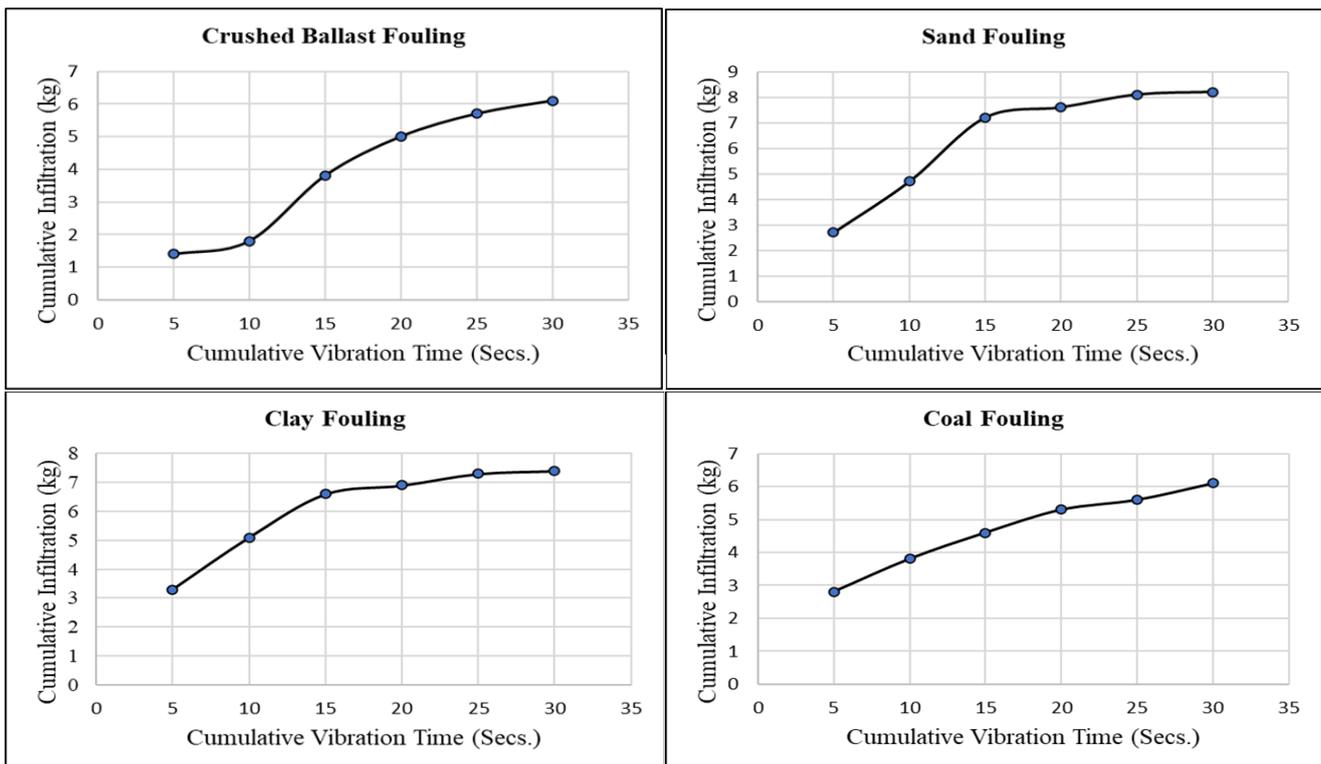
Figure 9: Fouling infiltration into sub-ballast during 30 seconds of vibration

Figure 9 illustrates the cumulative infiltration of various fouling materials into the sub-ballast layer during a 30-second vibration period. The data clearly demonstrates that the cumulative infiltrations for each fouling material progressively increase with the duration of vibration. This observation aligns with the finding of Esmaili et al. [33] that the ballast fouling percentage increases with an increase in environmental vibration due to train passing assessed by acceleration and displacement. Track vibrations caused by acceleration are another contributing factor to the downward movement of particles in the ballast layer, as stated by Bian et al. [9]. Thus, as vibration intensity increases, the amount of fouling particle material that infiltrates the sub-ballast layer also increases. At five seconds of vibration time, clay

fouling exhibited the highest cumulative infiltration (3.3 kg), followed by coal (2.8 kg), sand (2.7 kg), and crushed ballast (1.4 kg).

Similarly, at 10 seconds, clay fouling continued to lead in terms of cumulative infiltration (5.1 kg), followed by sand (4.7 kg), coal (3.8 kg), and crushed ballast (1.8 kg). Notably, at five and 10 seconds of cumulative vibration time, clay fouling infiltrated more than the other three fouling materials. Clay fouling led to more cumulative infiltration in the first five and 10 seconds compared to others at the initial stage due to its fine nature. The fine clay particles had more space in between the ballast voids to pass through; they served as a lubricating agent and reduced particle interlocking. Particle movement and behaviour due to vibration are forms of translational

However, at 15, 20, 25, and 30 seconds of cumulative vibration time, the cumulative infiltration for sand fouling became higher than that for the other three fouling materials. Sand fouling showed cumulative infiltrations of 7.2 kg, 7.6 kg, 8.1 kg, and 8.2 kg at 15 seconds, 20 seconds, 25 seconds, and 30 seconds,

respectively. This is because the sand utilised for the study had a small amount of silt content (7.5%). The silt acted as a lubricant that strengthened the sand particles, thus enabling more of it to pass through more voids than the other three types of particles [35][36]. The amounts of cumulative infiltration for other fouling materials after 30 seconds of vibration were 6.1 kg for both coal and crushed ballast and 7.4 kg for clay.

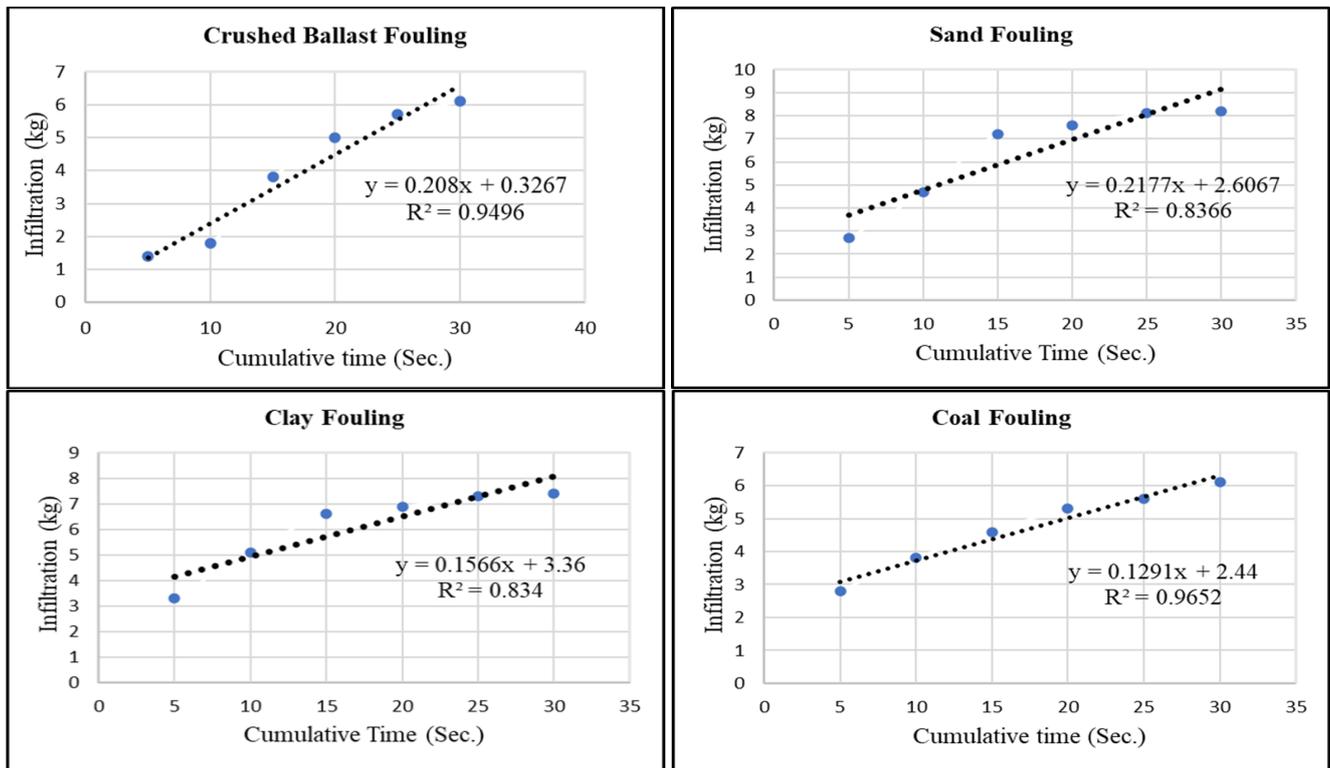
Figure 10: Relationship between vibration time and fouling infiltration

Figure 10 shows the relationship between vibration time and fouling infiltration for each type of fouling material. The regression line represents a strong positive linear relationship between vibration time and fouling infiltration. It indicates that vibration time due to loading impacts the weight of fouling infiltration into the sub-ballast layer. Under actual operating conditions, trains continuously pass over the track and generate vibrations that consequently impact fouled ballasts [3]. Consequently, all the fouling materials on the fouled ballast will become percolated and will infiltrate the sub-ballast layer. When this happens without maintenance, sub-ballast layer saturation occurs, which compromises the integrity of the sub-ballast and minimises its ability to perform optimally. Therefore, sub-ballast layer saturation should not be ignored. It should be managed with immediate and continuous maintenance to keep the sub-ballast layer in an operational state.
