Anaesthesia in the MRI suite

Reinier Swart^{a*} and William Ian Duncombe Rae^b

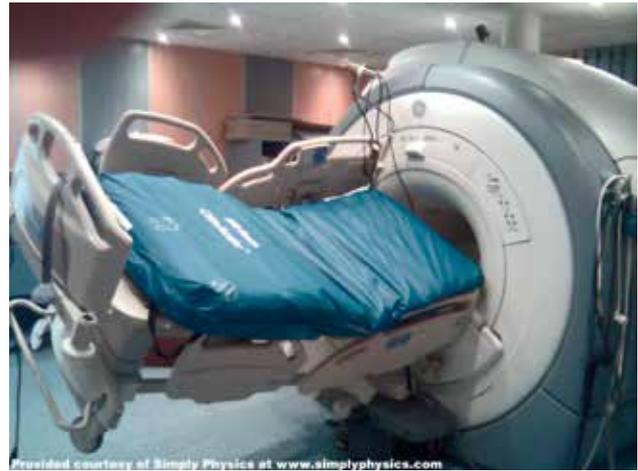
Figure 1: Hospital bed stuck to the inner bore of an MRI magnet – quenching will be the only way to release it

Not enough emphasis can be placed on the dangers of the projectile effect. Anecdotal reports of multiple fractures and internal injuries have been recorded worldwide when incompatible beds and large ferromagnetic objects (such as office chairs) have been brought into the MRI suite when absolute vigilance was not applied (see Figure 1).⁷ The projectile effect has led to injury in

both patients and staff, and is one of the only reasons why an MRI magnet may need to be quenched.
