ENVIRONMENTAL RISKS FOR GEMSTONE MINERS WITH REFERENCE TO MERELANI TANZANITE MINING AREA, NORTHEASTERN TANZANIA

EP Malisa and CP Kinabo,

Department of Geology, University of Dar es Salaam,

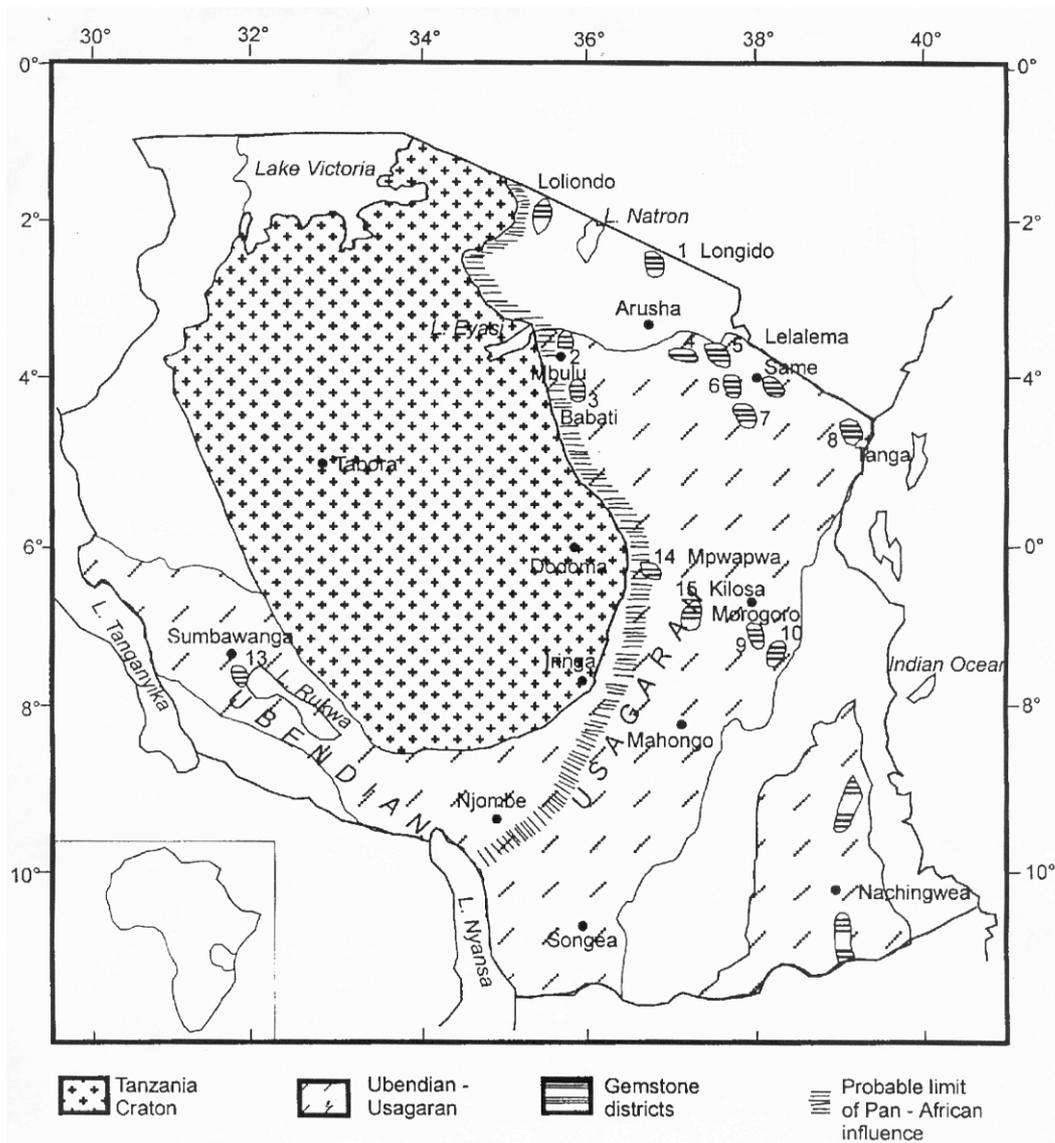
Figure 1: Sketch map showing gemstone mineralization in the Mozambique belt of Tanzania. 1) Longido, 2) Manyara, 3) Babati, 4) Merelani, 5) Lelatema, 6) Tiriri, 7) Landanai, 8) Uмба, 9) Mvuha, 10) Magogoni, 11) Namaputa, 12) Nabunju, 13) Sumbawanga, 14) Mpwapwa, 15) Kilosa and 16) Loliondo (After Malisa and Muhongo 1990).

gemstones (Fig.1). This paper concentrates on the Merelani tanzanite mining area lying near the contact between the volcanic and the high-grade metamorphic rocks of the Mozambique Belt.

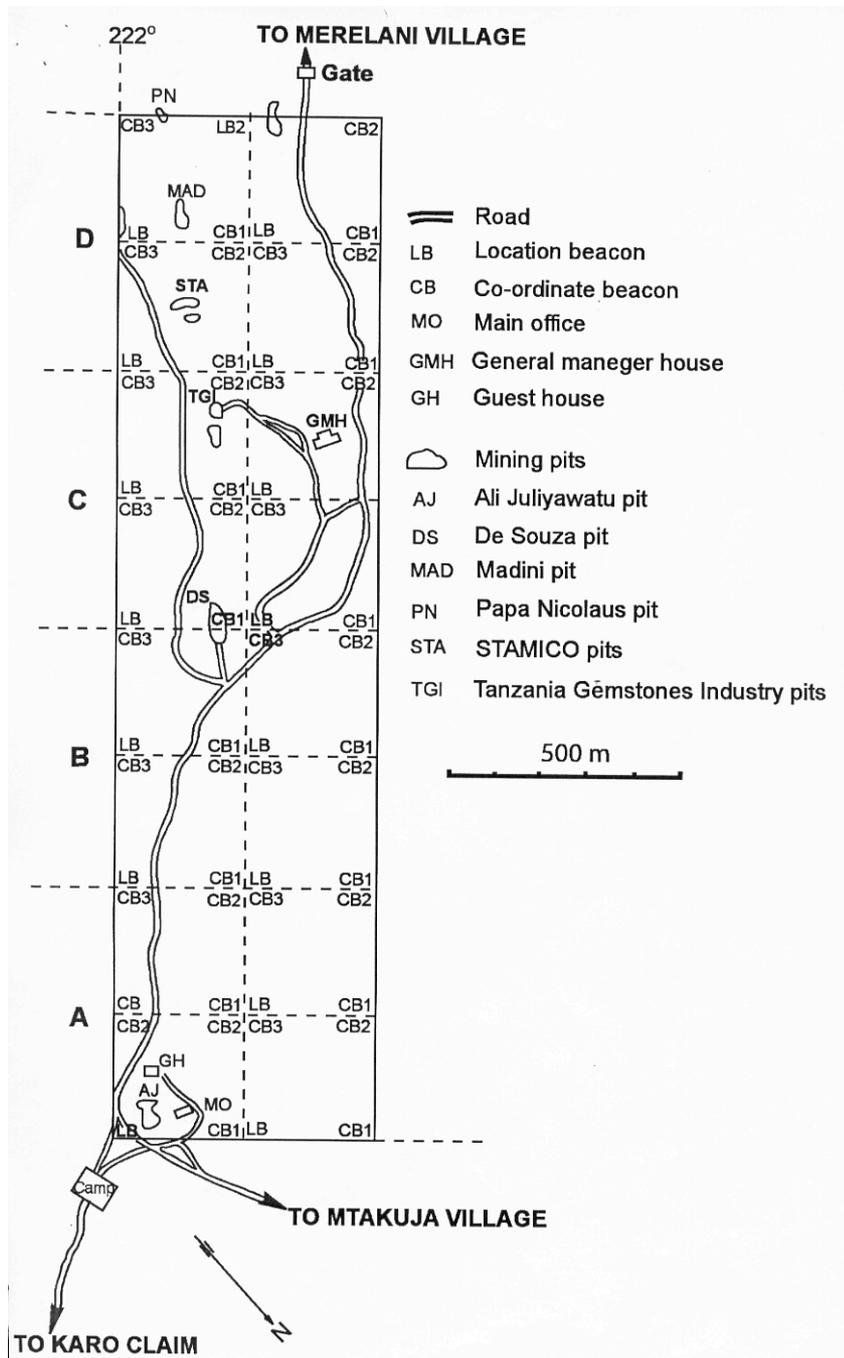
Figure 2: Tanzanite claims in the Merelani mining area, NE Tanzania (After Malisa 1987).

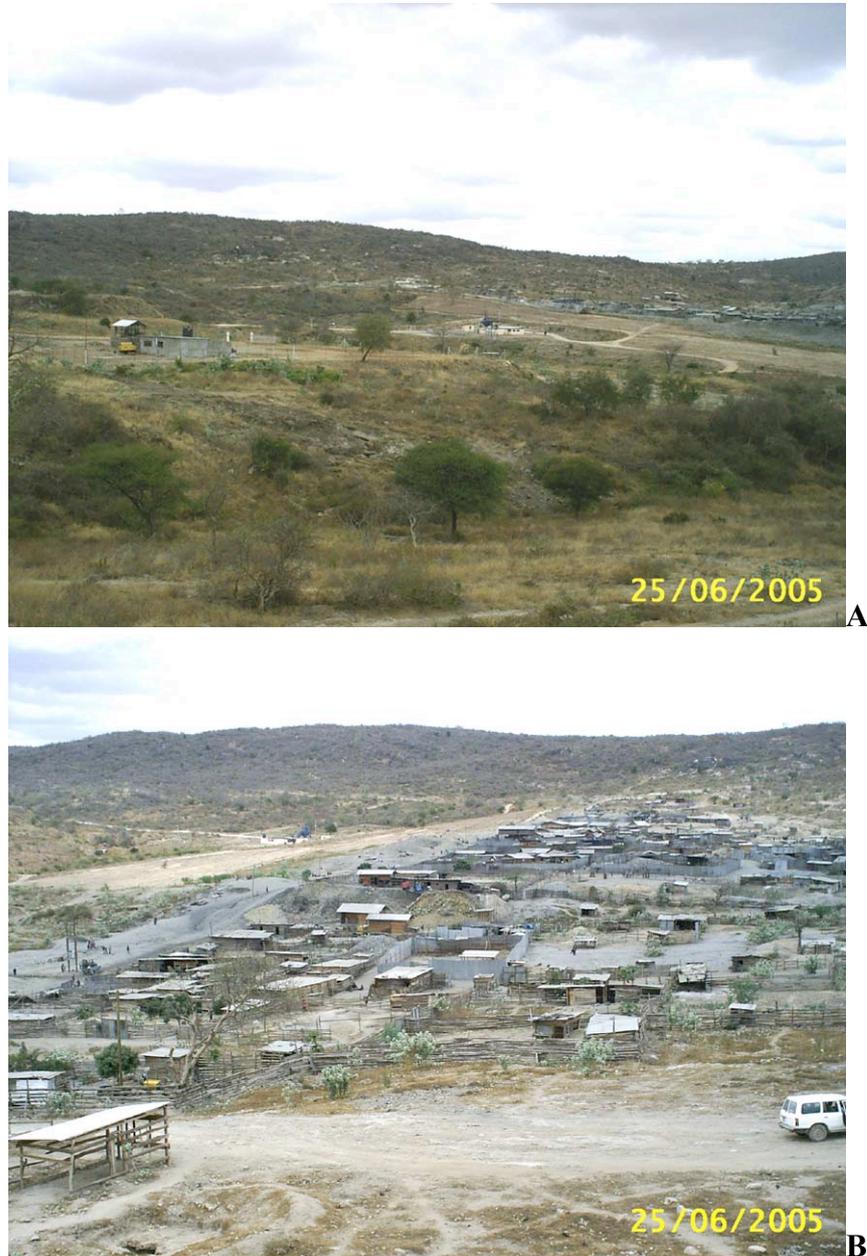
Figure 3: Photos showing A) Fenced claim of AFGEM with a patrol road around the fence. B) Local miners mining through the old mine tailings.

The date of the first discovery of tanzanite is not exactly known. However, two prospectors, Mr. Manuel de Souza and Mr. Daudi Mayaya, have laid claim to the discovery at the Merelani area Saria (1973). It is without doubt that the Masai who live and graze cattle there showed the area to them. Private prospectors and local miners continued to mine from the time of discovery until 1971 when the government of Tanzania took over the administration of all mines. In 1971-1972, the Merelani mines operated under Tanzanian Gemstone Industries Ltd. (TGI), a subsidiary of the National Development Corporation (NDC). In 1972, the newly formed State Mining Corporation (STAMICO) took over the mines. Mining was done on small scale until recently when the government split the area into blocks of which block B and D were given to small-scale miners and Block A and C to large mining companies (Fig. 2). Large mining area which was been mined by the State Mining Company was given to a South African Company (AFGEM) who fenced it (see Fig. 3A) while the some artisanal miners have small plots around the fence (see Fig. 3B).
